CALIFORNIA  
PLASTERING  
CONSULTANTS

March 28, 2022

**RE: Building 3- Soffit Collapse Evaluation  
Surfside III  
600 Sunfish Way  
Port Hueneme, CA 91041**

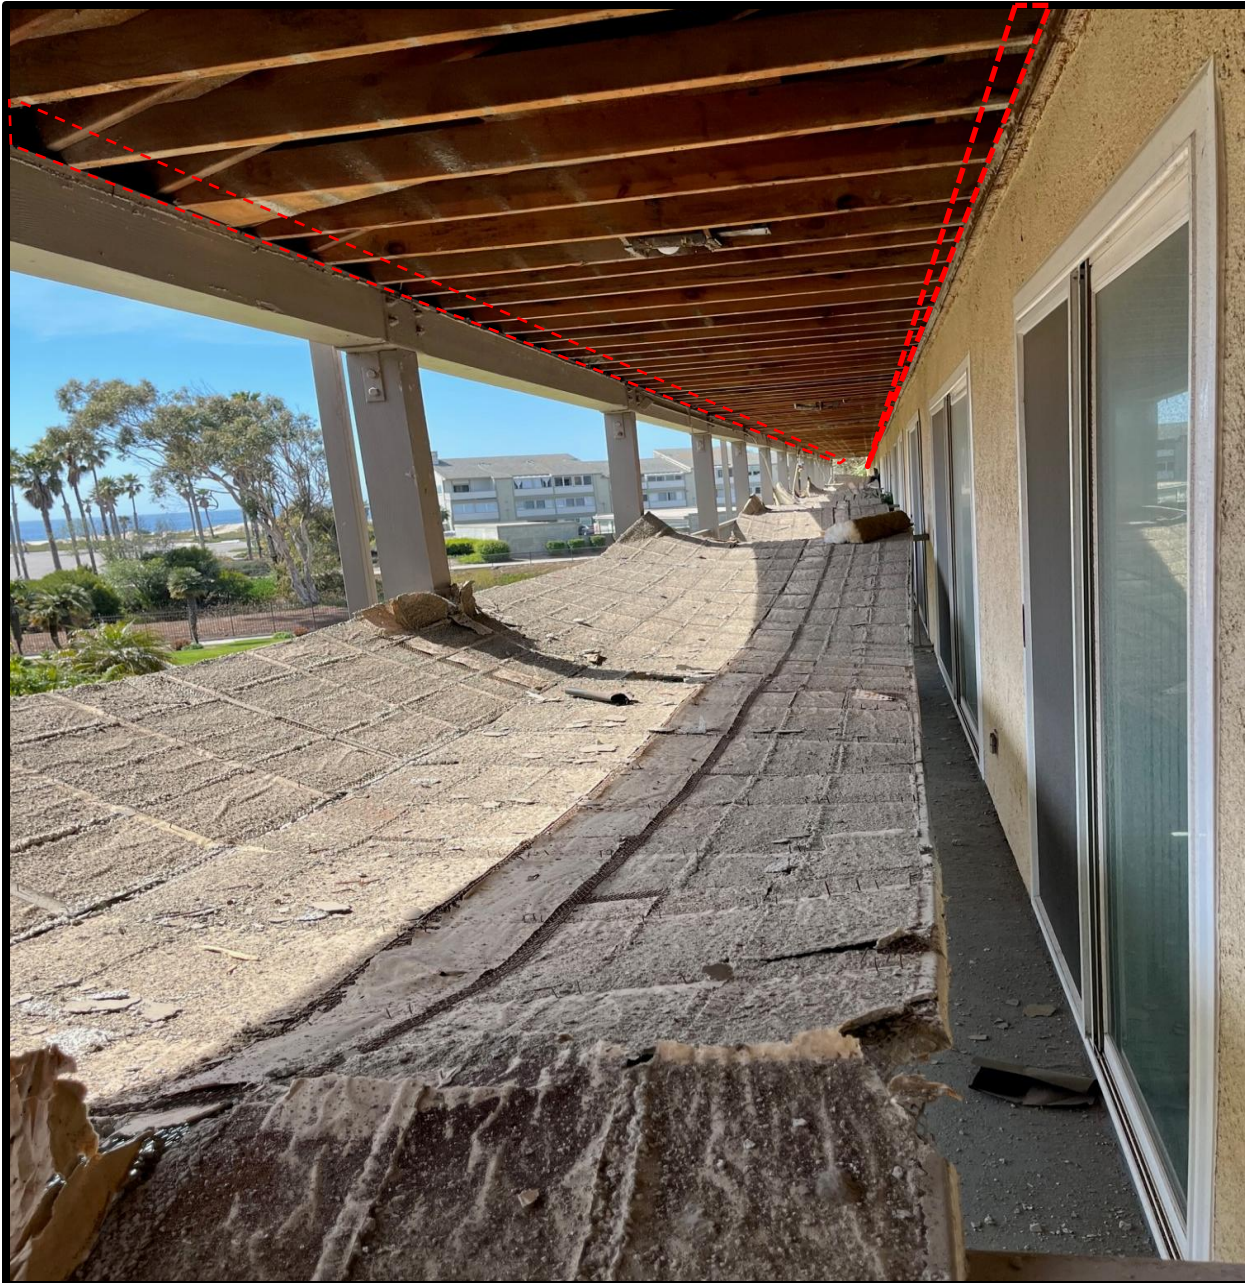
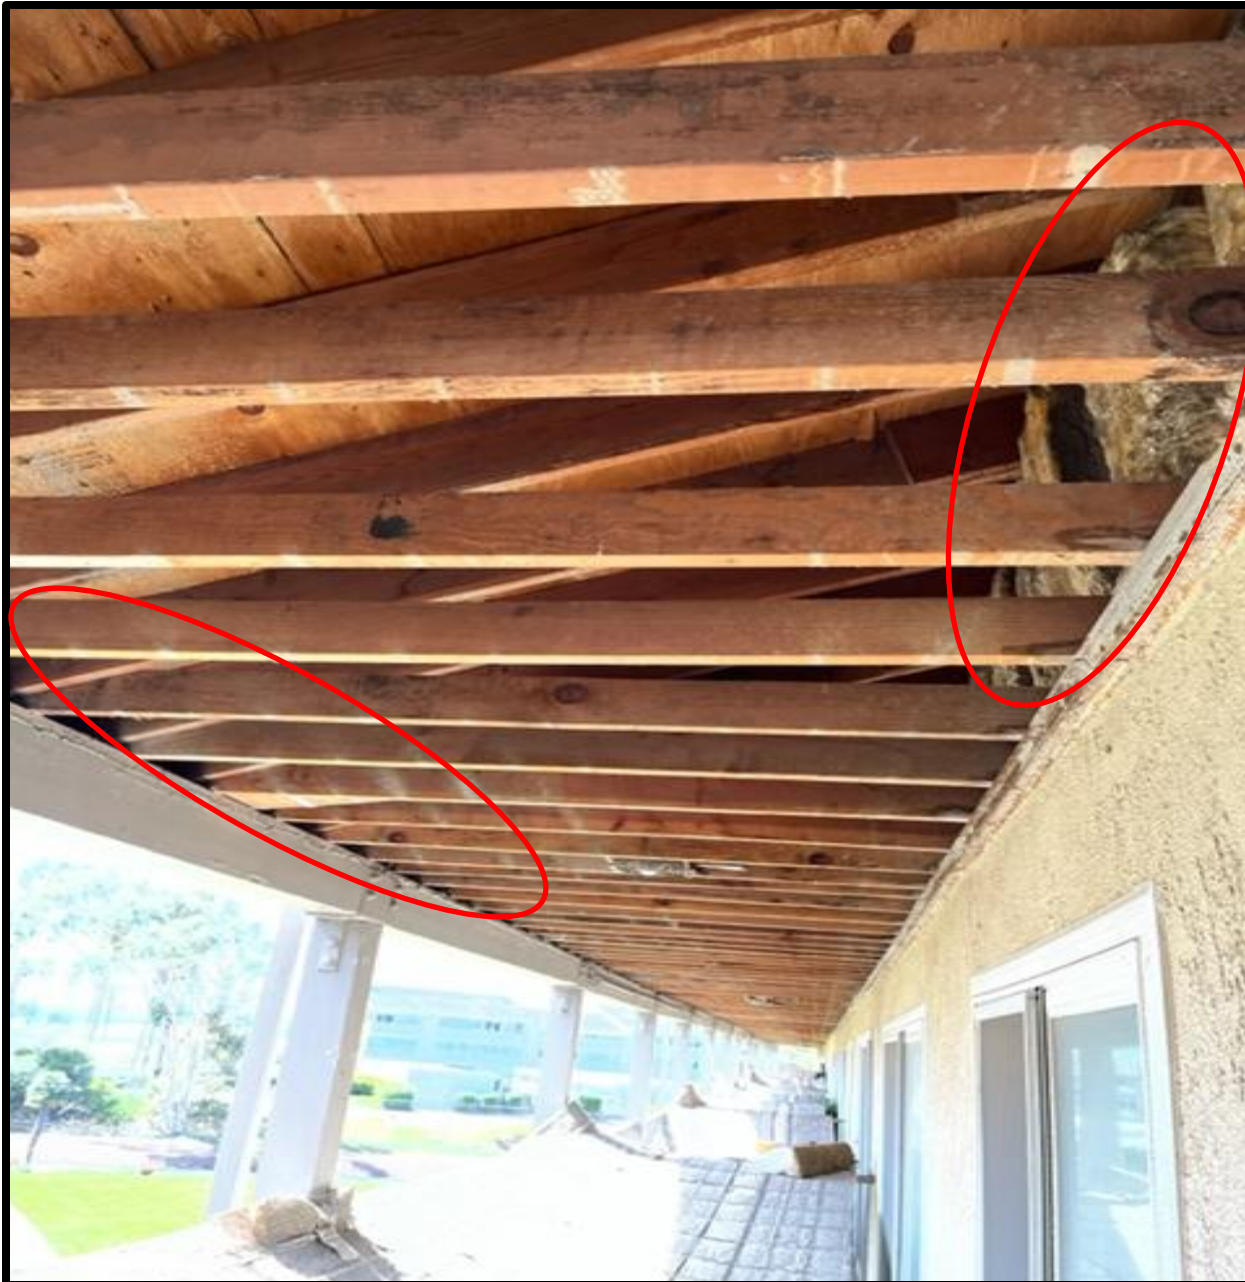
During the original construction of Building 3, boundary framing (blocking) was missing between individual stud bays, along the front and rear portions of the framed soffit (see **Photographs #001- 002**). This omission prohibited the soffit lath from being properly secured above the front soffit beam and rear vent screed. Lath staples utilized for securing the soffit lath to the framing above were only engaged at individual studs that were spaced 16-inches on center. The missing boundary blocking and consequential lath attachment undermined the holding strength of the stucco soffit.

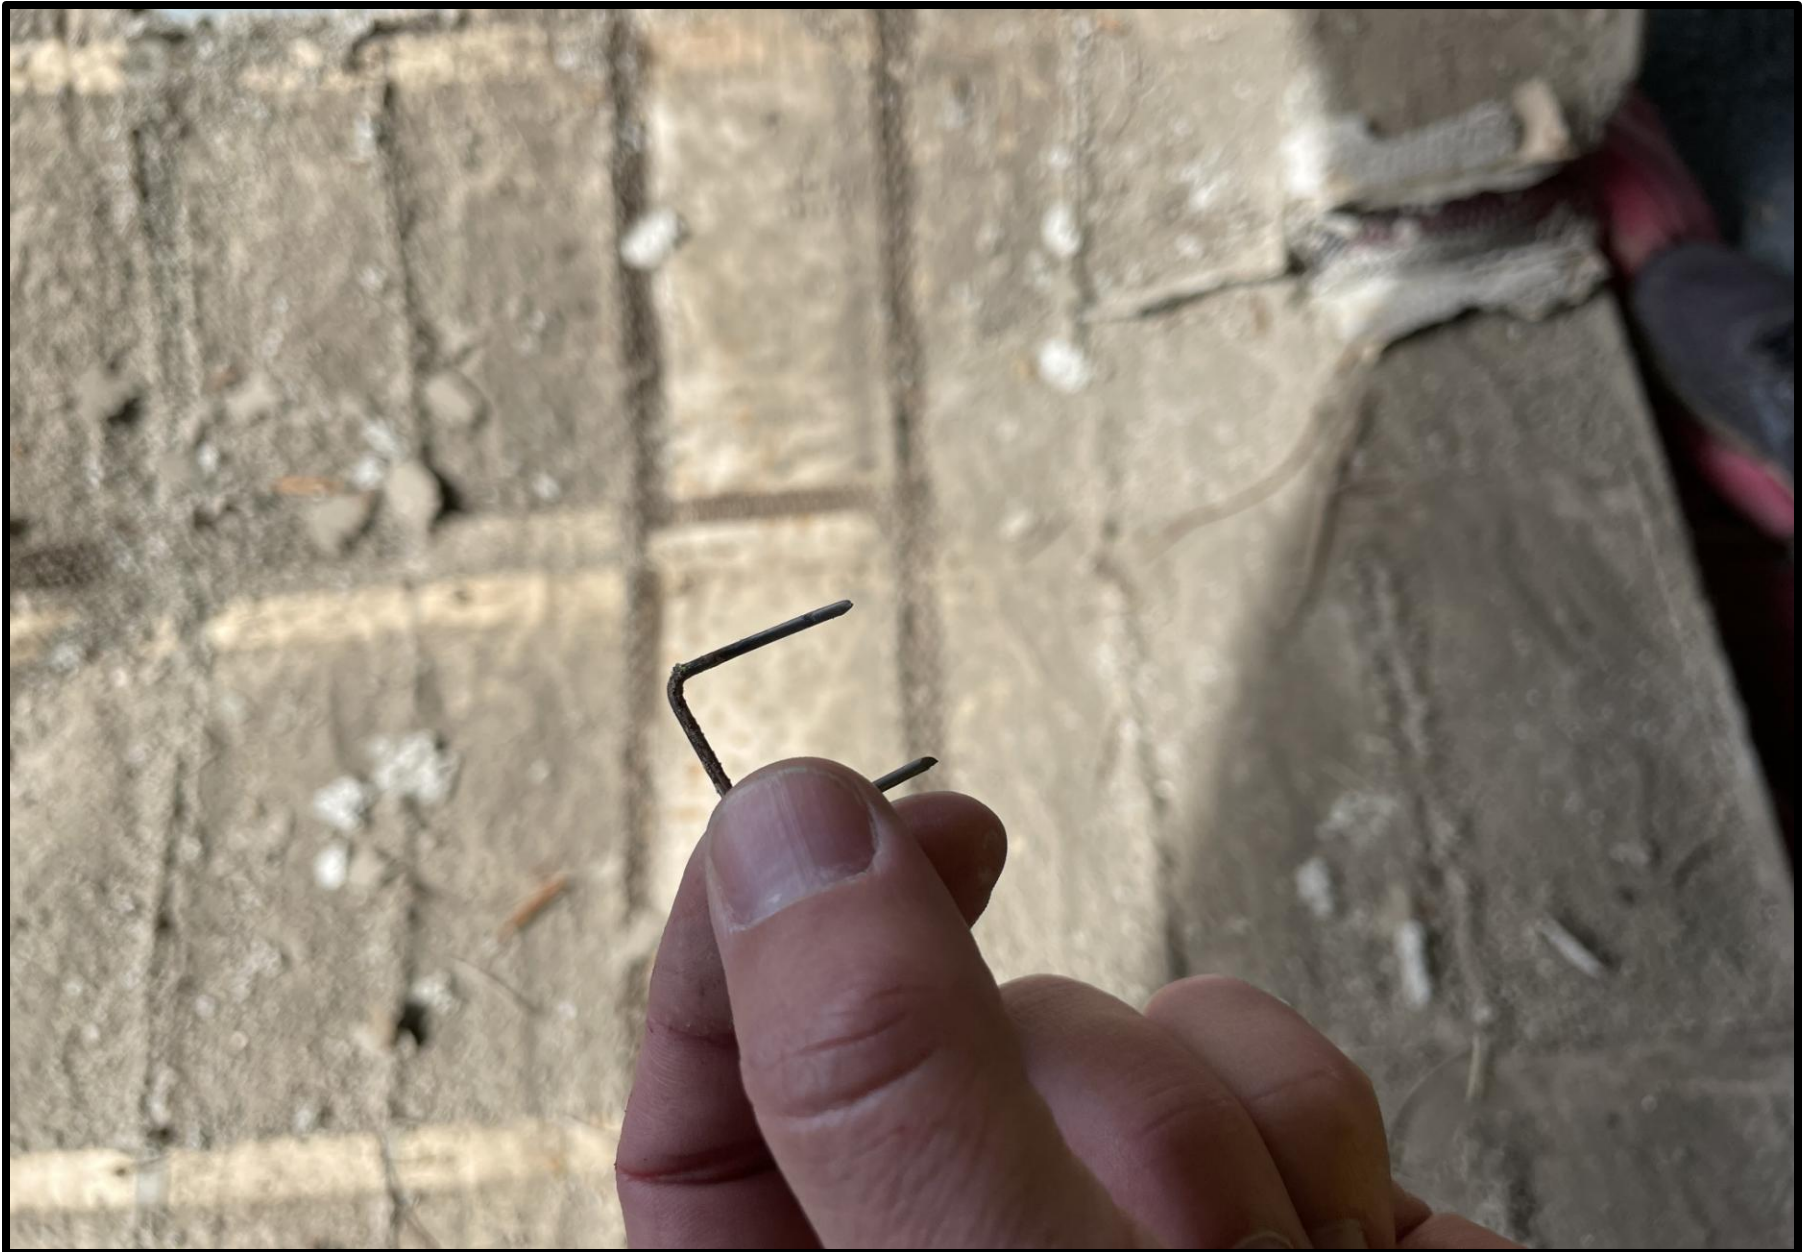
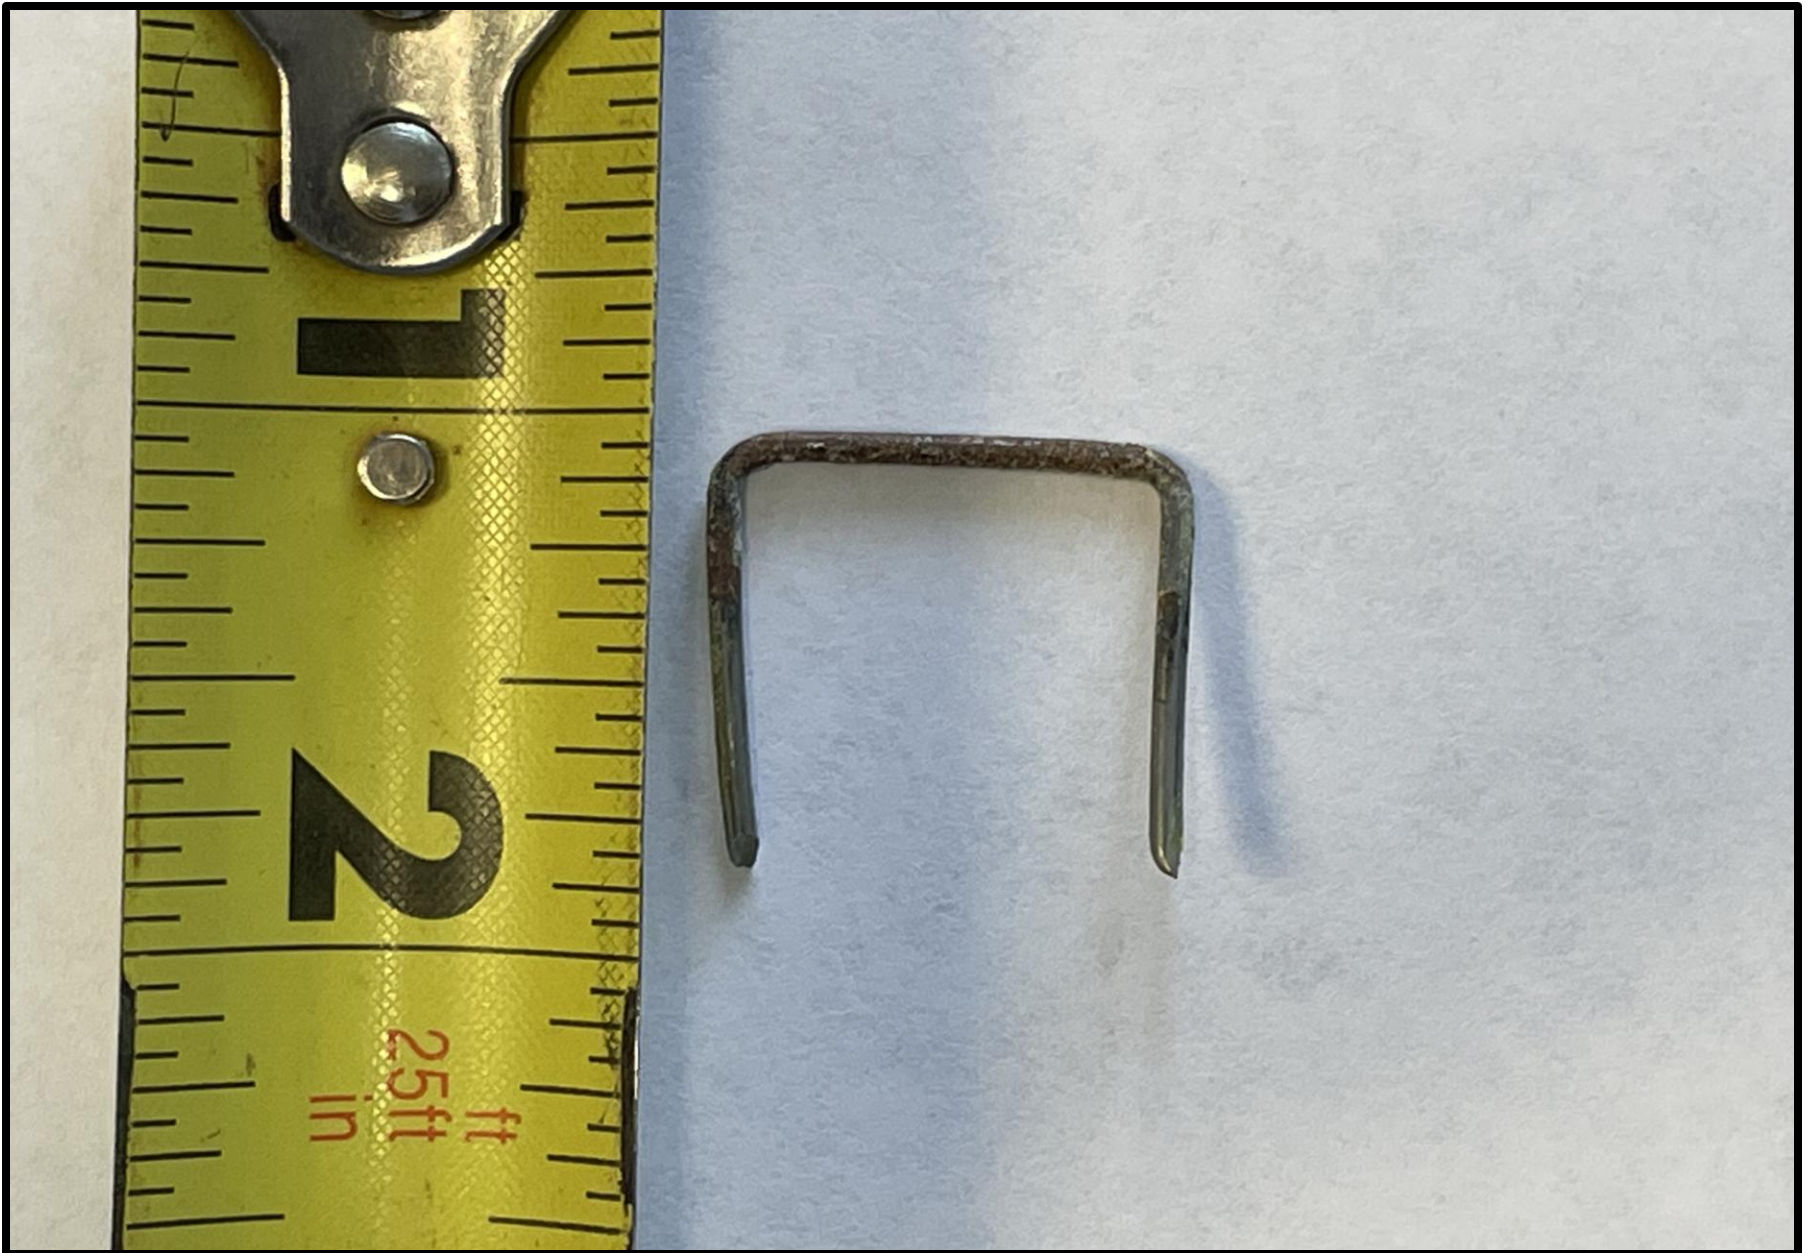
Lath staples utilized to secure the soffit lath to framing members were too short. The length of individual lath staples were measured and found to be only  $\frac{3}{4}$ -inches in length (see **Photographs #003- 004**). Building codes during the 1976-1978 time frame required minimum staple lengths to be  $\frac{7}{8}$ -inches. Furthermore, staple lengths are increased when metal lath at soffits contain either Hi-Rib or other self-furred devices (i.e. "V" grooves, crimped/ dimpled). It appears from the photographs you provided, a "V" groove-type lath was utilized (see **Photographs #005- 007**). These "V" grooves provide the necessary  $\frac{1}{4}$ -inch furring off the wood supports, to allow for proper embedment and keying of the scratch coat.

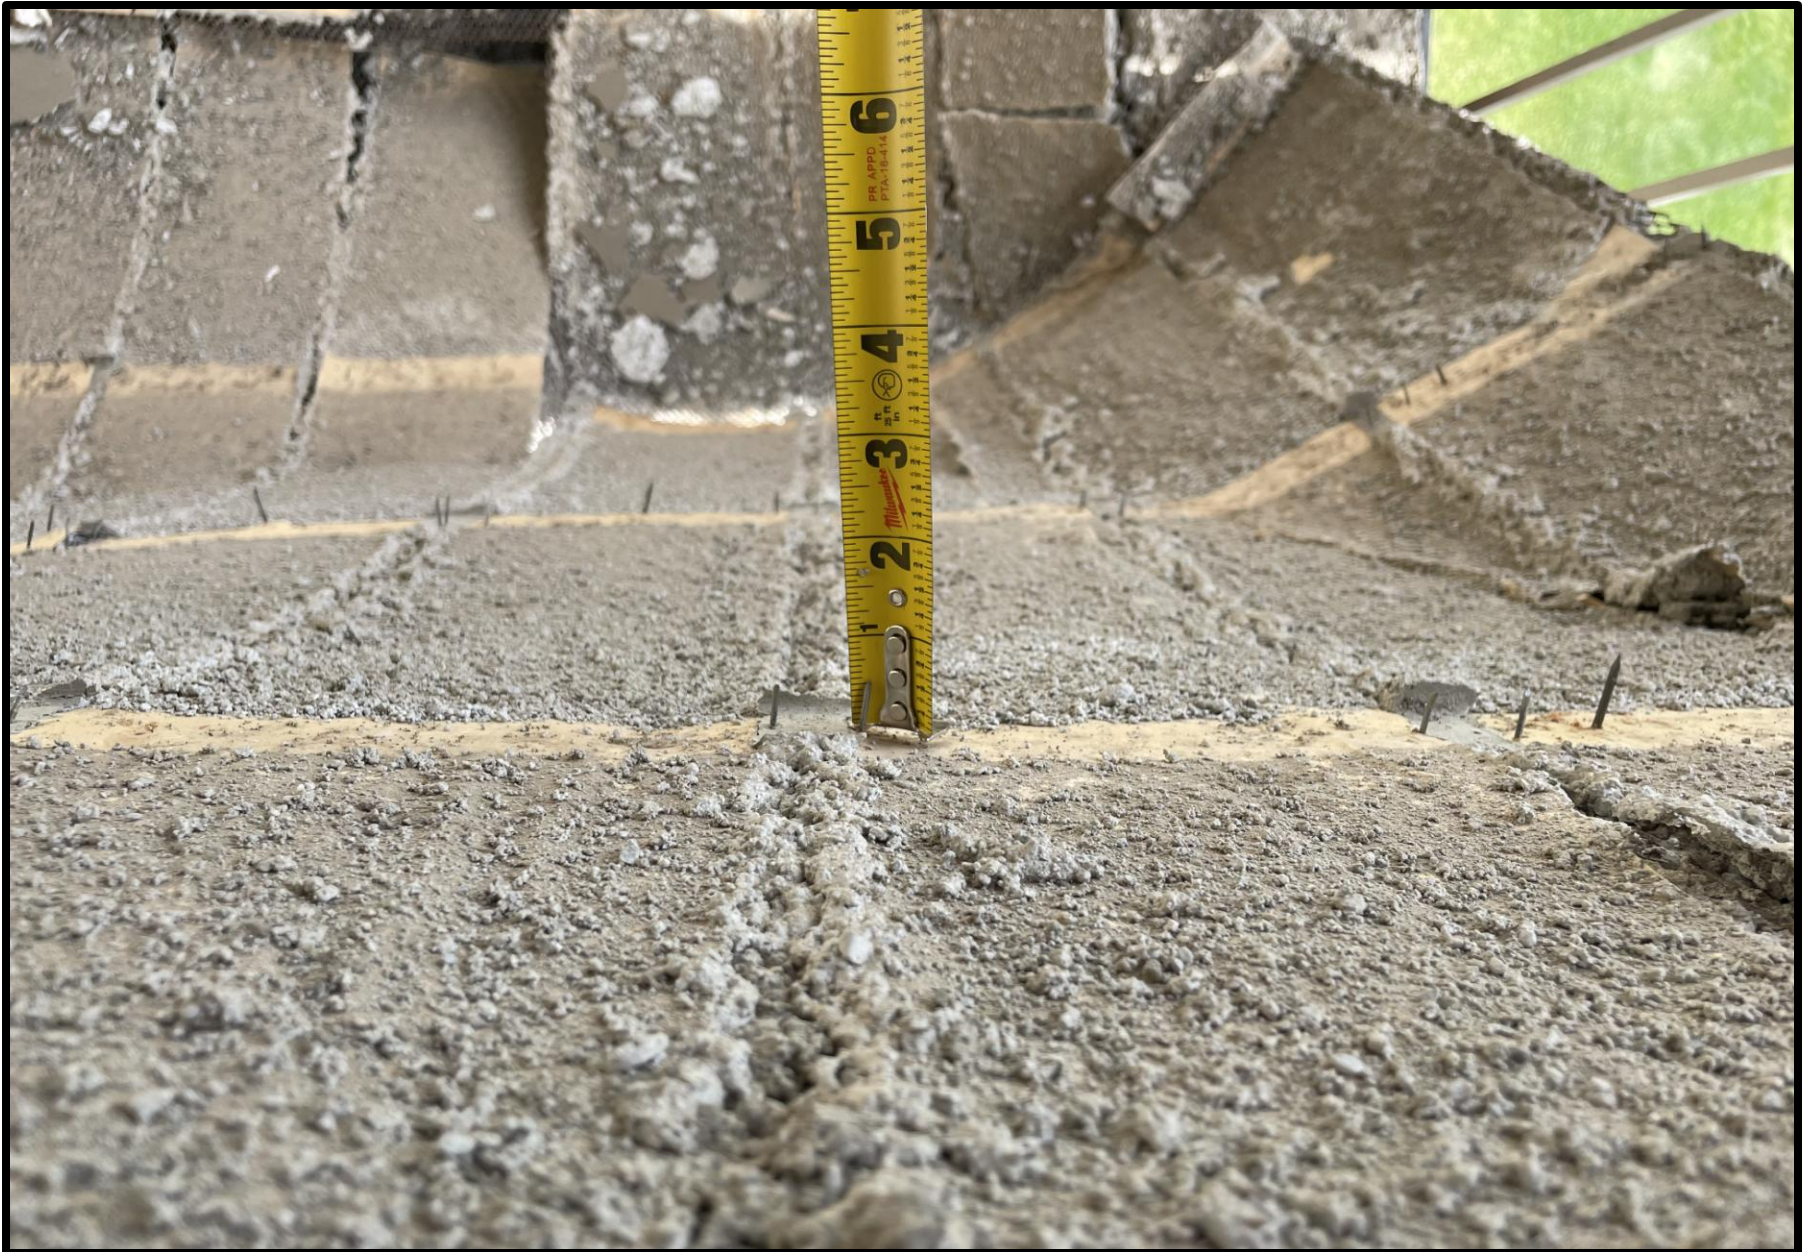
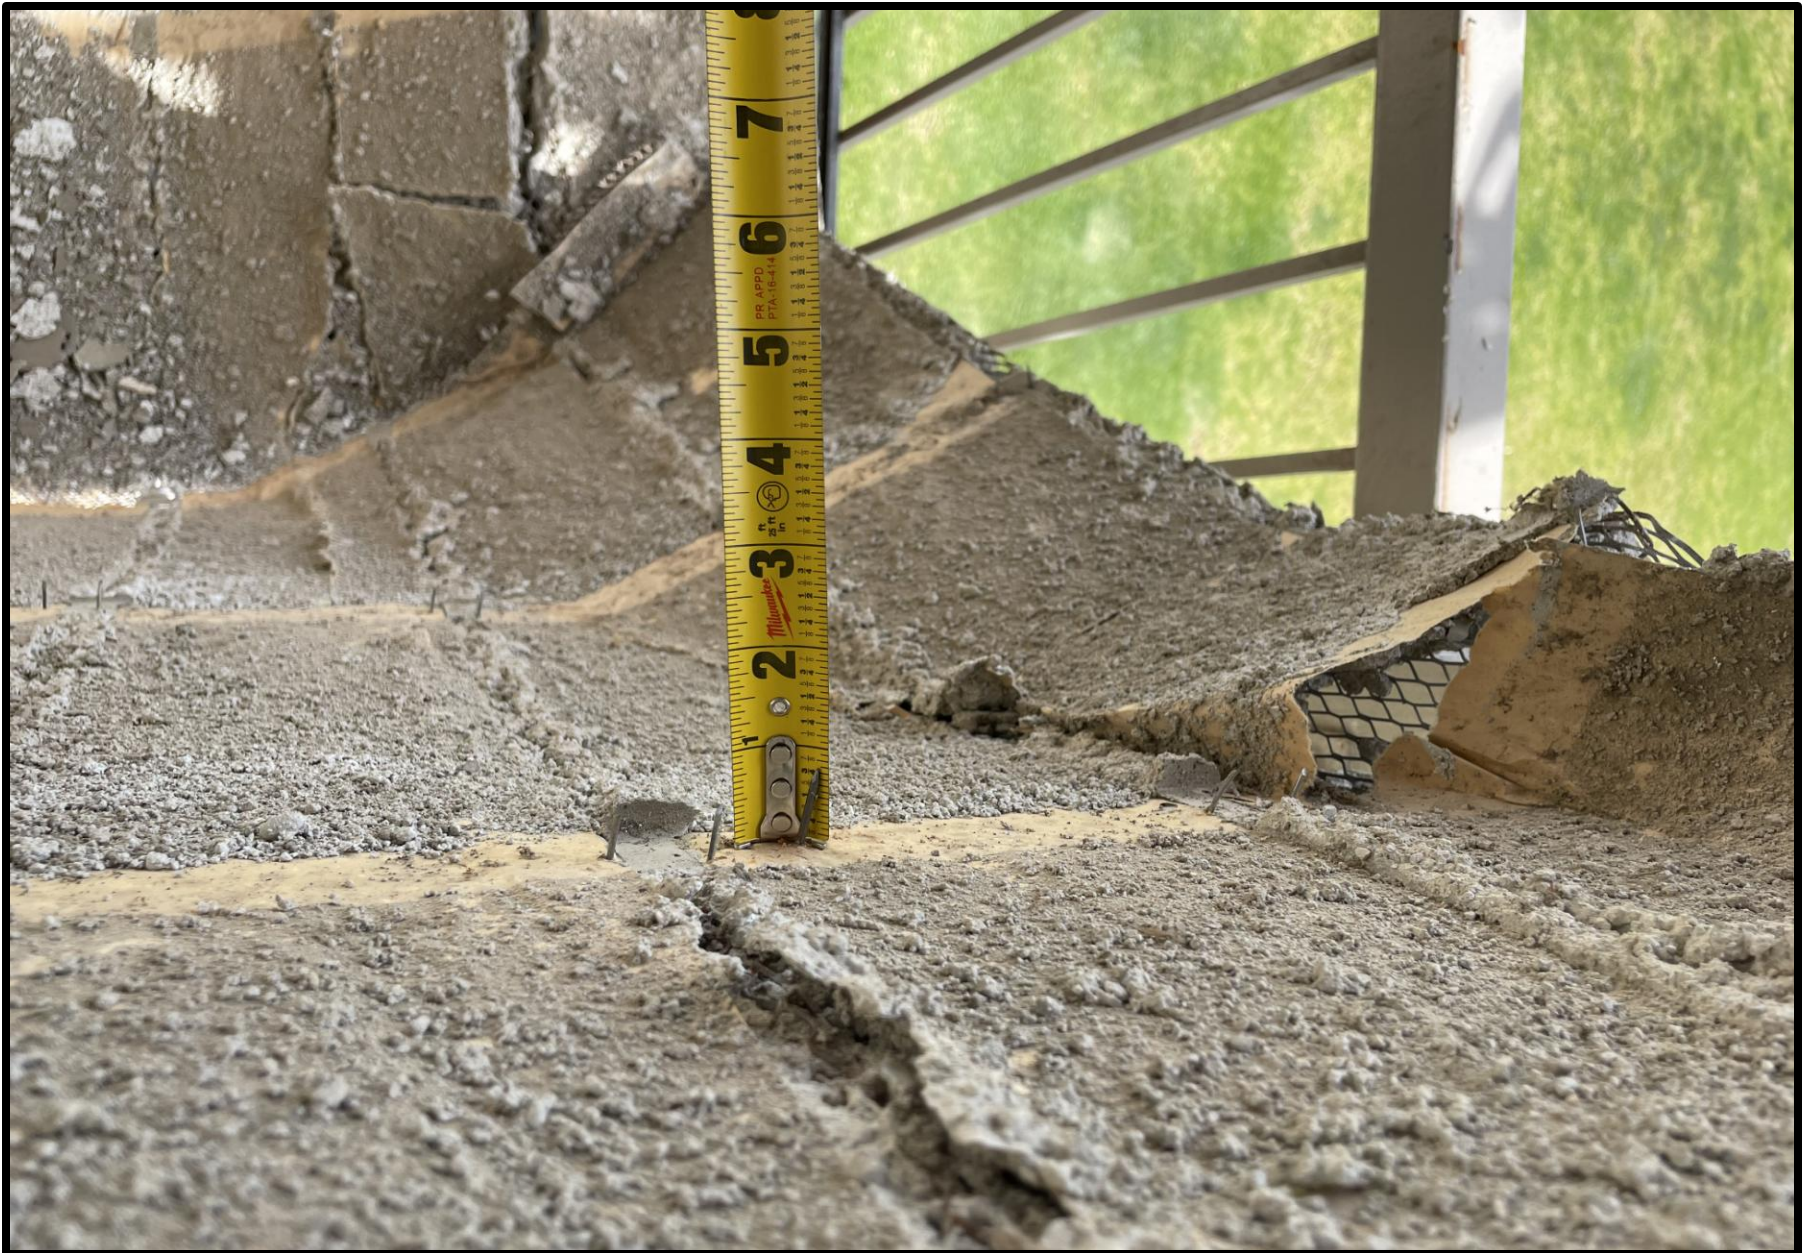
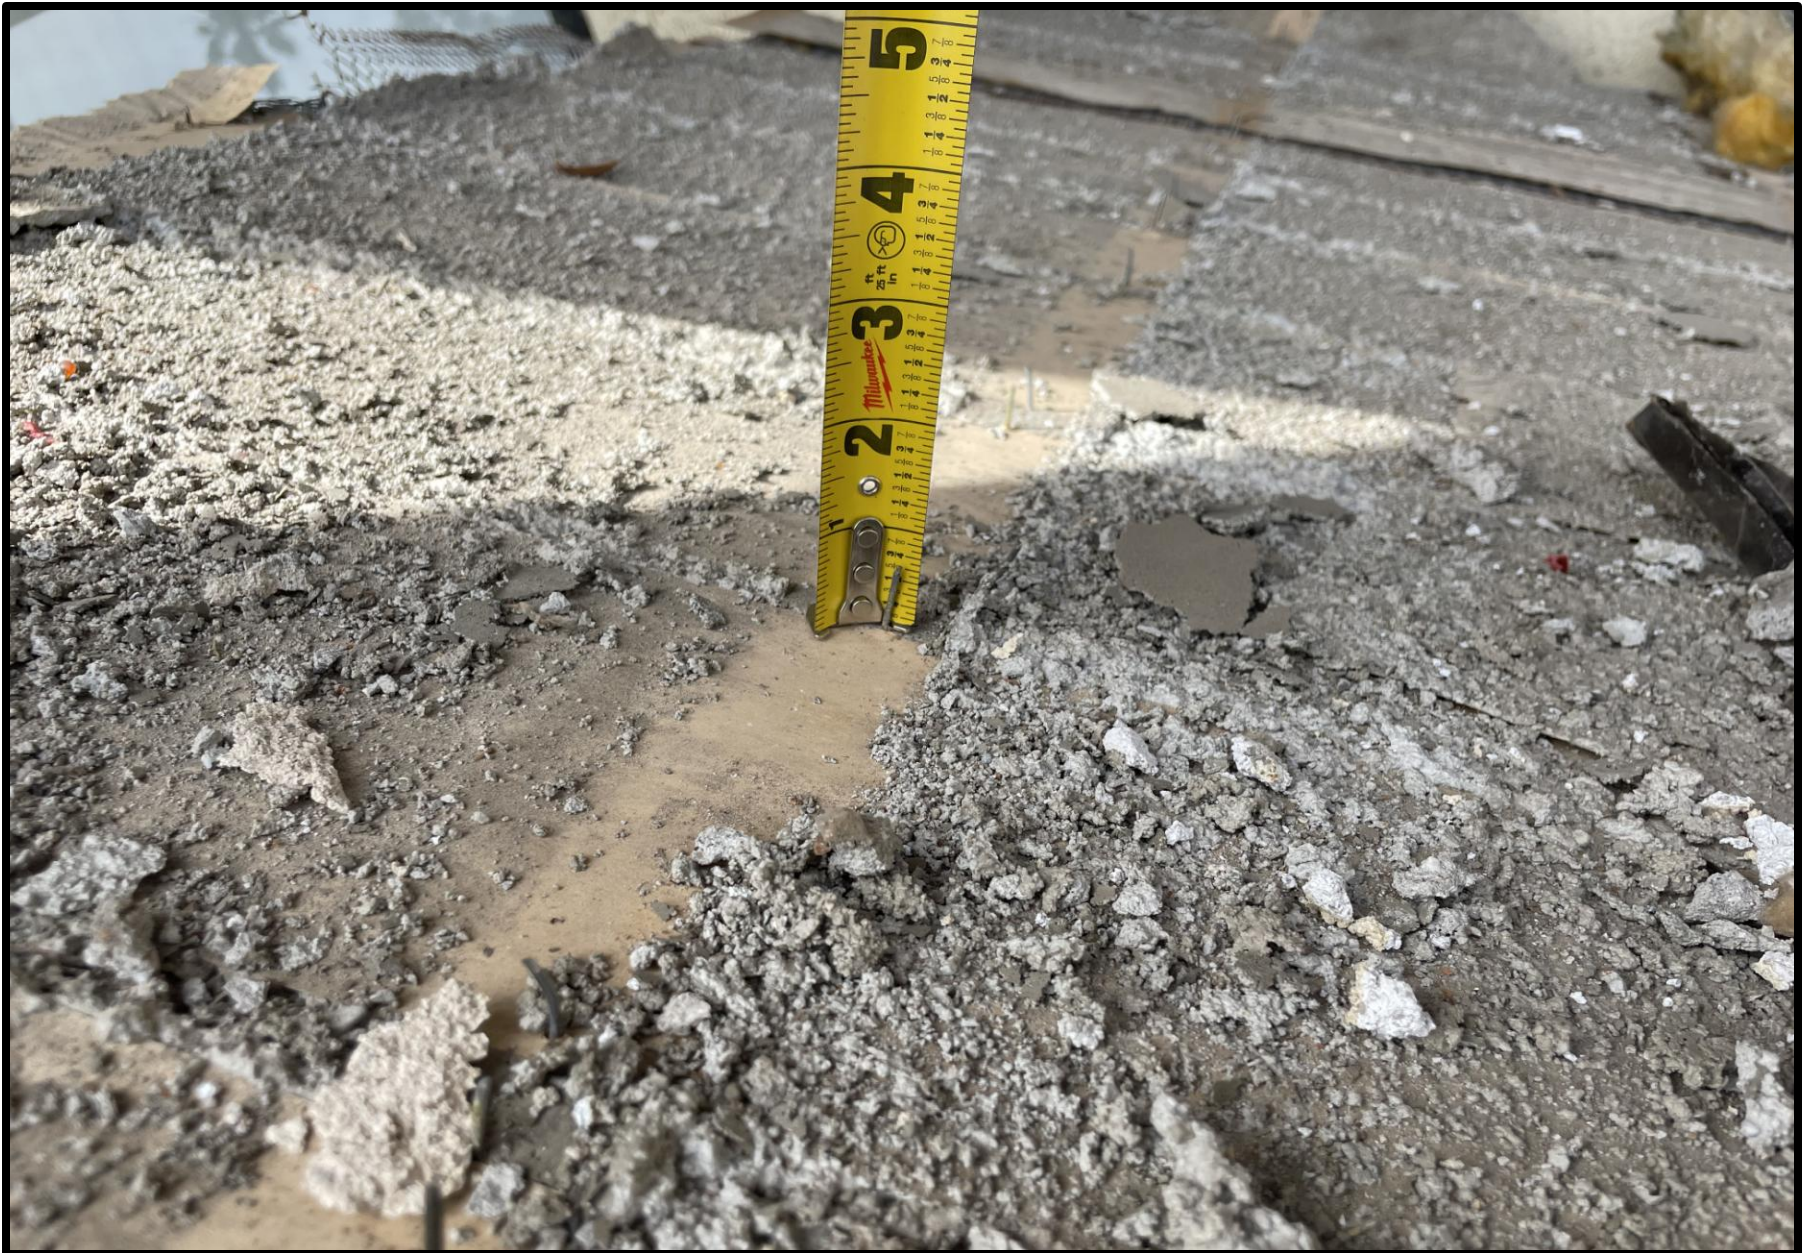
Moreover, when attaching metal lath to wood supports (soffits), lath staples must be placed at the self-furred "V" grooves, so as not to inhibit embedment. In my opinion, the use of  $\frac{3}{4}$ -inch staples was inadequate in size and should have been increased to a required minimum  $1\frac{1}{4}$ - inches, in length. Furthermore, photographs indicate that the staple legs only engaged  $\frac{1}{2}$ -inches, and not the minimum  $\frac{7}{8}$ - inches into wood supports (see **Photographs #008- 010**). The undersized staples contributed to the collapse of the stucco soffit.

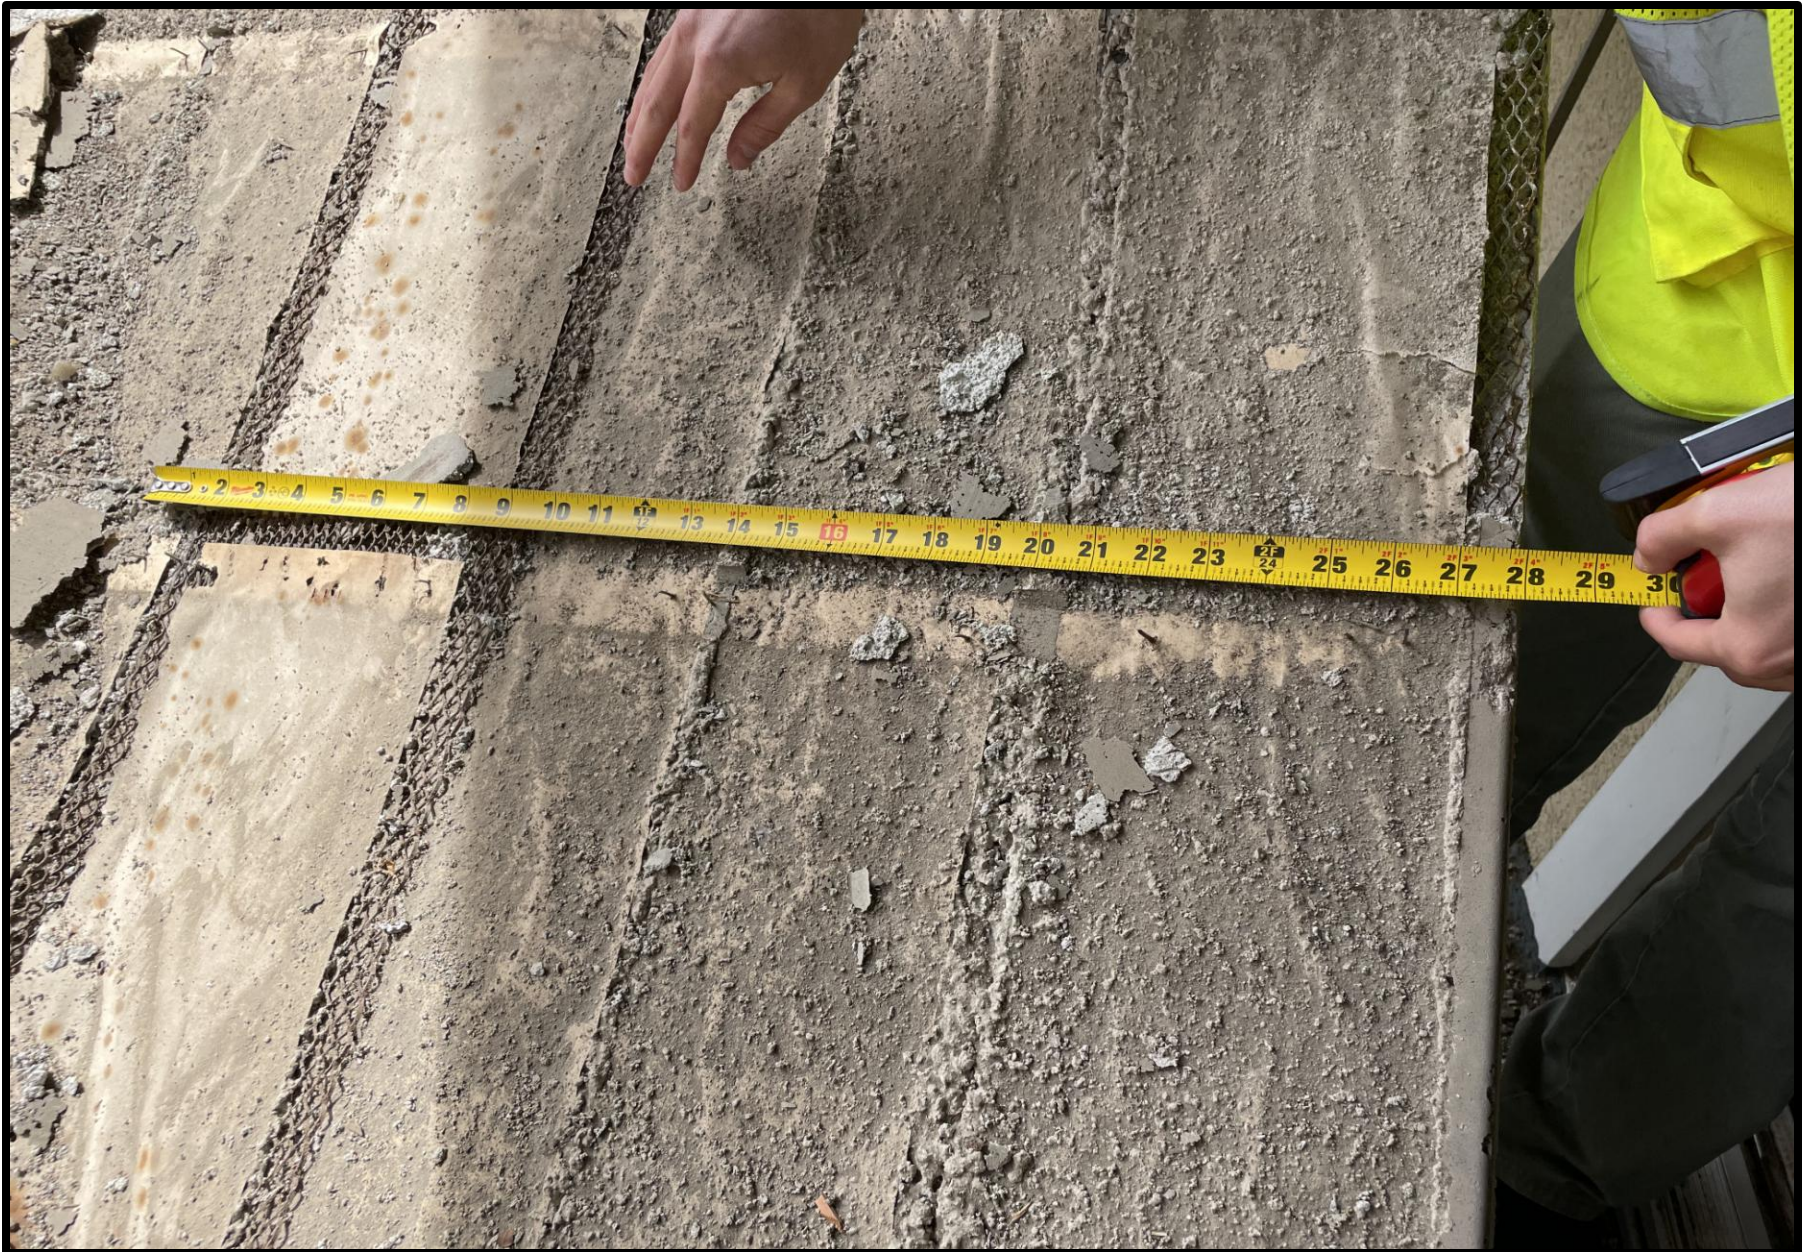
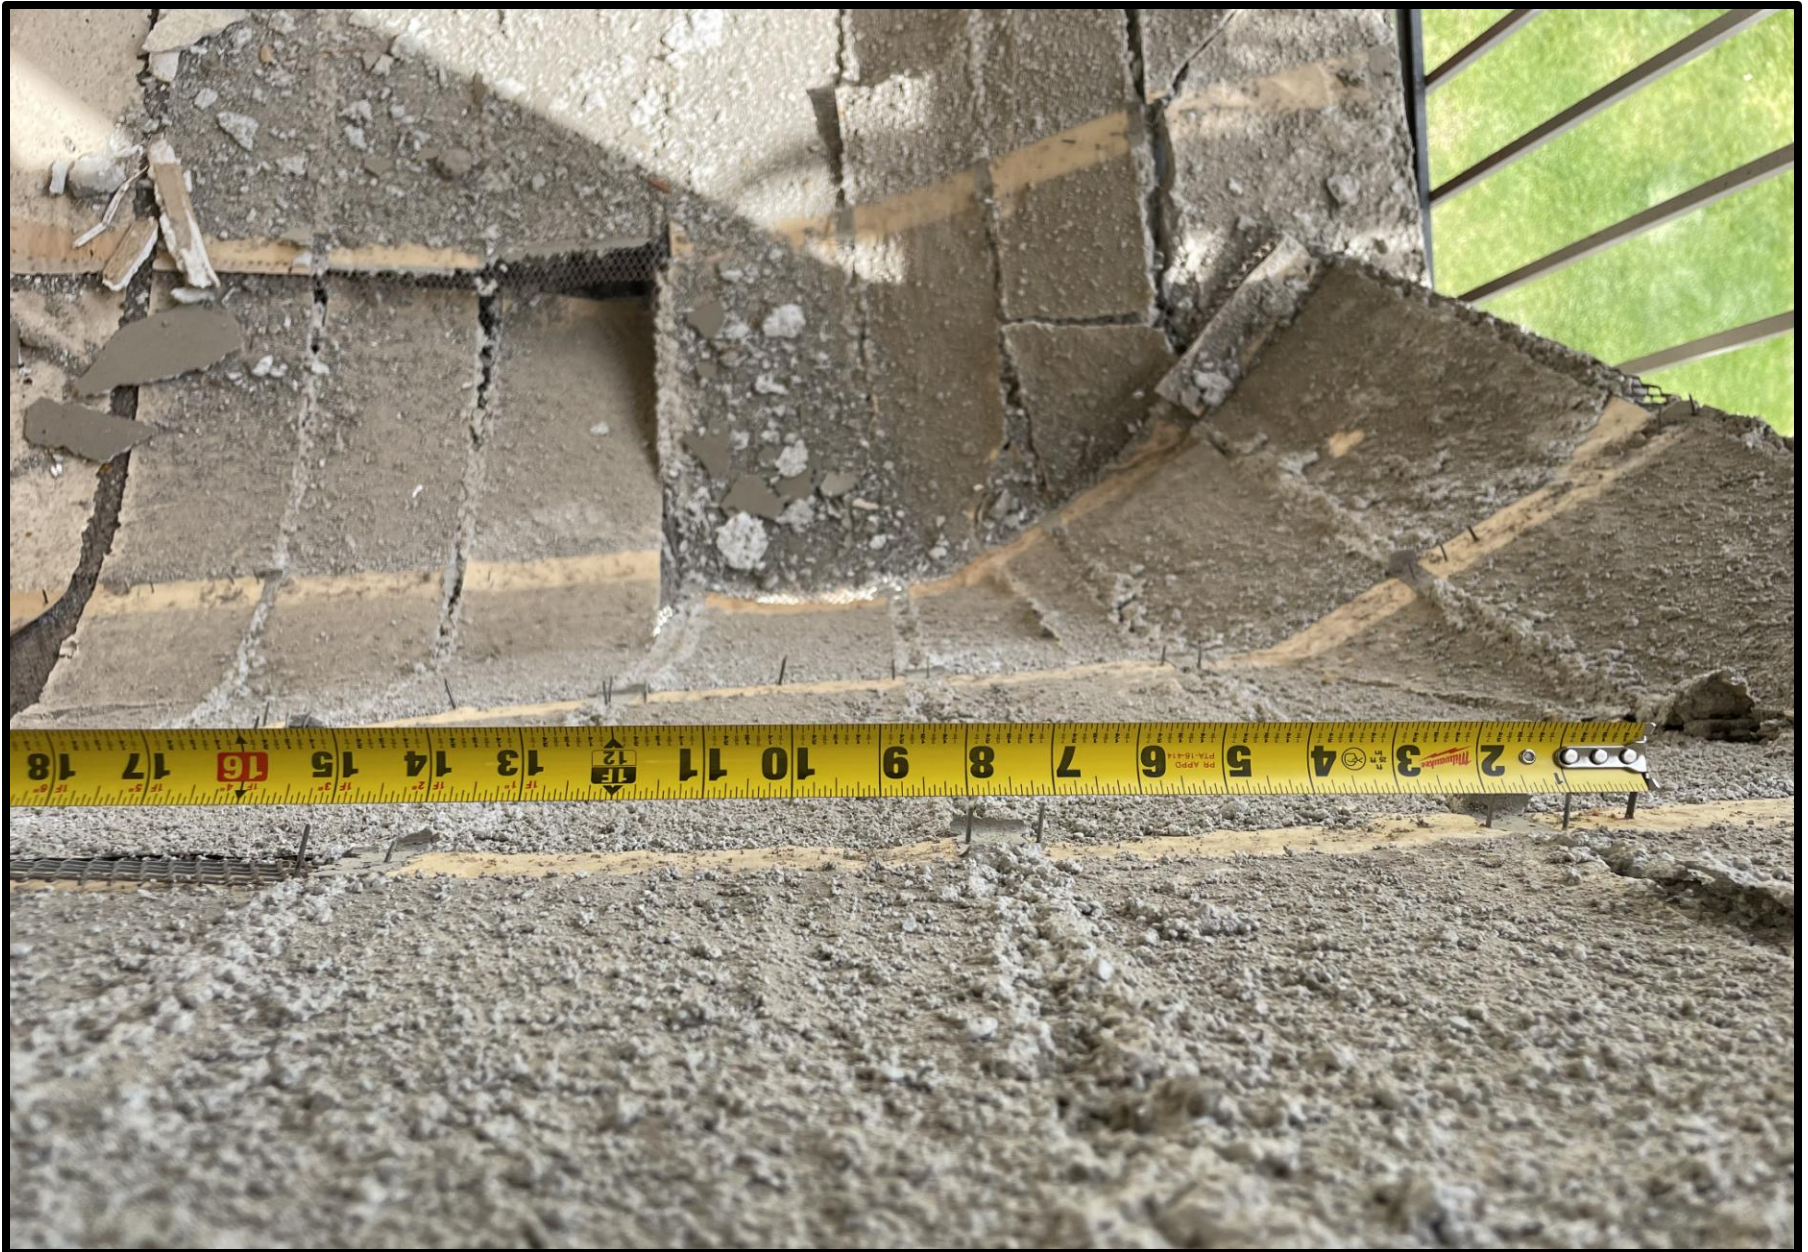
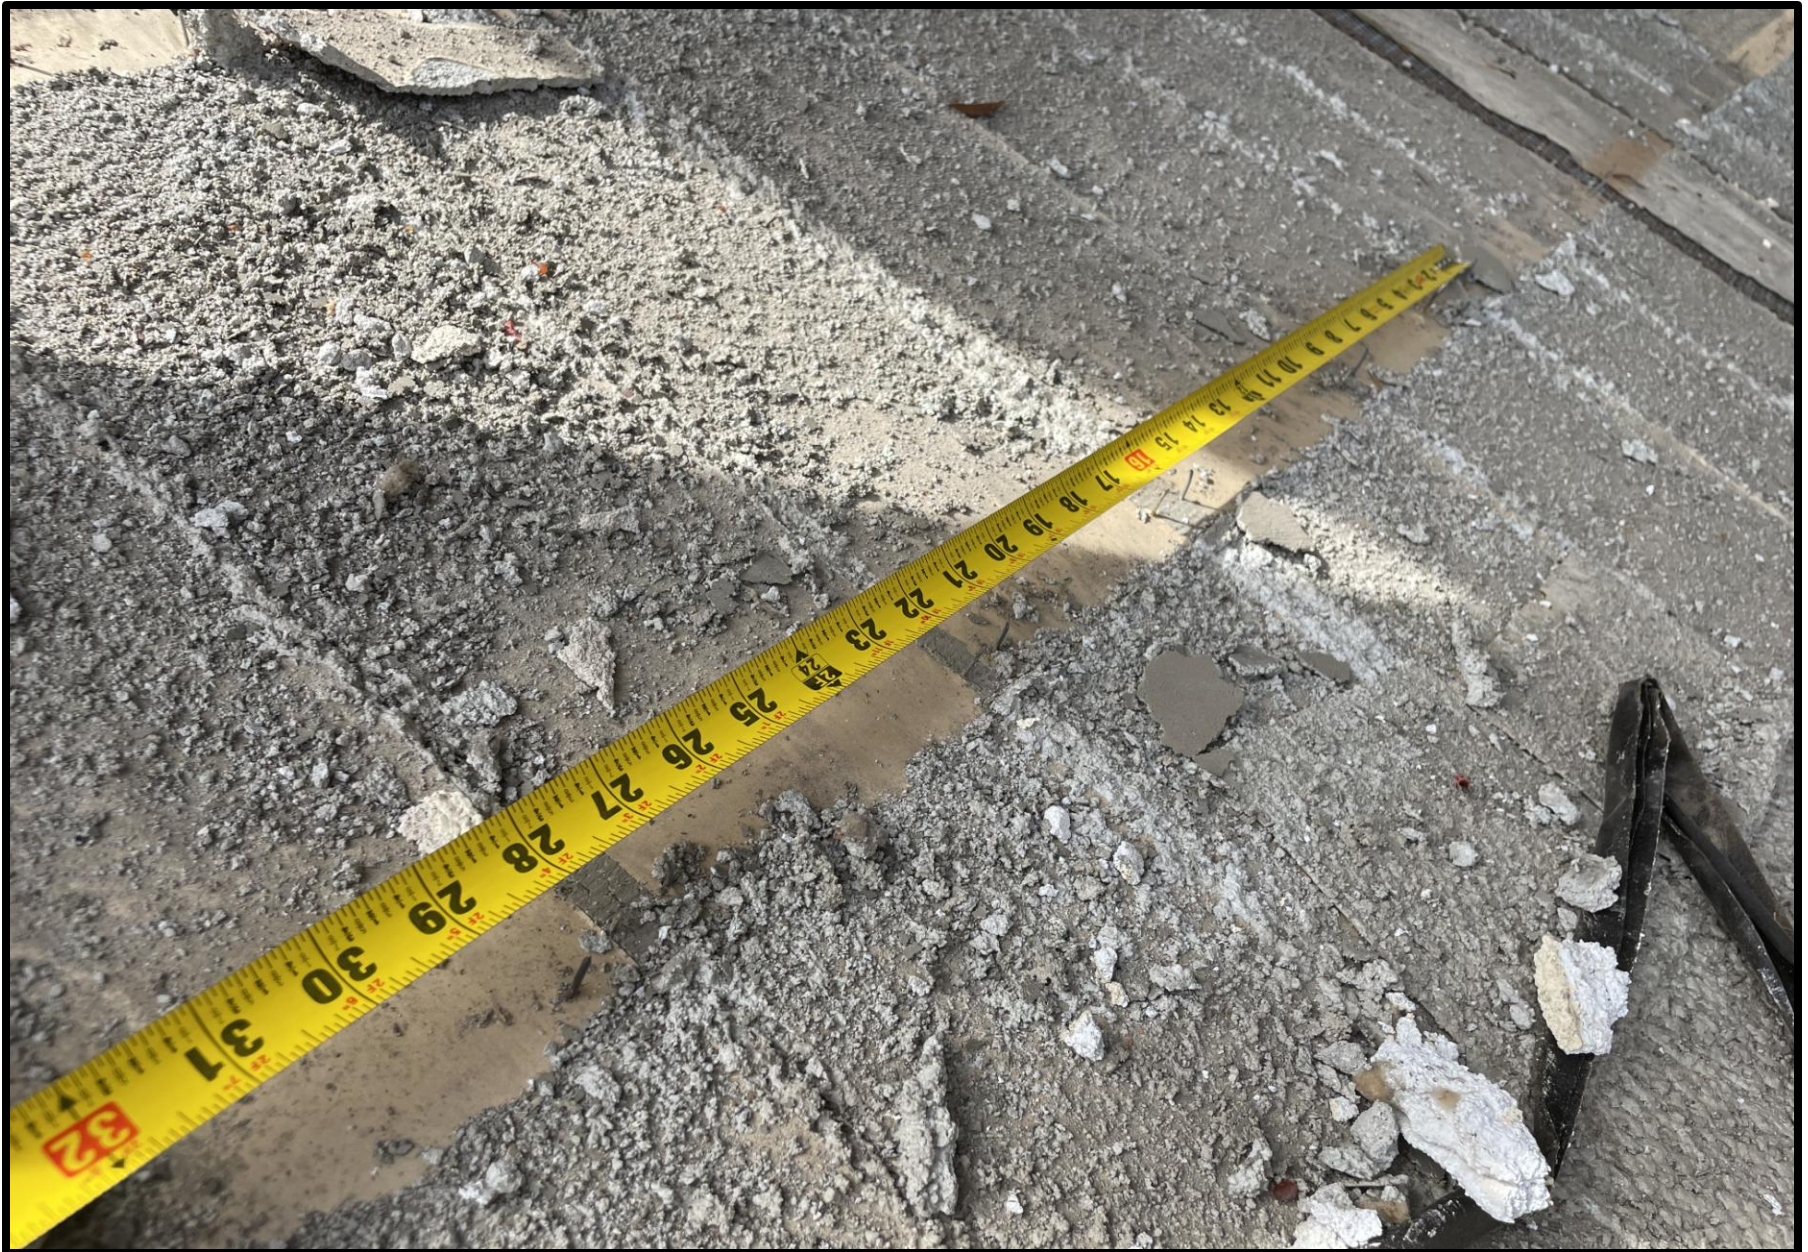
Building codes during the 1976-1978 time frame required the maximum spacing of attachments (i.e. staples) to be placed 6-inches apart. It appears from the photographs provided that some staple spacing exceeded the maximum 6-inch spacing requirement (see **Photographs #011- 013**). The over-spacing of staples could also have contributed to the soffit failure.
