CALIFORNIA  
PLASTERING  
CONSULTANTS

March 28, 2022

**RE: Building 3- Soffit Collapse Evaluation  
Surfside III  
600 Sunfish Way  
Port Hueneme, CA 91041**

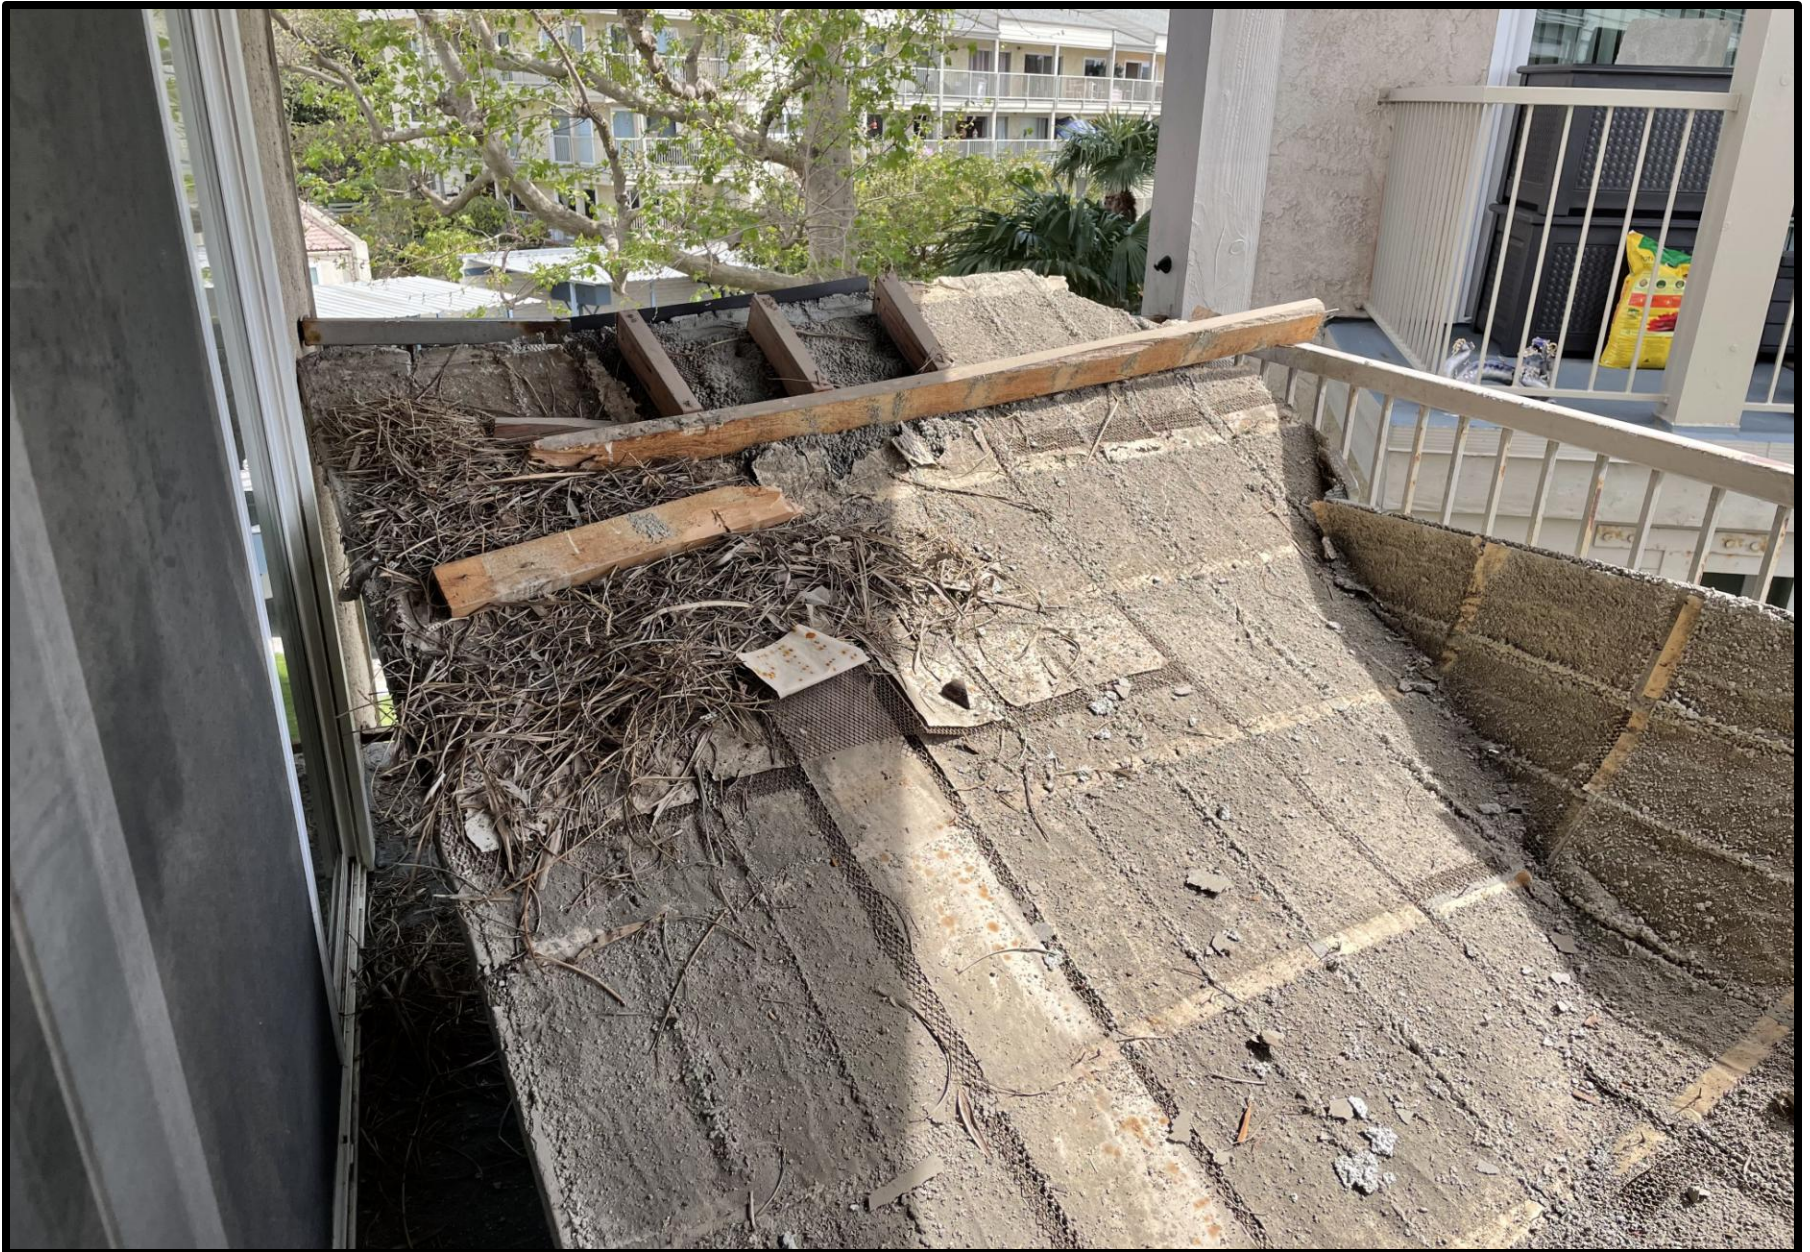
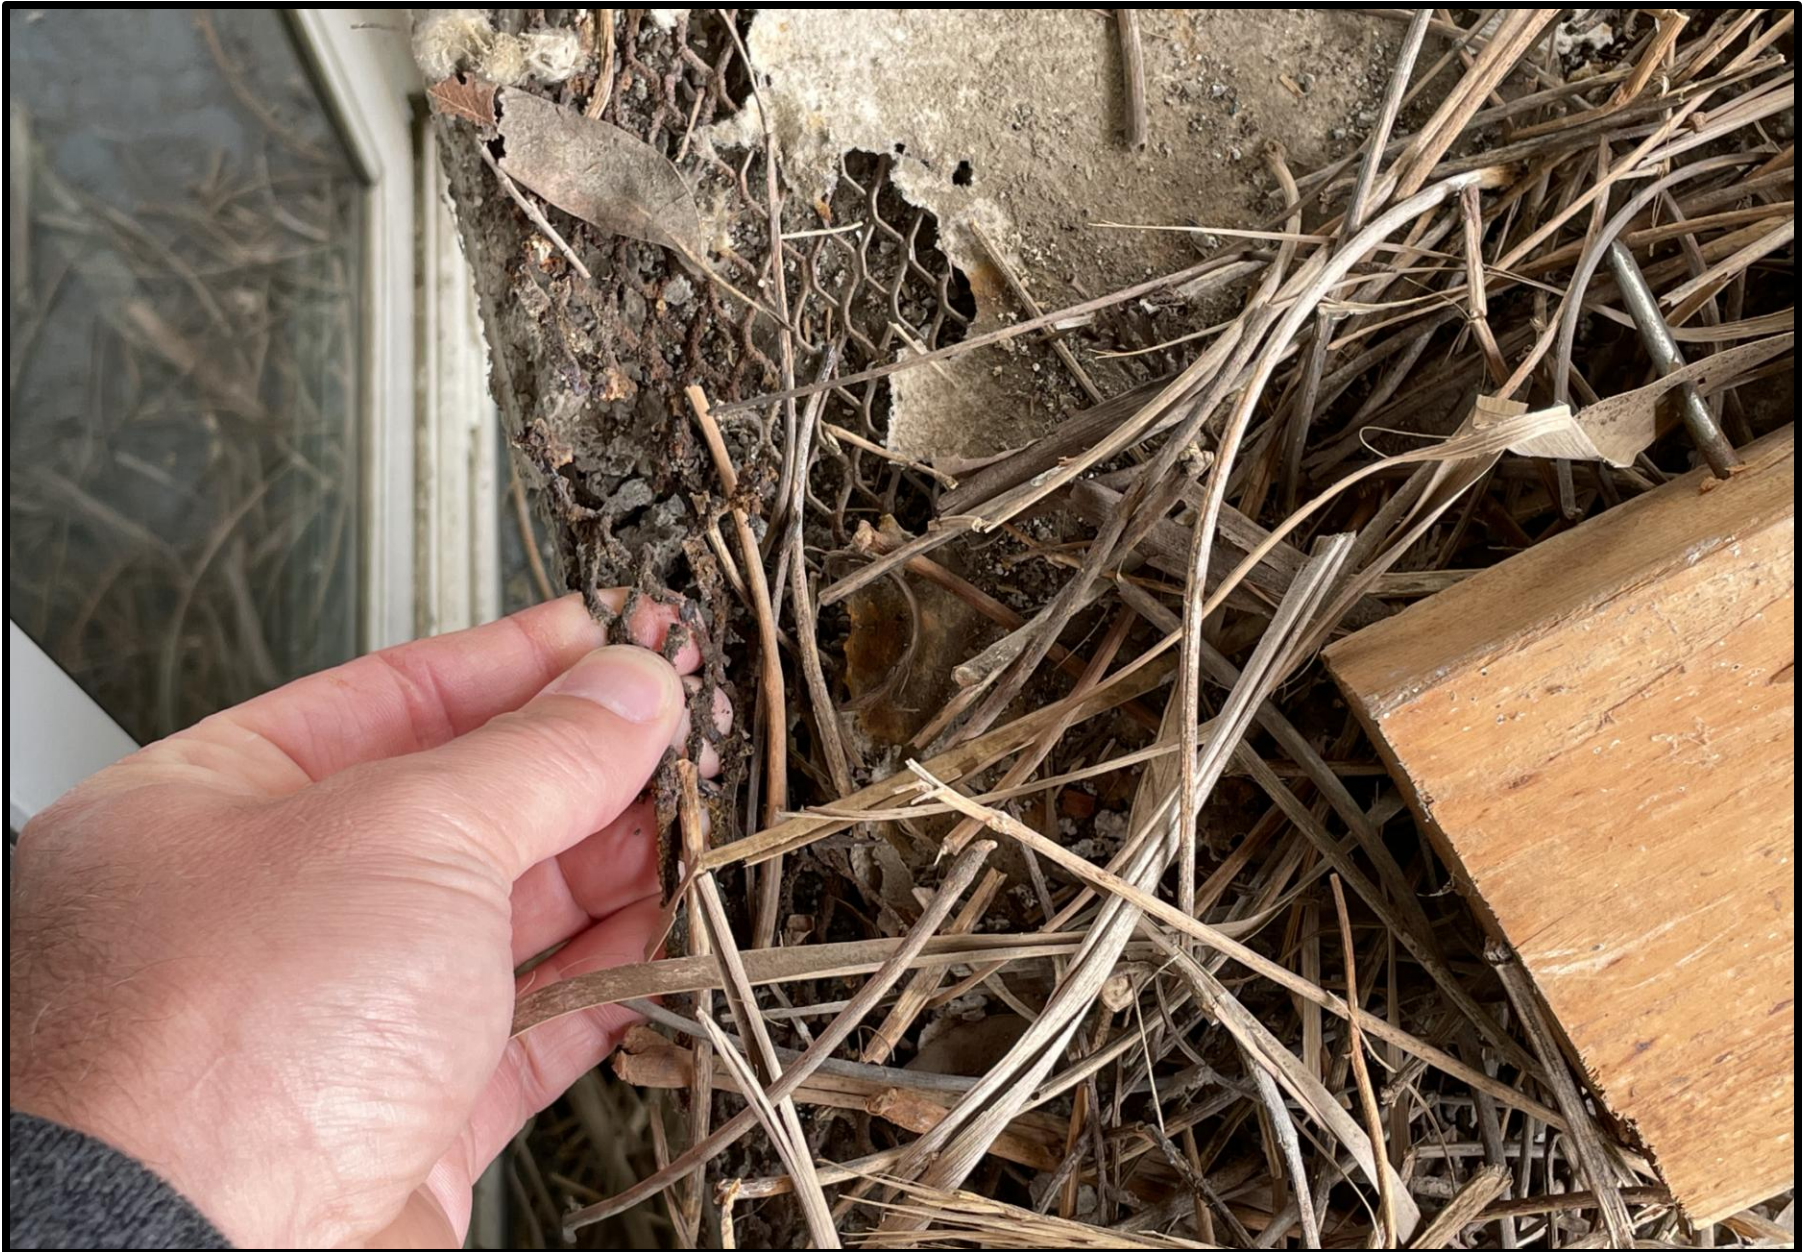
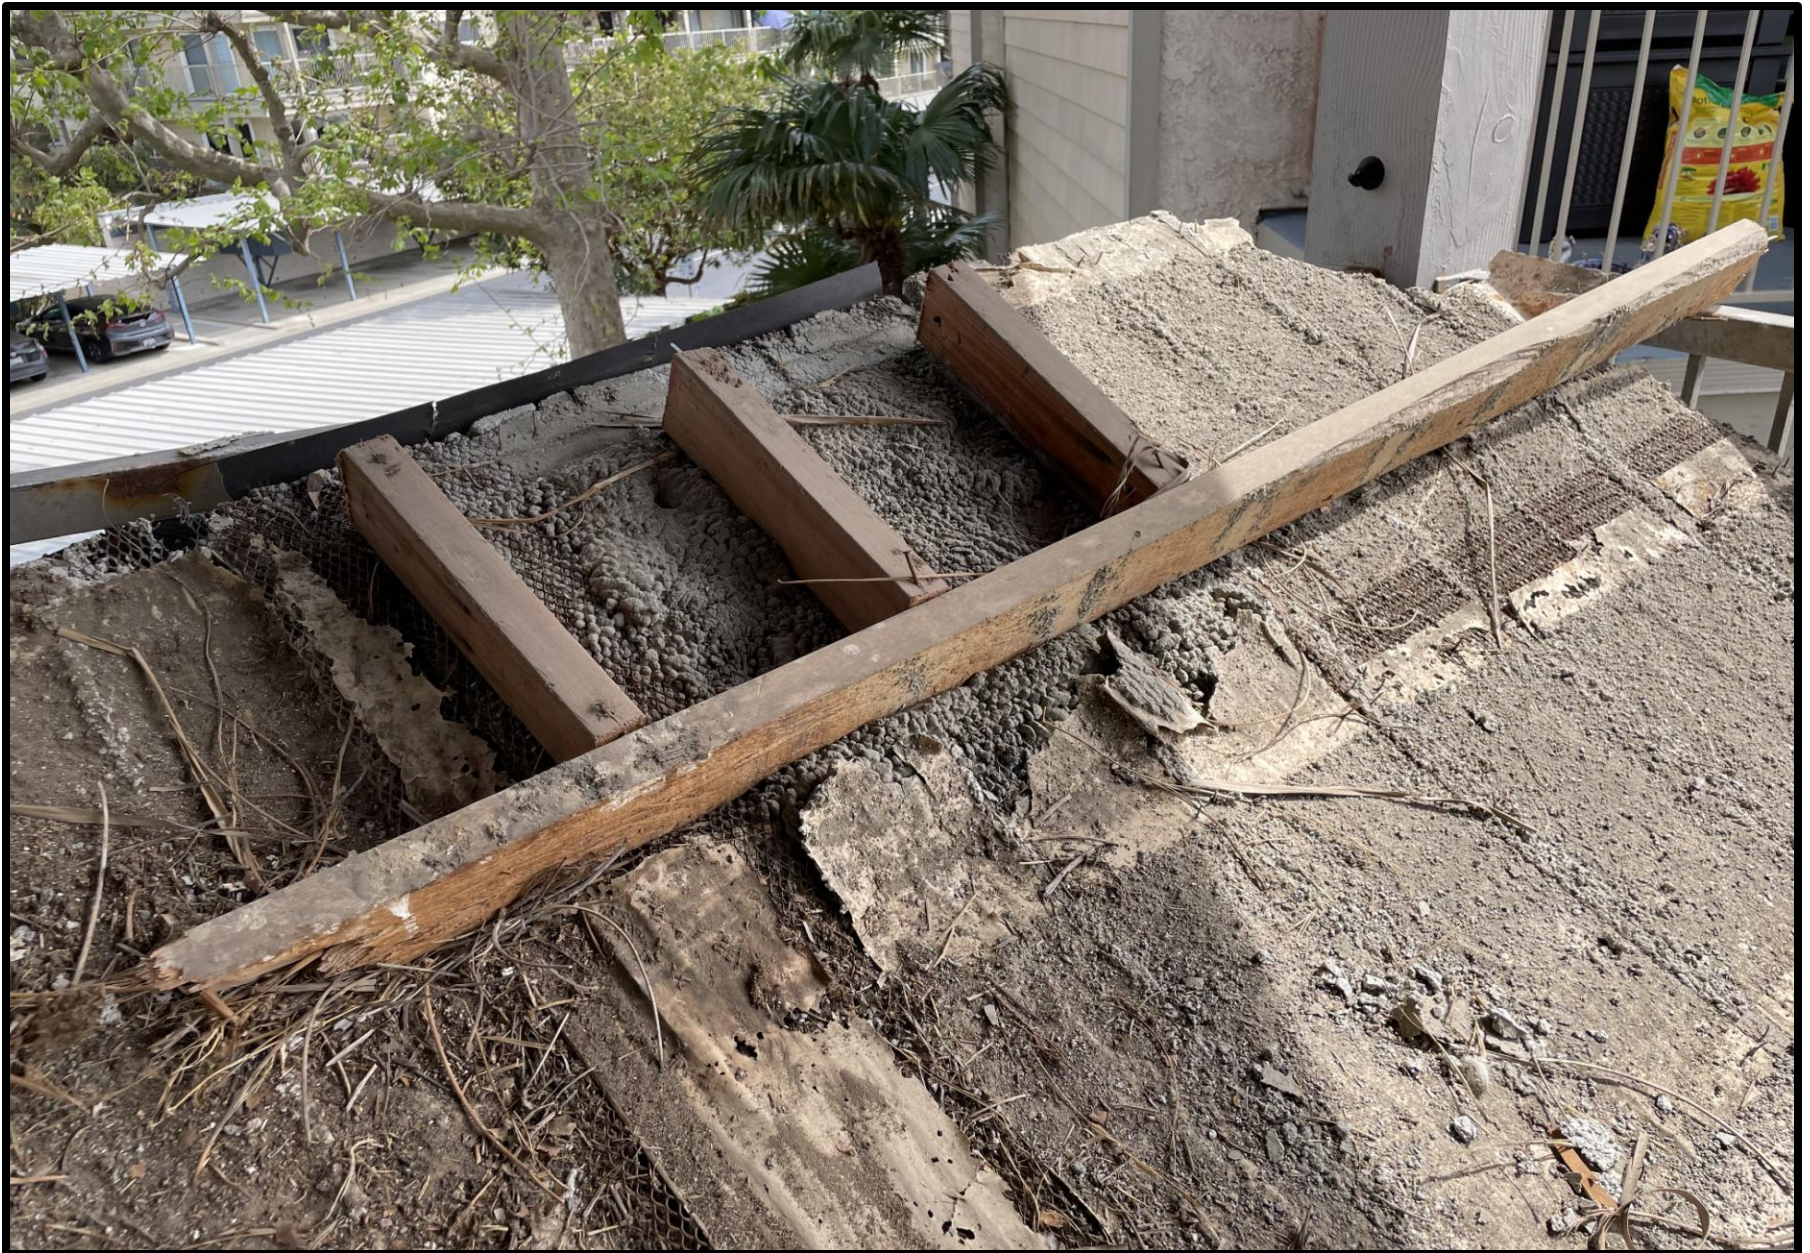
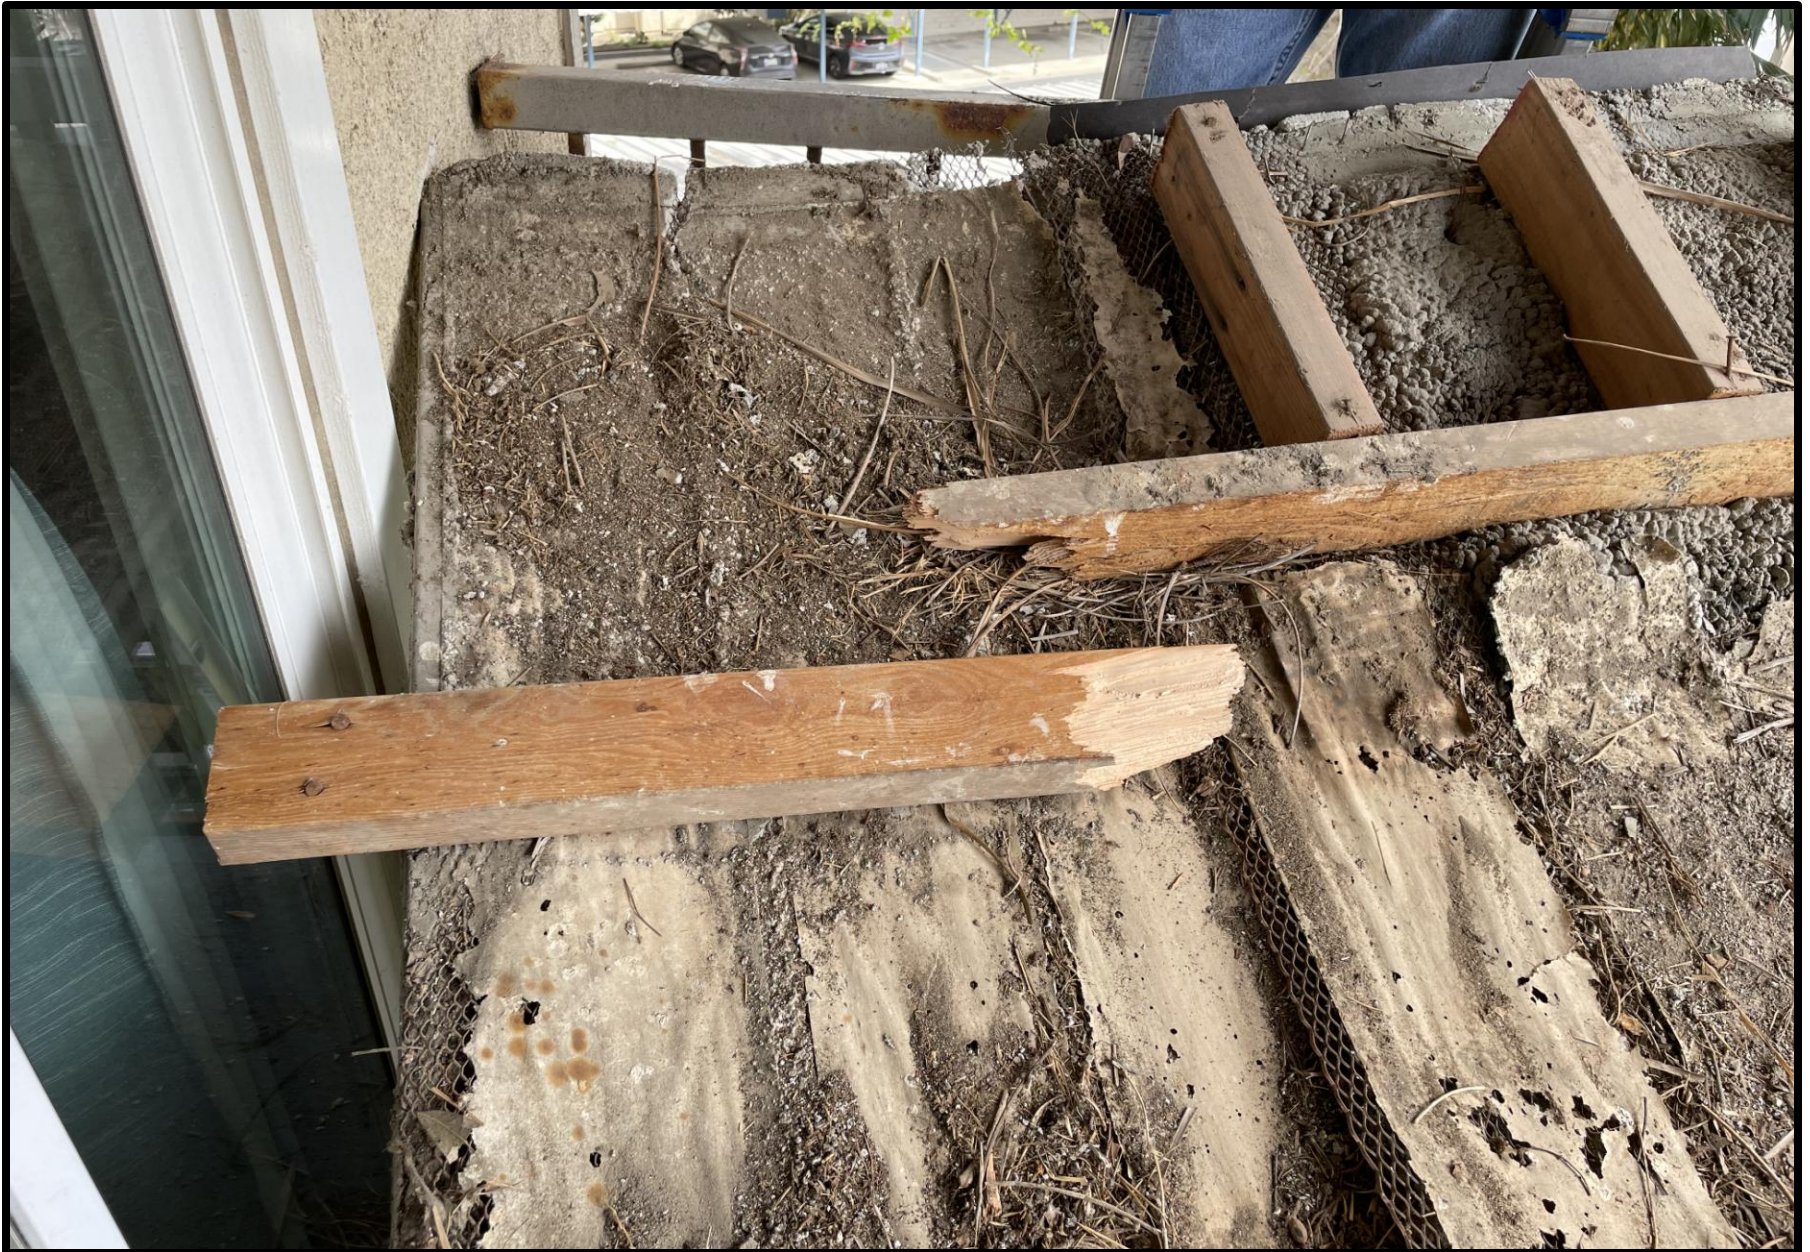
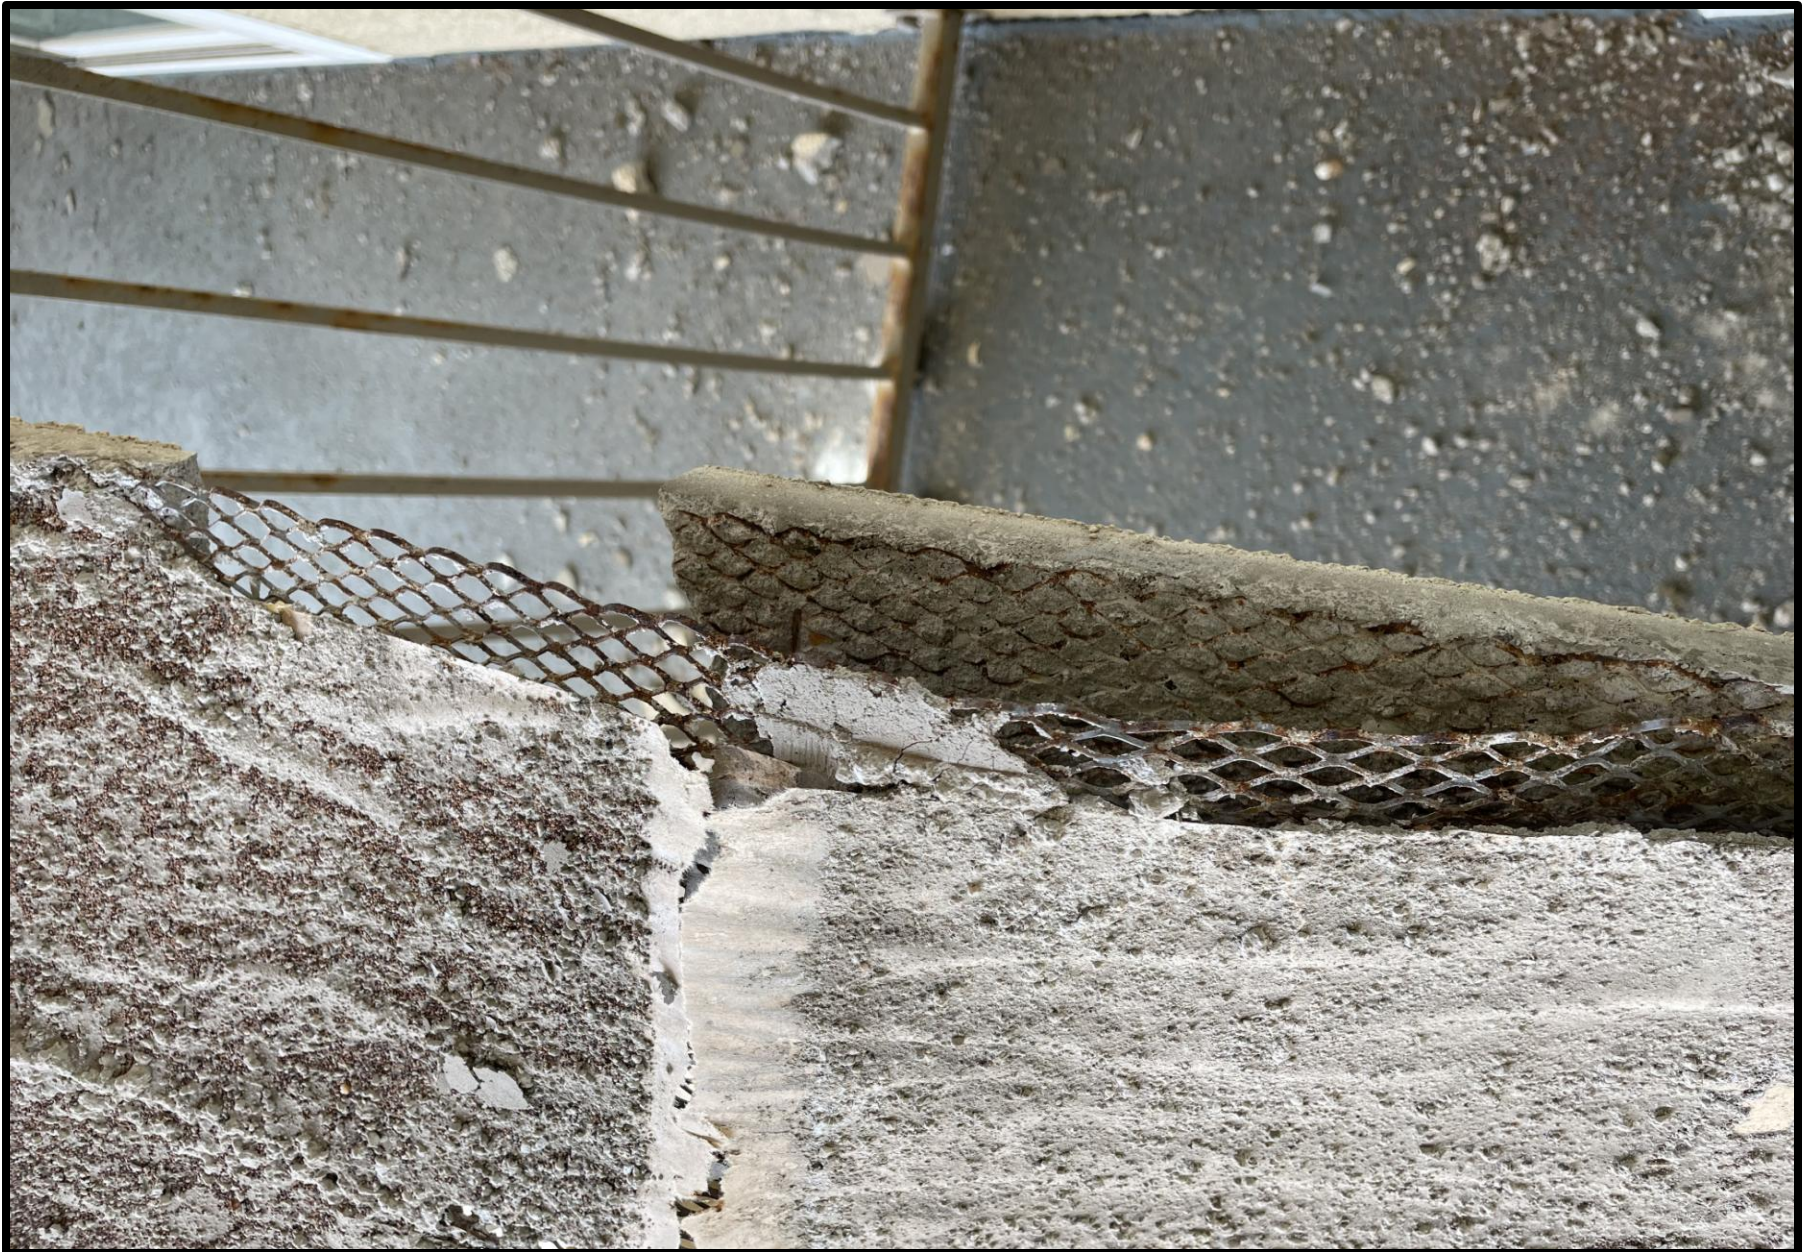
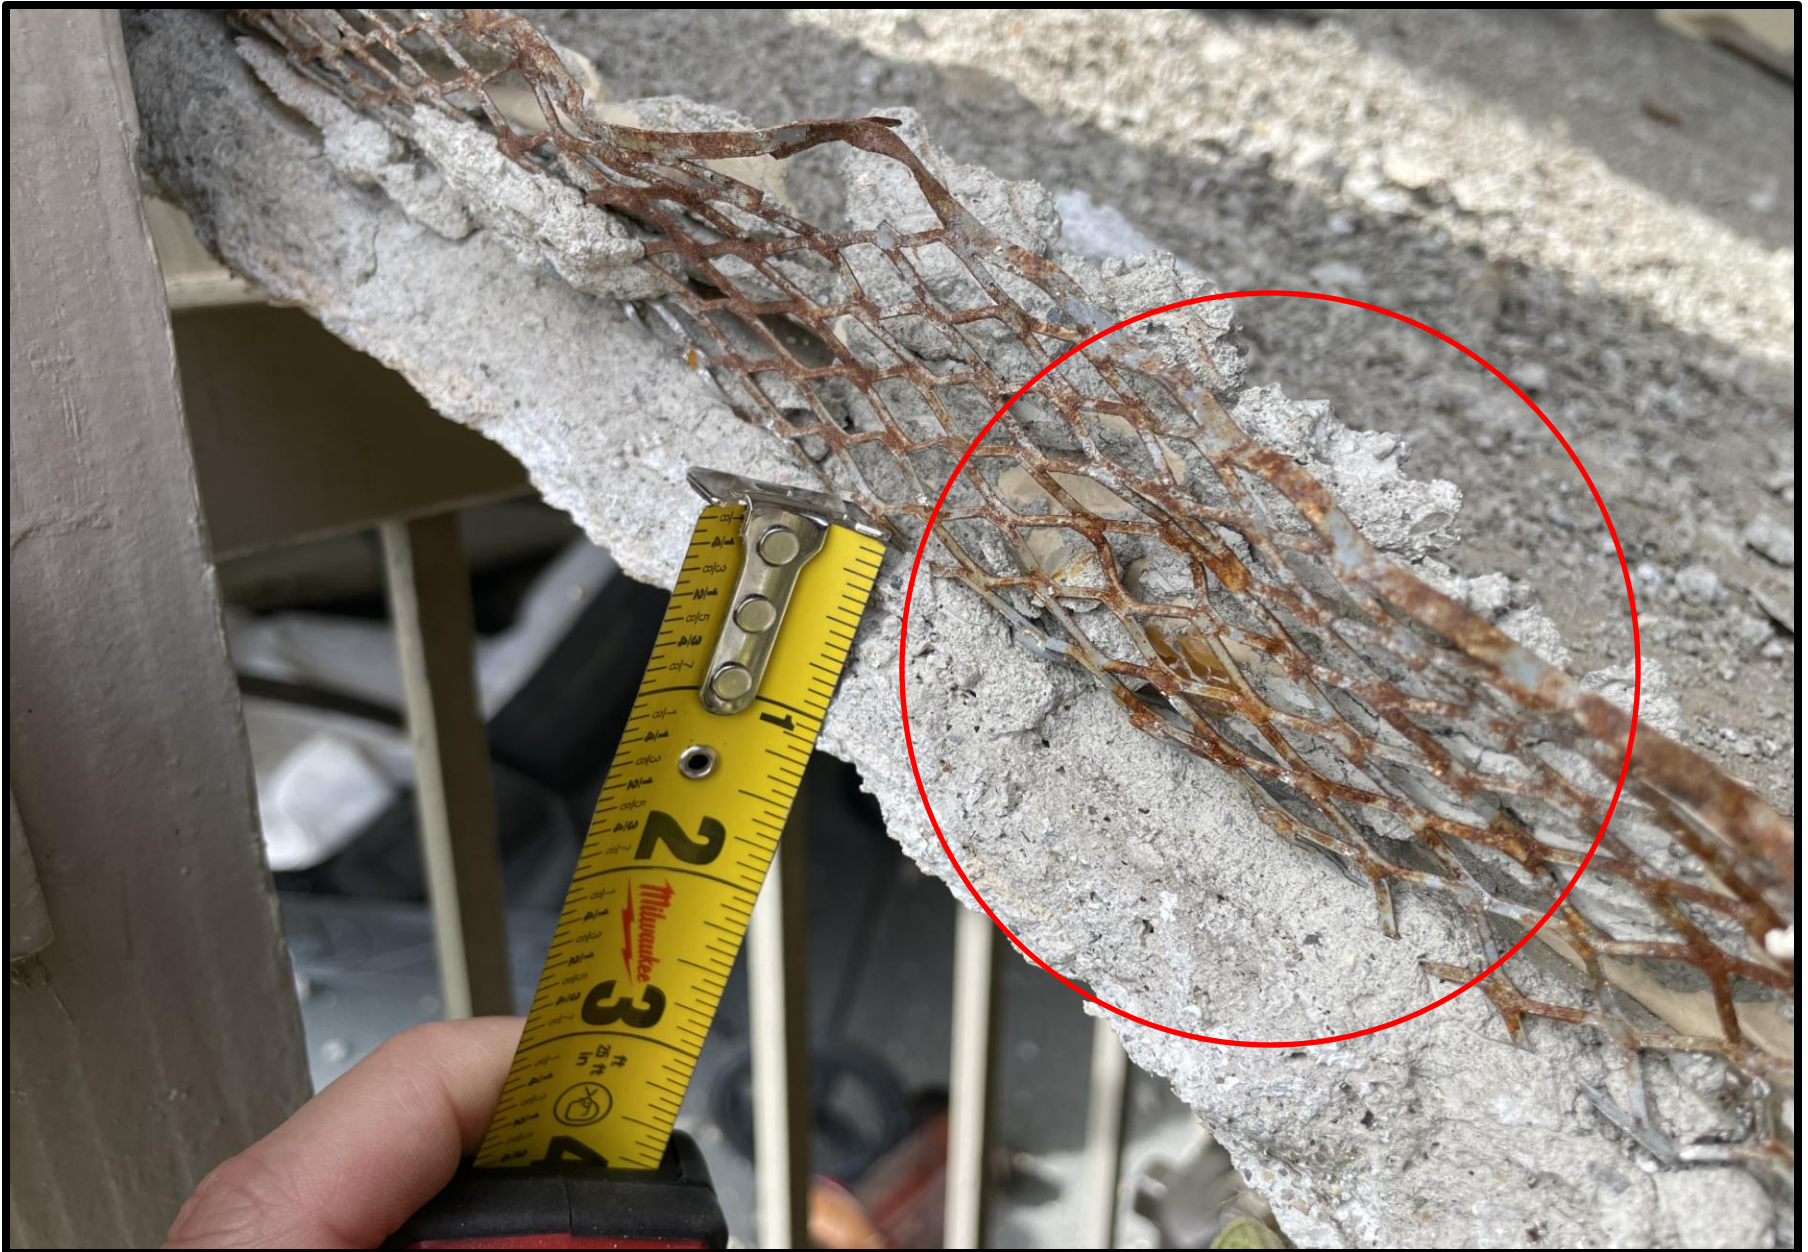
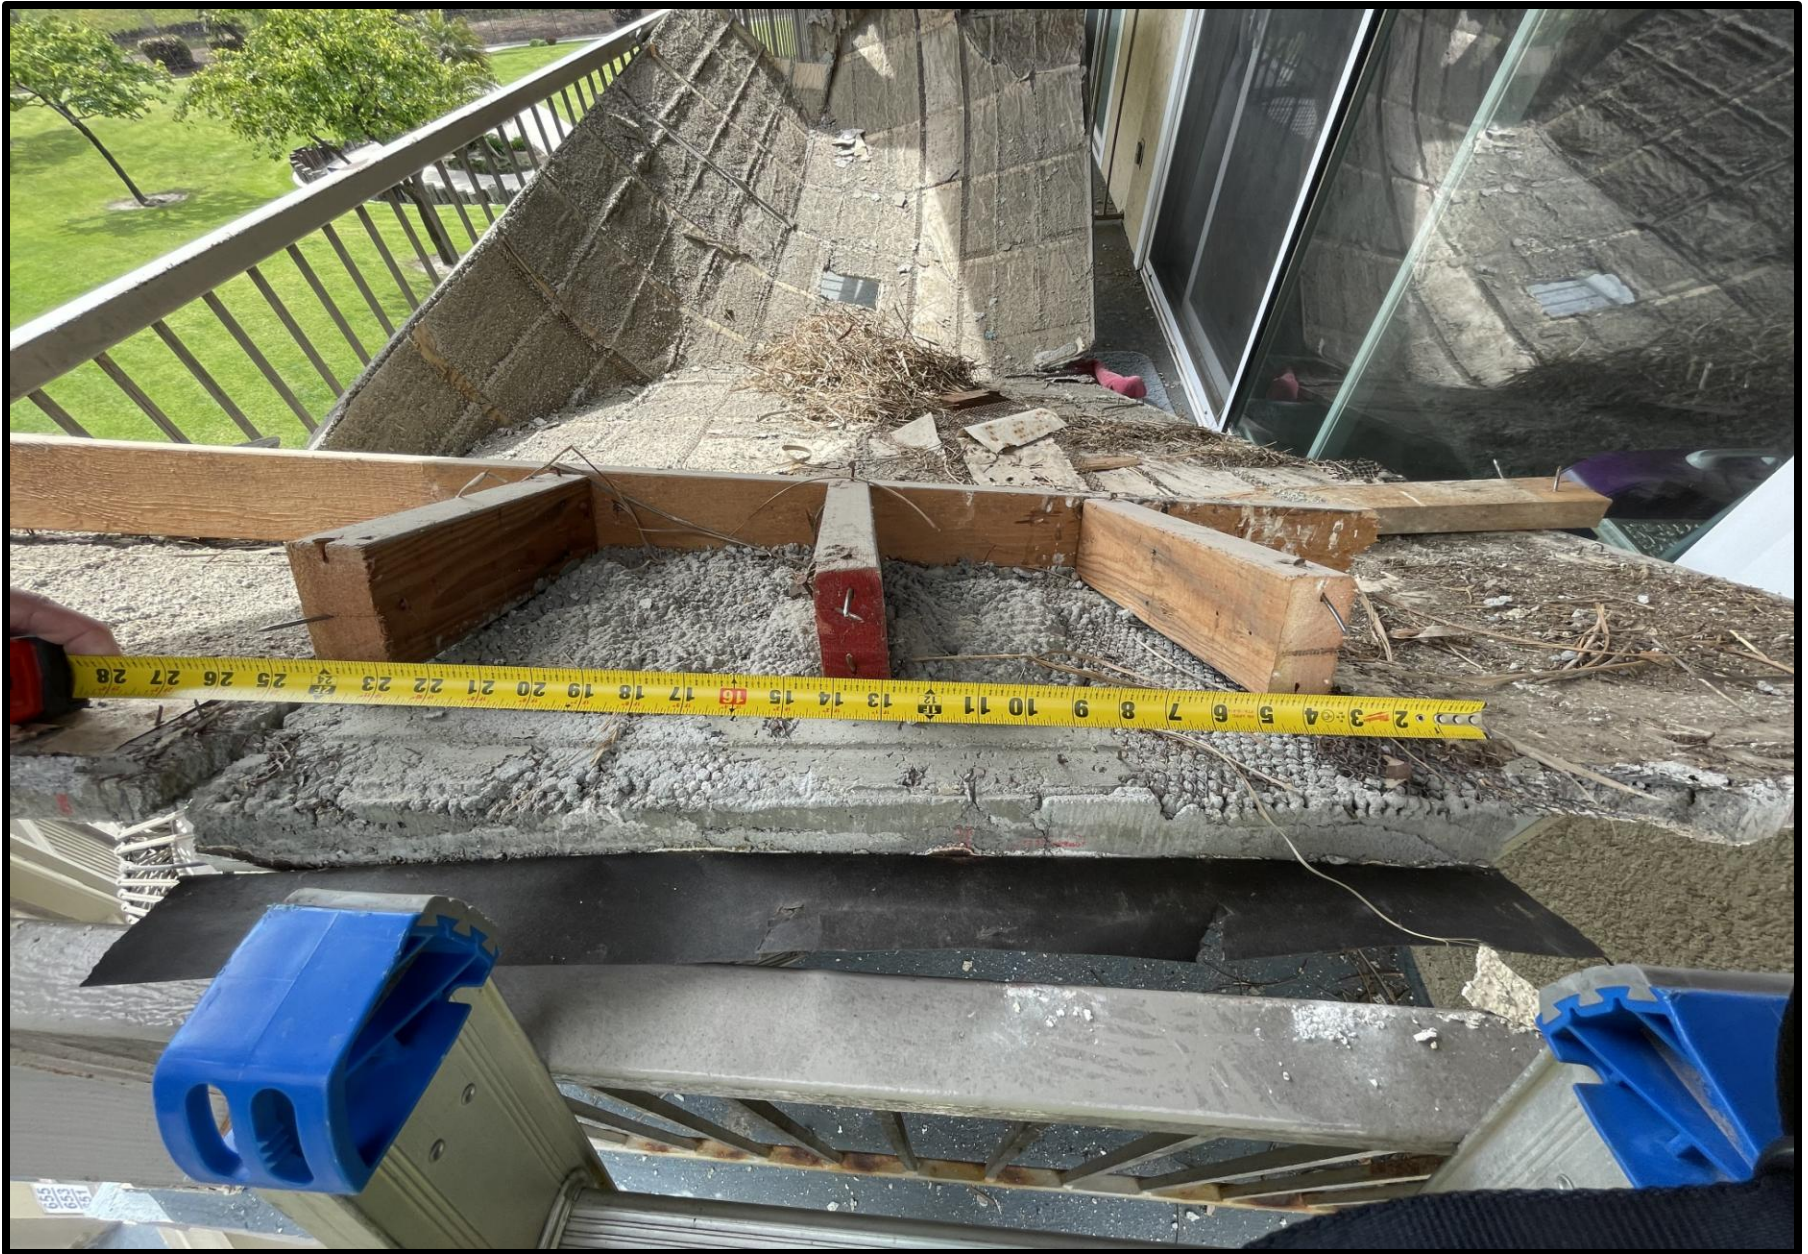
It appears from photographs you provided, that water infiltration, wood decay, rusting of metal lath and fasteners were all likely sources that led to the initial "domino effect" and collapse of the entire stucco soffit (see **Photographs #016- 022**). You indicated that this particular section (corner) of the soffit appears to have been repaired in the past, and where ultimately the soffit began its initial collapse. In my opinion, the consequence of a series of events, including the water infiltration, wood decay, and rusted lath, ultimately set off this chain reaction (domino-effect), due to the above listed lath and plaster deficiencies.
