SURFSIDE III
PROJECT SUMMARY REPORT

JANUARY 26, 2024

This report prepared for:
Surfside III
600 Sunfish Way
Port Hueneme, CA 93041

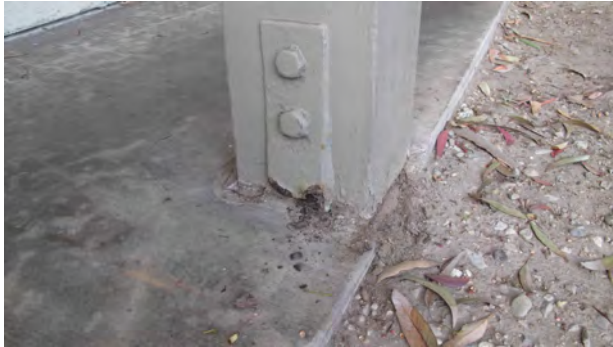
1. ORIGINAL - 8/10/21
(ELEVATED WALK- RUST AT HARDWARE)

NEW - 10/23/23

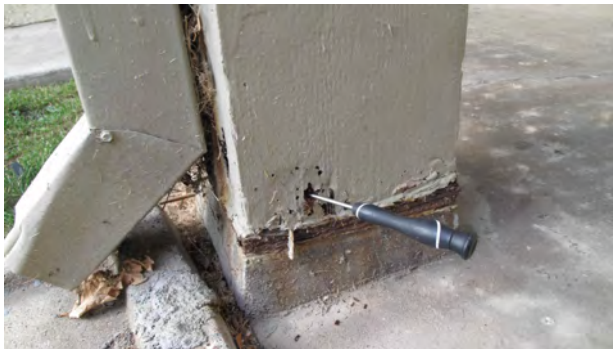
2. ORIGINAL - 8/10/20212.
(ELEVATED WALK- DRY ROT AT POST)

NEW - 10/23/23

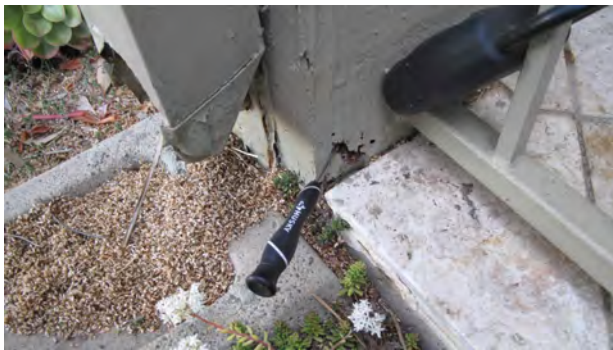
3. ORIGINAL - 8/10/21
(ELEVATED WALK- DRY ROT AT POST)

NEW - 10/23/23

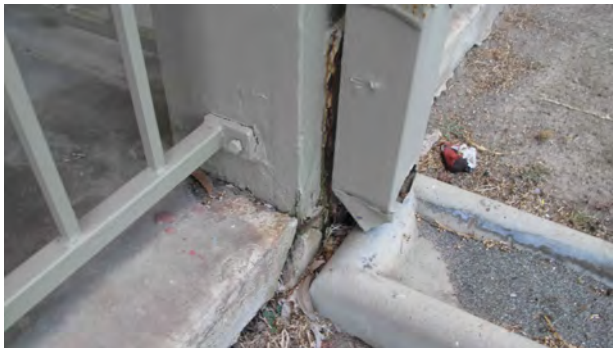
4. ORIGINAL - 8/10/21
(ELEVATED WALK- RUST AT HARDWARE)

NEW - 10/23/23

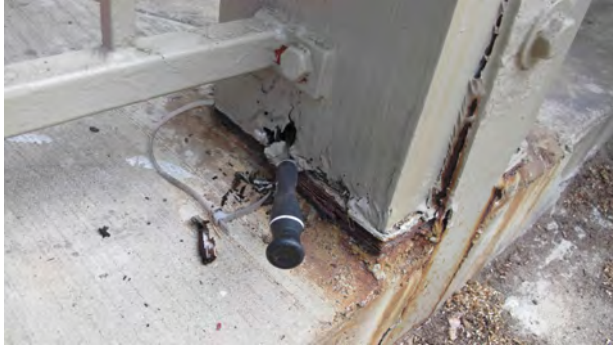
5. ORIGINAL - 8/10/21
(ELEVATED WALK- DRY ROT AT POST)

NEW - 10/23/23

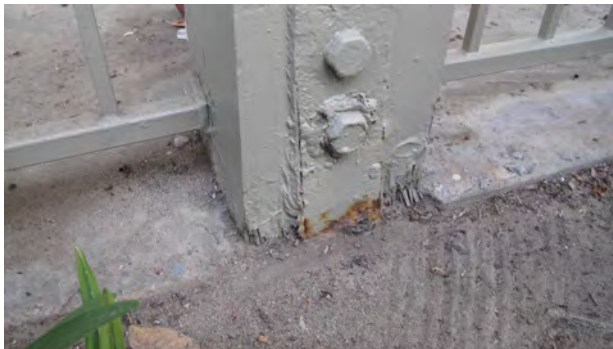
6. ORIGINAL - 8/10/21
(ELEVATED WALK- RUST AT HARDWARE)

NEW - 10/23/23

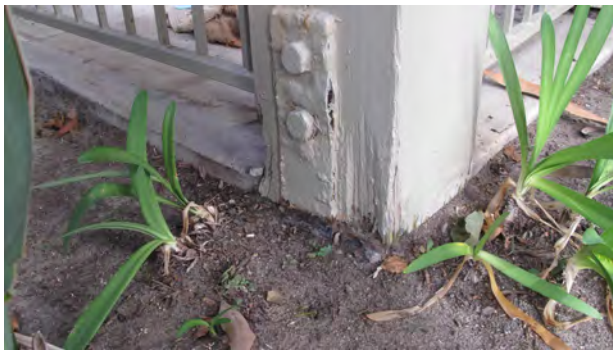
7. ORIGINAL - 8/10/21
(ELEVATED WALK- RUST AT HARDWARE)

NEW - 10/23/23

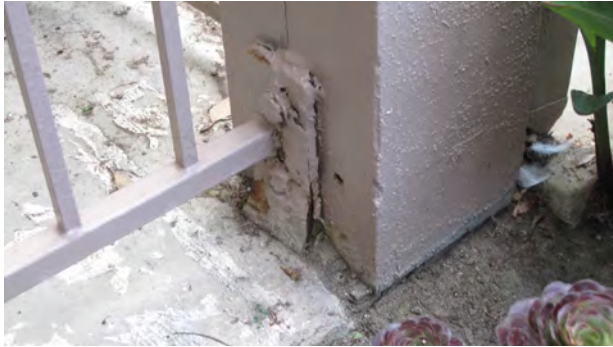
1. ORIGINAL - 8/10/21
(ELEVATED WALK- RUST AT HARDWARE)

NEW - 10/23/23

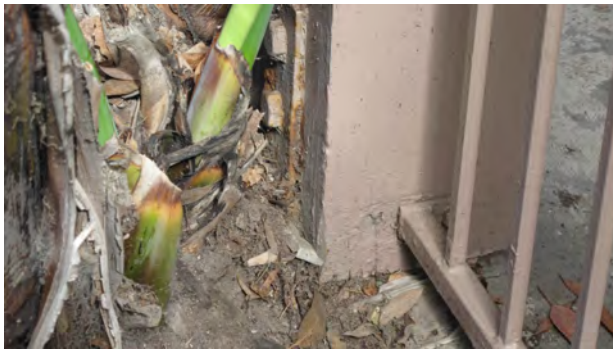
2. ORIGINAL - 8/10/21
(ELEVATED WALK- RUST AT HARDWARE)

NEW - 10/23/23

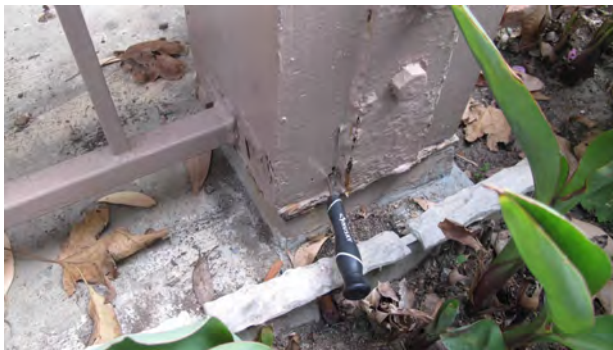
3. ORIGINAL - 8/10/21 (ELEVATED WALK- RUST
AT HARDWARE AND DRY ROT AT POST)

NEW - 10/23/23

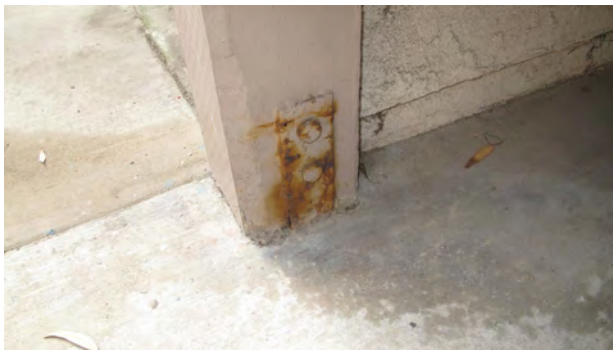
4. ORIGINAL - 8/10/21
(ELEVATED WALK- RUST AT HARDWARE)

NEW - 10/23/23

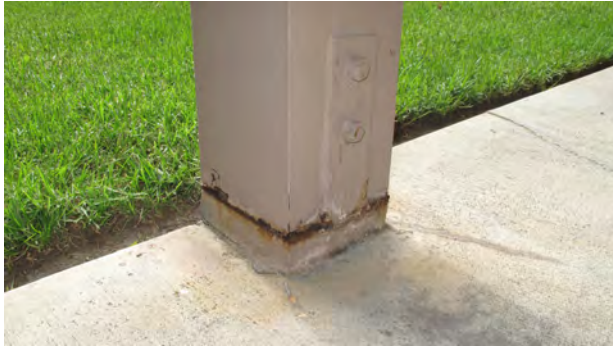
5. ORIGINAL - 8/10/21
(ELEVATED WALK- RUST AT HARDWARE)

NEW - 10/23/23

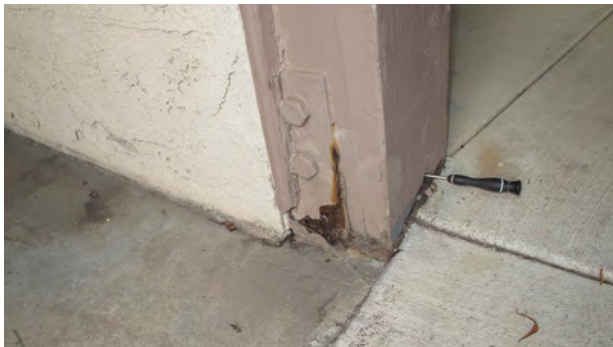
6. ORIGINAL - 8/10/21 (ELEVATED WALK- RUST AT
HARDWARE AND DRY ROT AT POST)

NEW - 10/23/23

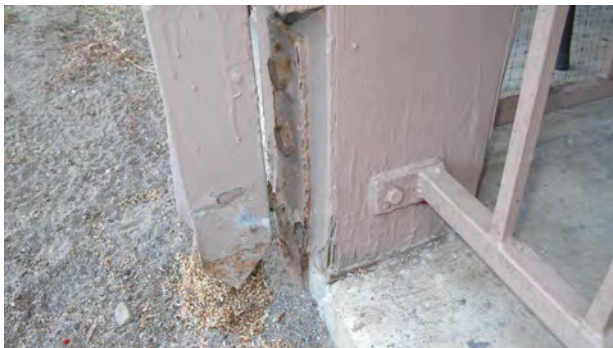
7. ORIGINAL - 8/10/21
(ELEVATED WALK- RUST AT HARDWARE)

NEW - 10/23/23

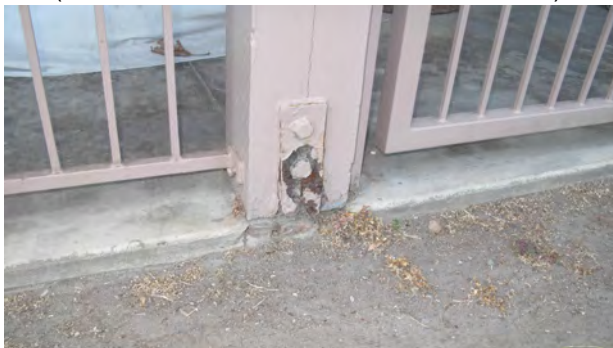
8. ORIGINAL - 8/10/21
(ELEVATED WALK- RUST AT HARDWARE)

NEW - 10/23/23

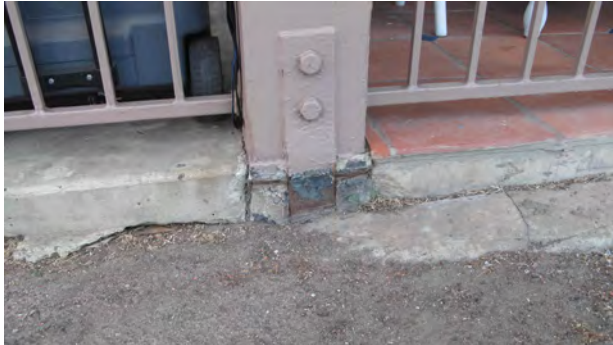
9. ORIGINAL - 8/10/21
(ELEVATED WALK - RUST AT HARDWARE)

NEW - 10/23/23

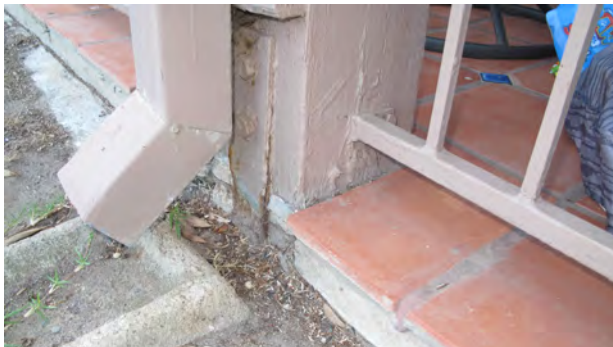
10. ORIGINAL - 8/10/21
(ELEVATED WALK- RUST AT HARDWARE)

NEW - 10/23/23

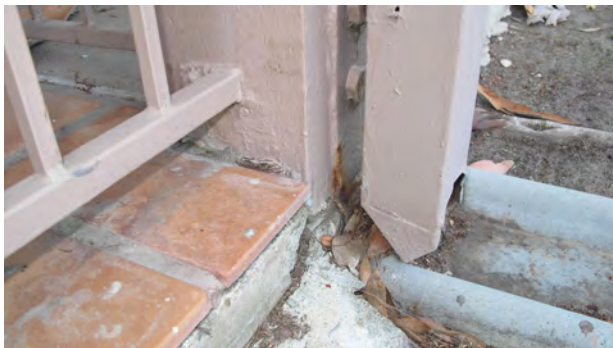
11. ORIGINAL - 8/10/21
(ELEVATED WALK- RUST AT HARDWARE)

NEW - 10/23/23

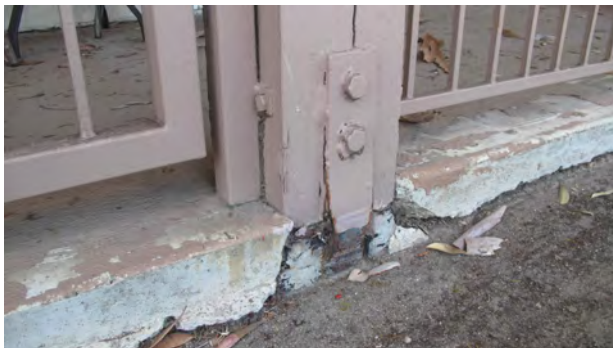
12. ORIGINAL - 8/10/21
(ELEVATED WALK- RUST AT HARDWARE)

NEW - 10/23/23

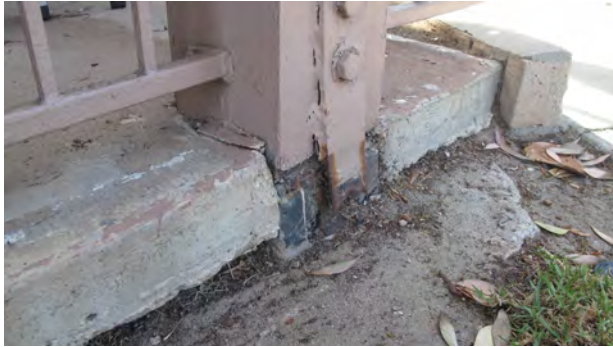
13. ORIGINAL - 8/10/21
(ELEVATED WALK- RUST AT HARDWARE)

NEW - 10/23/23

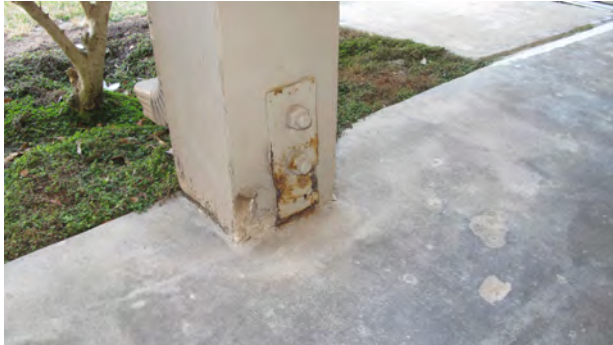
1. ORIGINAL - 8/10/21
(ELEVATED WALK- RUST AT HARDWARE)

NEW - 09/25/23

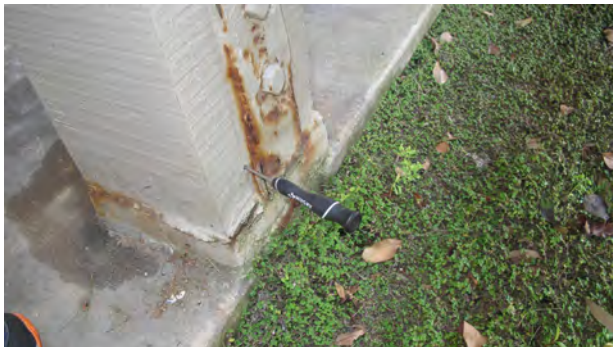
2. ORIGINAL - 8/10/21 (ELEVATED WALK- RUST AT HARDWARE AND DRY ROT AT POST)

NEW - 09/25/23

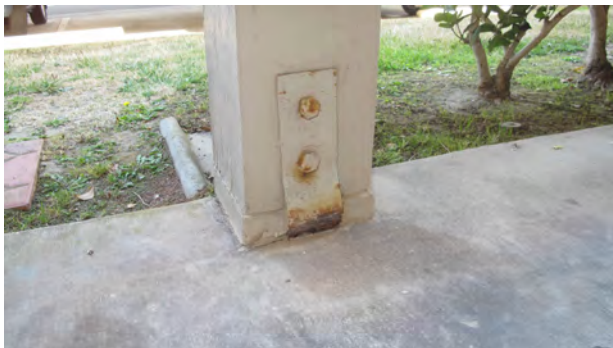
3. ORIGINAL - 8/10/21
(ELEVATED WALK- RUST AT HARDWARE)

NEW - 09/25/23

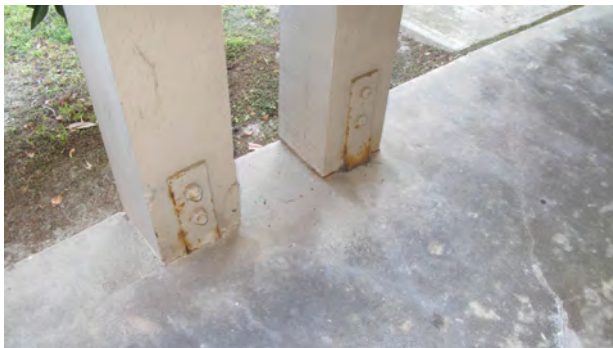
4. ORIGINAL - 8/10/21
(ELEVATED WALK- RUST AT HARDWARE)

NEW - 09/25/23

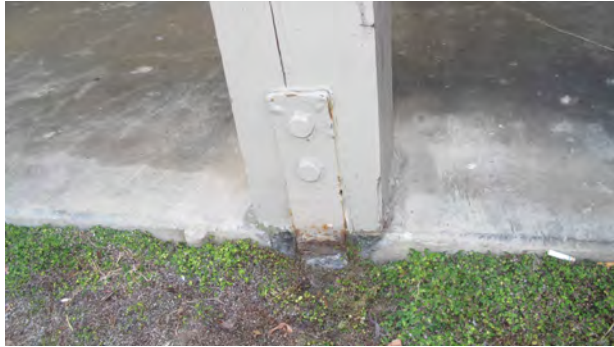
5. ORIGINAL - 8/10/21
(ELEVATED WALK- RUST AT HARDWARE)

NEW - 09/25/23

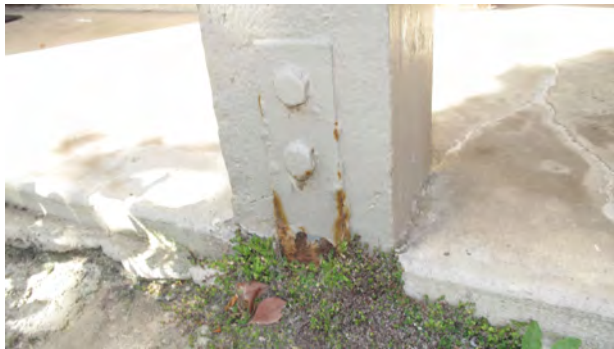
6. ORIGINAL - 8/10/21
(ELEVATED WALK- RUST AT HARDWARE)

NEW - 09/25/23

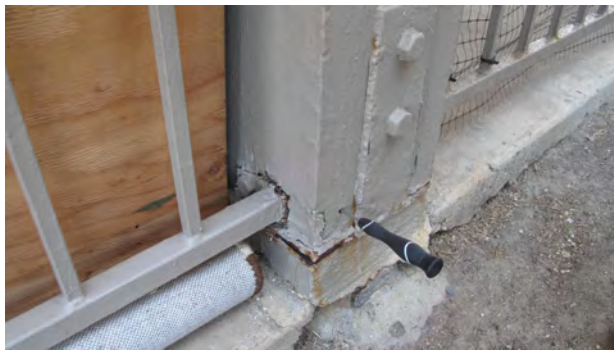
7. ORIGINAL - 8/10/21 (ELEVATED WALK- DRY
ROT AT POST AND RUST AT HARDWARE)

NEW - 10/23/23

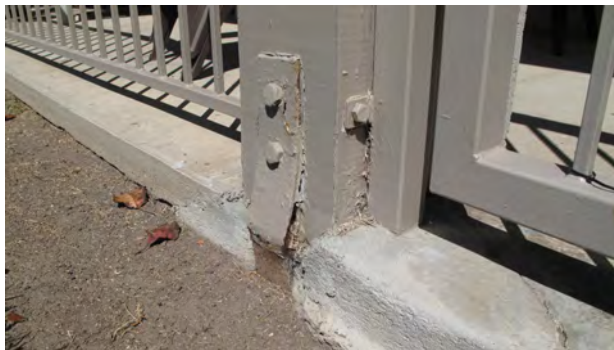
8. ORIGINAL - 8/10/21
(ELEVATED WALK- RUST AT HARDWARE)

NEW - 09/25/23

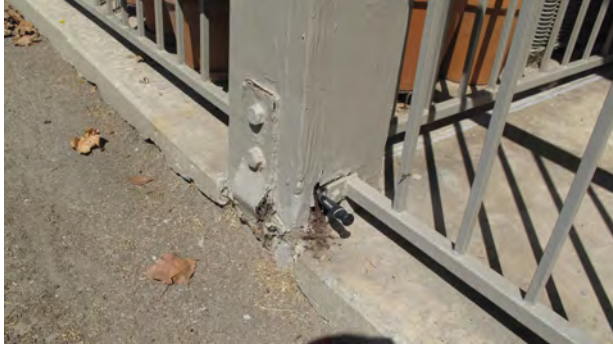
9. ORIGINAL - 8/10/21 (ELEVATED WALK- DRY ROT AT POST AND RUST AT HARDWARE)

NEW - 09/25/23

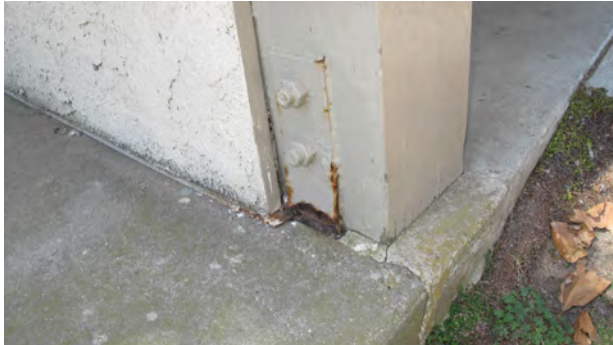
1. ORIGINAL - 8/10/21
(ELEVATED WALK- RUST AT HARDWARE)

NEW - 09/25/23

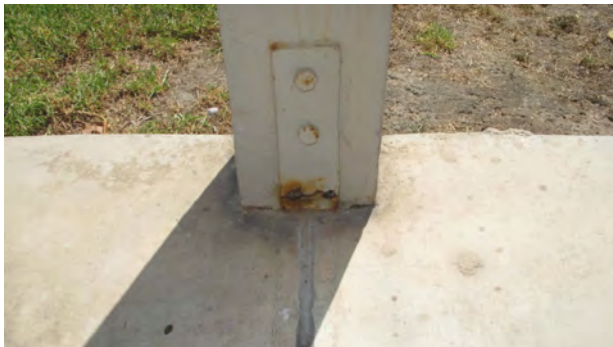
2. ORIGINAL - 8/10/21
(ELEVATED WALK- RUST AT HARDWARE)

NEW - 09/25/23

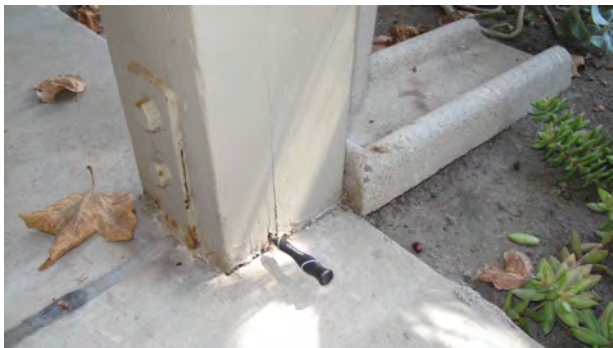
3. ORIGINAL - 8/10/21 (ELEVATED WALK- DRY
ROT AT POST AND RUST AT HARDWARE)

NEW - 09/25/23

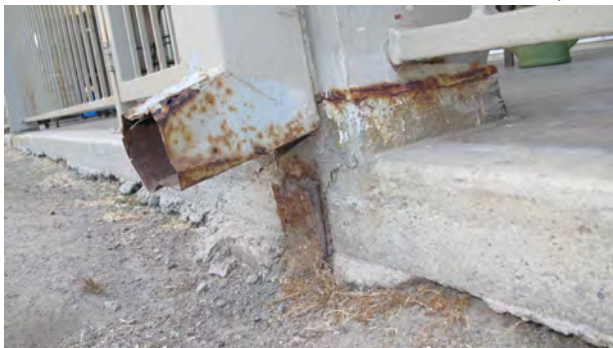
4. ORIGINAL - 8/10/21
(ELEVATED WALK- RUST AT HARDWARE)

NEW - 09/25/23

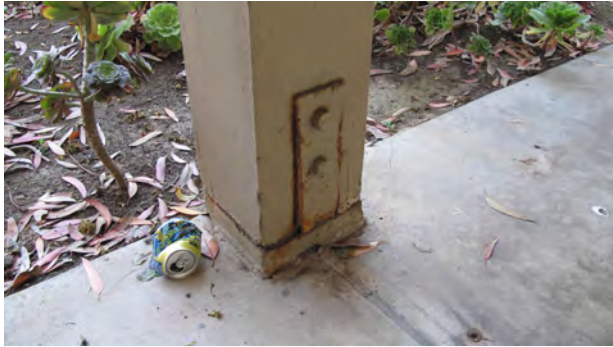
1. ORIGINAL - 8/10/21
(ELEVATED WALK- RUST AT HARDWARE)

NEW - 07/26/23

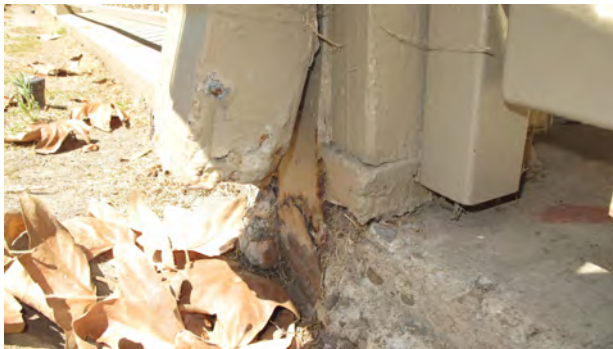
2. ORIGINAL - 8/10/21
(ELEVATED WALK- RUST AT HARDWARE)

NEW - 07/26/23

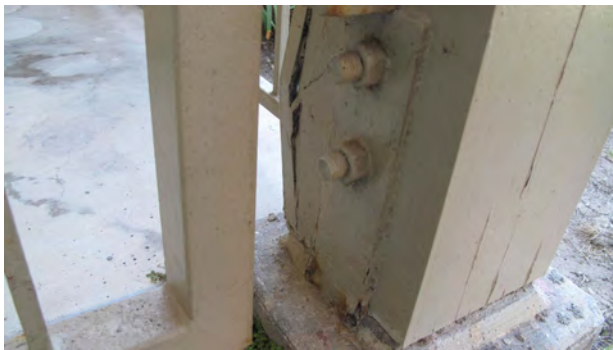
3. ORIGINAL - 8/10/21
(ELEVATED WALK- RUST AT HARDWARE)

NEW - 07/26/23

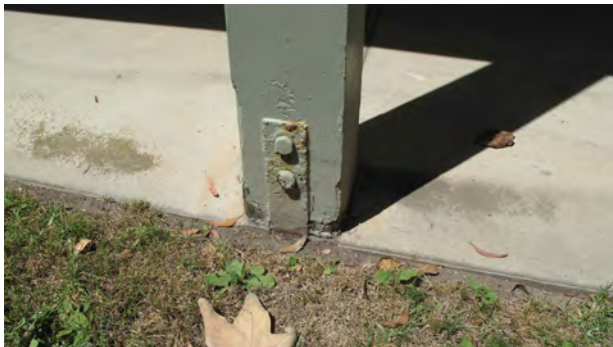
2. ORIGINAL - 8/10/21
(ELEVATED WALK- RUST AT HARDWARE)

NEW - 07/26/23

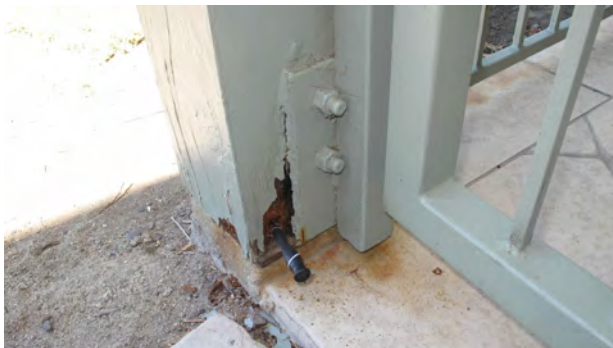
3. ORIGINAL - 8/10/21 (ELEVATED WALK- DRY
ROT AT POST AND RUST AT HARDWARE)

NEW - 07/26/23

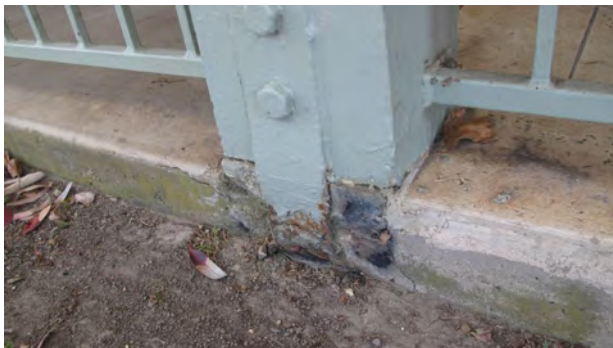
4. ORIGINAL - 8/10/21
(ELEVATED WALK- RUST AT HARDWARE)

NEW - 07/26/23

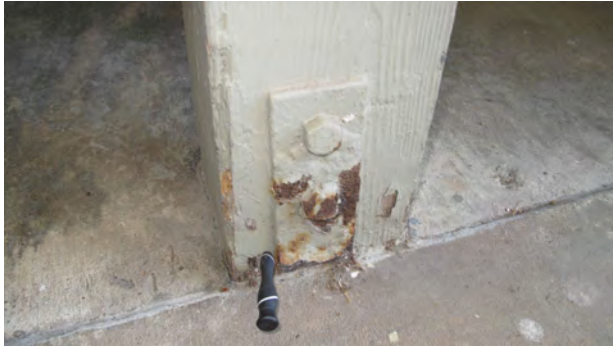
1. ORIGINAL - 8/10/21 (ELEVATED WALK- DRY ROT AT POST AND RUST AT HARDWARE)

NEW - 07/26/23

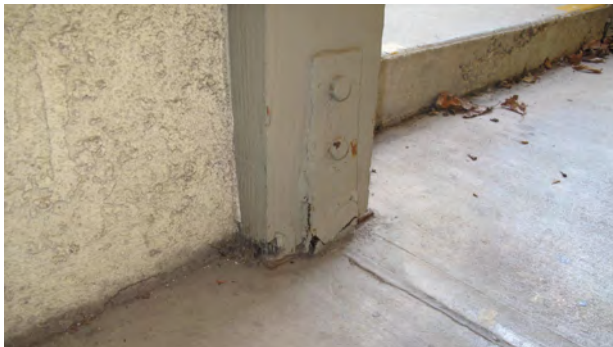
2. ORIGINAL - 8/10/21
(ELEVATED WALK- RUST AT HARDWARE)

NEW - 07/26/23

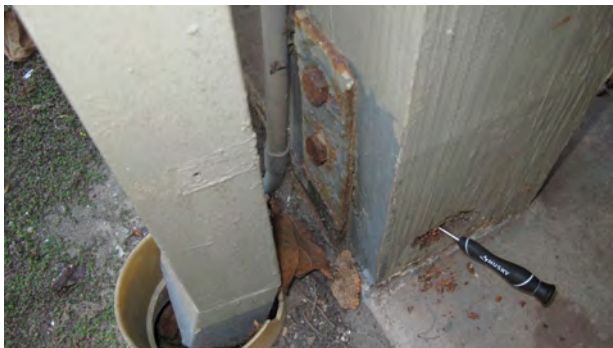
3. ORIGINAL - 8/10/21 (ELEVATED WALK- DRY ROT AT POST AND RUST AT HARDWARE)

NEW - 07/26/23

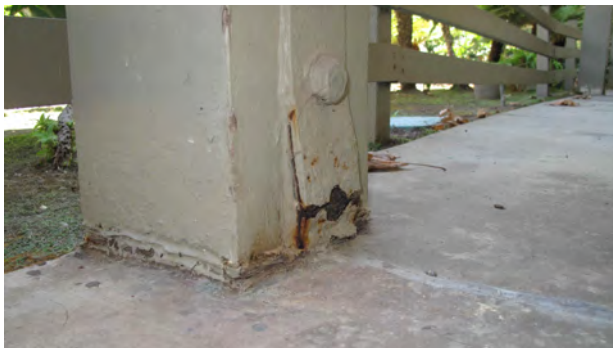
4. ORIGINAL - 8/10/21
(ELEVATED WALK- RUST AT HARDWARE)

NEW - 07/26/23

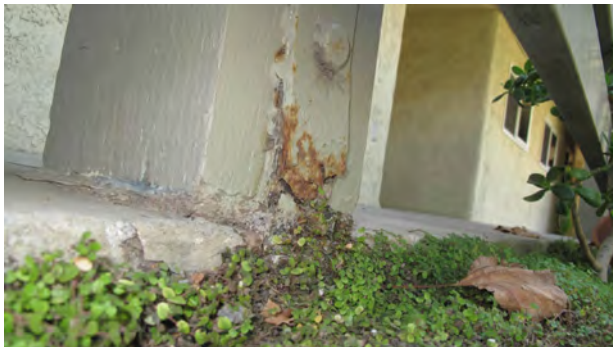
6. ORIGINAL - 8/10/21
(ELEVATED WALK- RUST AT HARDWARE)

NEW - 07/26/23

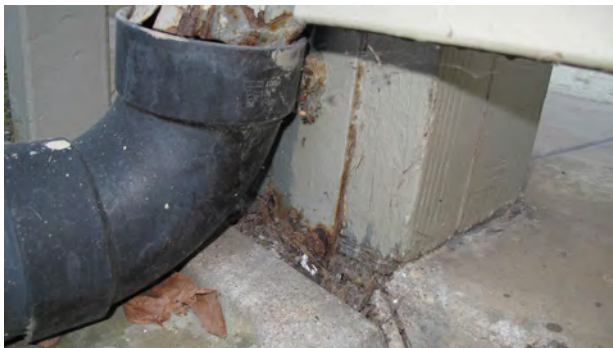
7. ORIGINAL - 8/10/21
(ELEVATED WALK- RUST AT HARDWARE)

NEW - 07/26/23

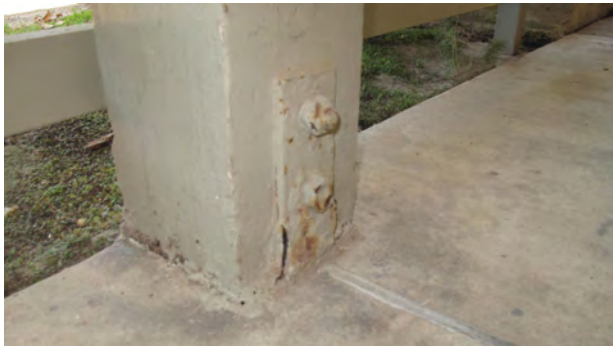
8. ORIGINAL - 8/10/21
(ELEVATED WALK- RUST AT HARDWARE)

NEW - 07/26/23
