CALIFORNIA  
PLASTERING  
CONSULTANTS

March 28, 2022

**RE: Building 3- Soffit Collapse Evaluation  
Surfside III  
600 Sunfish Way  
Port Hueneme, CA 91041**

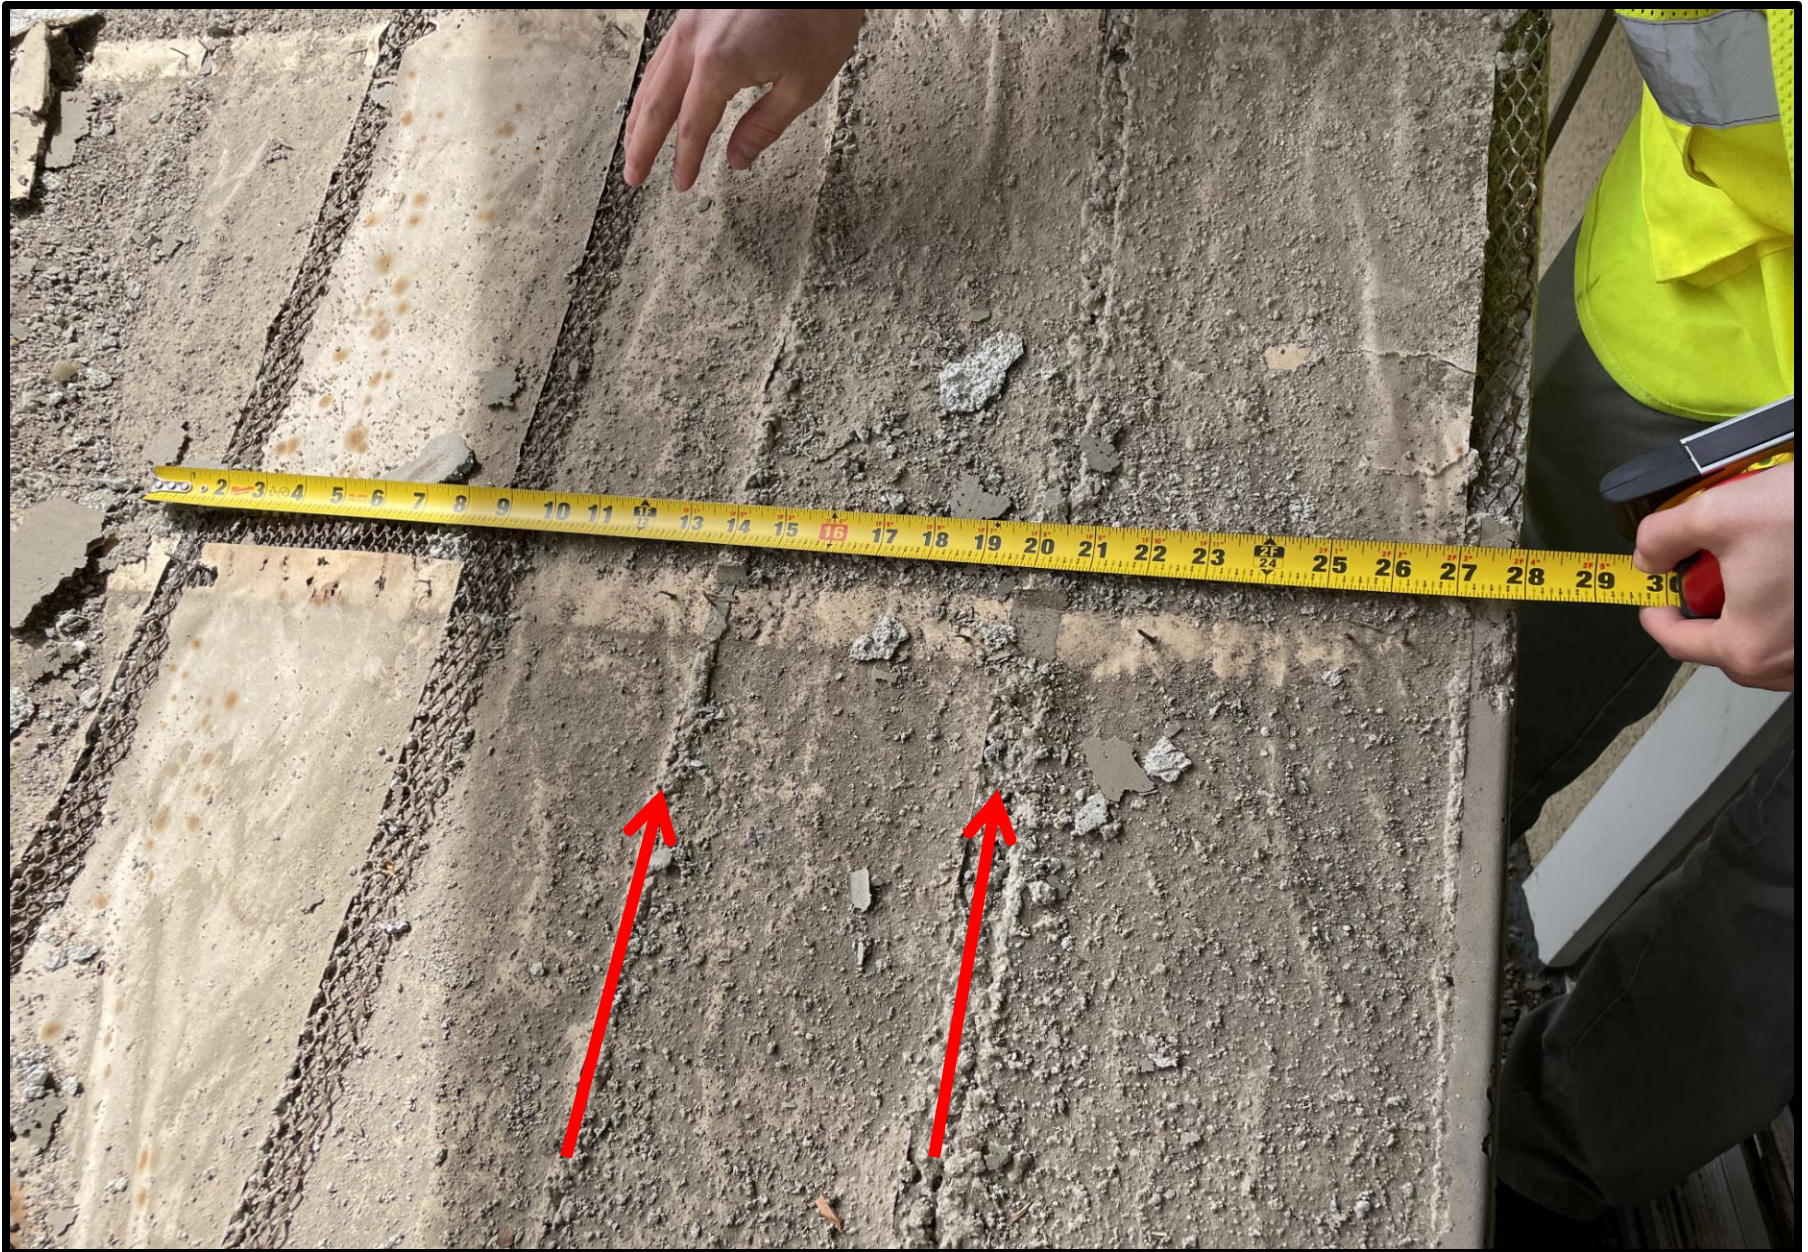
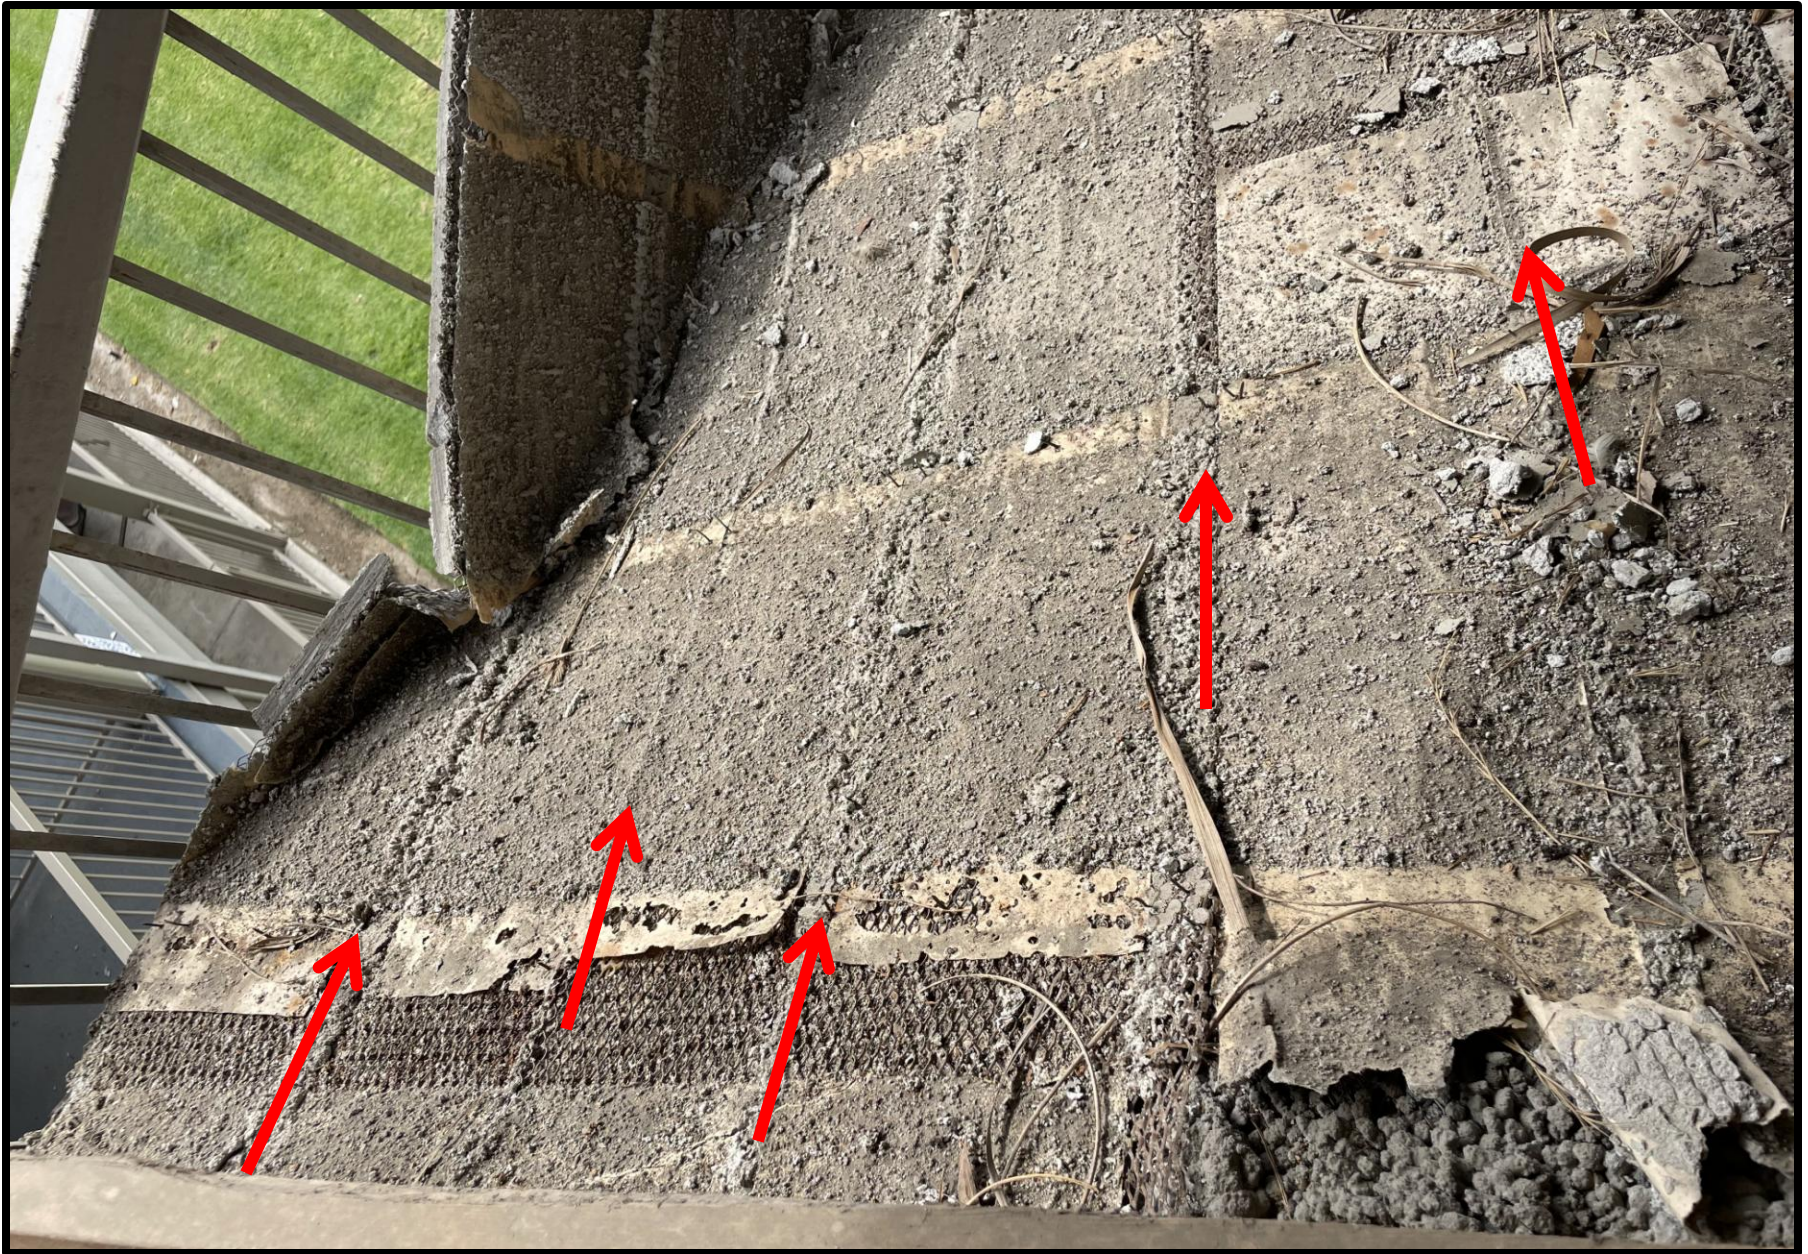
During the original construction of Building 3, boundary framing (blocking) was missing between individual stud bays, along the front and rear portions of the framed soffit (see **Photographs #001- 002**). This omission prohibited the soffit lath from being properly secured above the front soffit beam and rear vent screed. Lath staples utilized for securing the soffit lath to the framing above were only engaged at individual studs that were spaced 16-inches on center. The missing boundary blocking and consequential lath attachment undermined the holding strength of the stucco soffit.

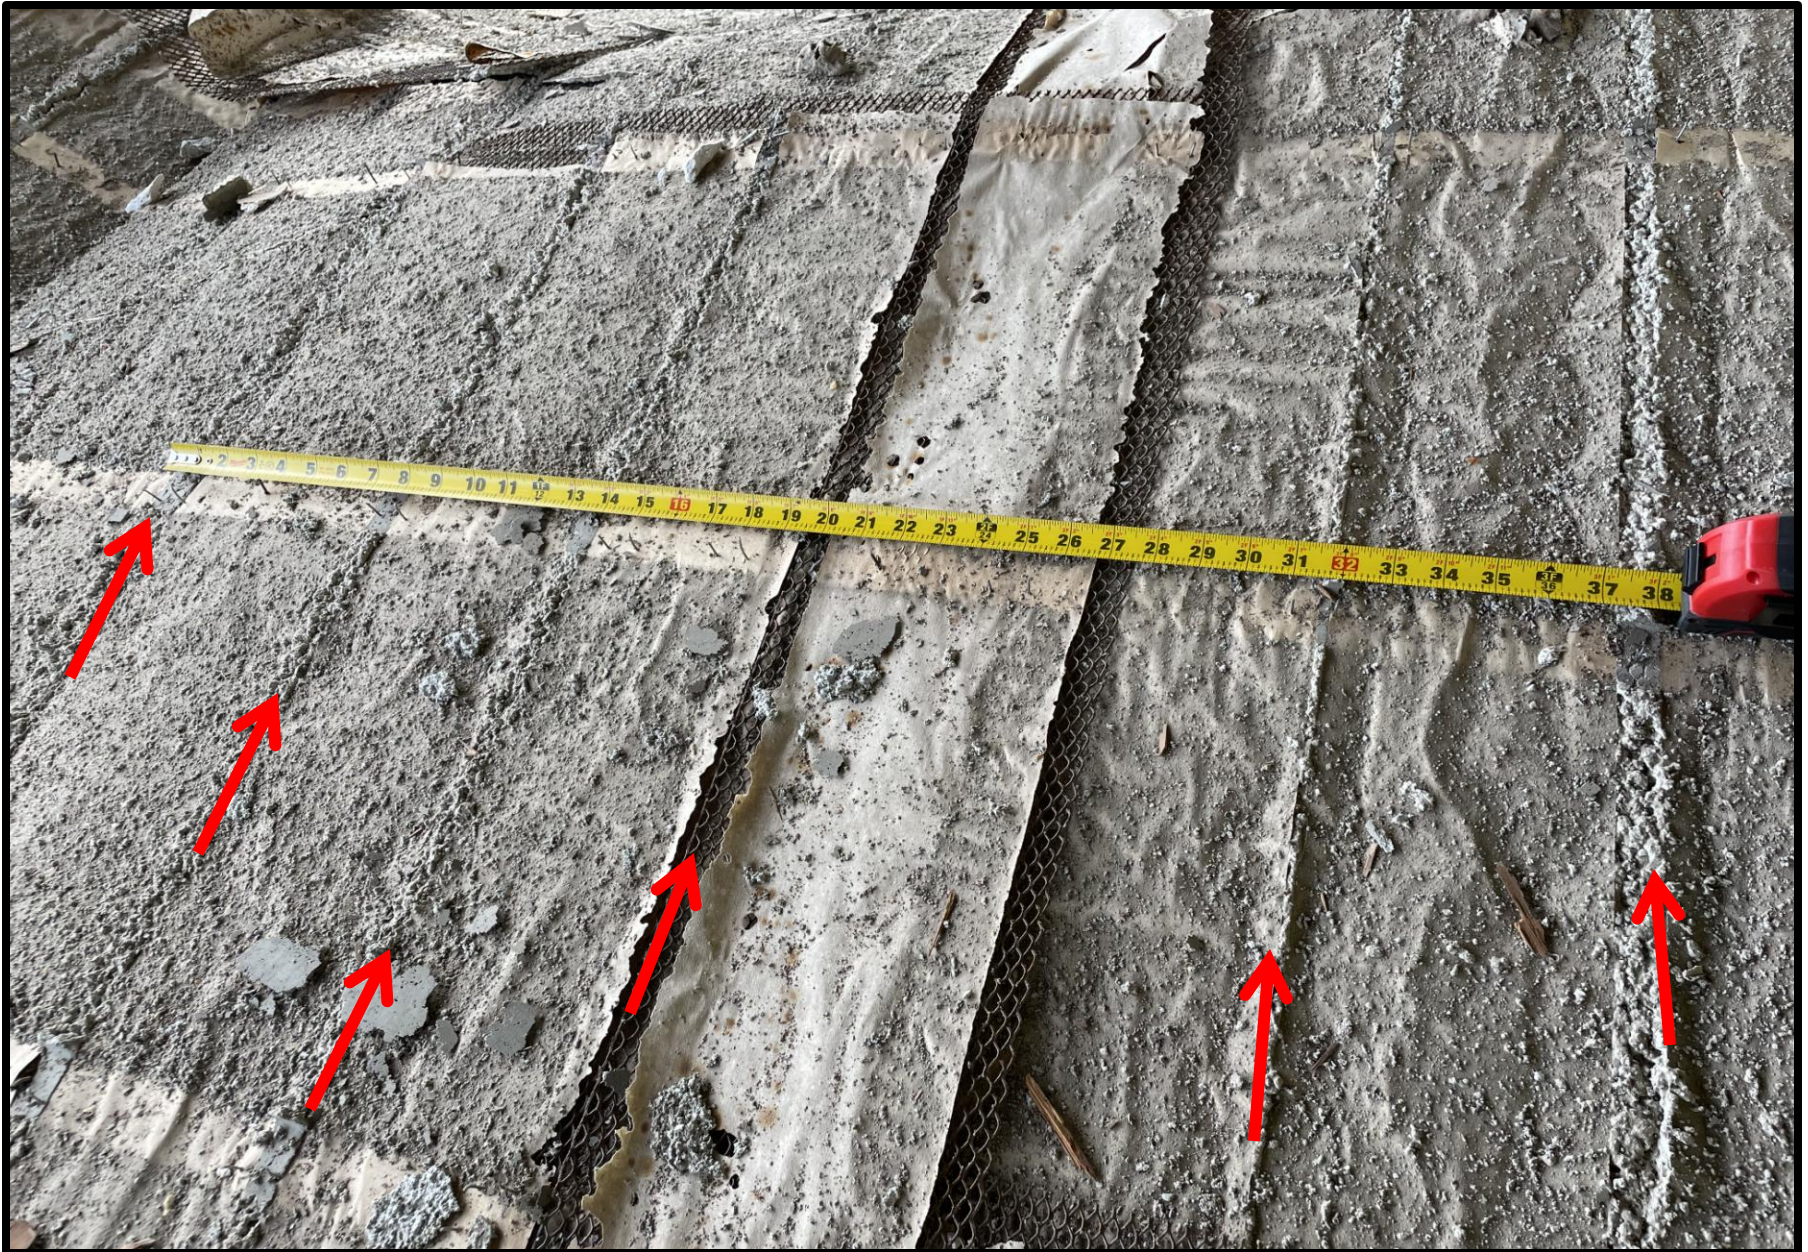
Lath staples utilized to secure the soffit lath to framing members were too short. The length of individual lath staples were measured and found to be only  $\frac{3}{4}$ -inches in length (see **Photographs #003- 004**). Building codes during the 1976-1978 time frame required minimum staple lengths to be  $\frac{7}{8}$ -inches. Furthermore, staple lengths are increased when metal lath at soffits contain either Hi-Rib or other self-furred devices (i.e. "V" grooves, crimped/ dimpled). It appears from the photographs you provided, a "V" groove-type lath was utilized (see **Photographs #005- 007**). These "V" grooves provide the necessary  $\frac{1}{4}$ -inch furring off the wood supports, to allow for proper embedment and keying of the scratch coat.

Moreover, when attaching metal lath to wood supports (soffits), lath staples must be placed at the self-furred "V" grooves, so as not to inhibit embedment. In my opinion, the use of  $\frac{3}{4}$ -inch staples was inadequate in size and should have been increased to a required minimum  $1\frac{1}{4}$ - inches, in length. Furthermore, photographs indicate that the staple legs only engaged  $\frac{1}{2}$ -inches, and not the minimum  $\frac{7}{8}$ - inches into wood supports (see **Photographs #008- 010**). The undersized staples contributed to the collapse of the stucco soffit.

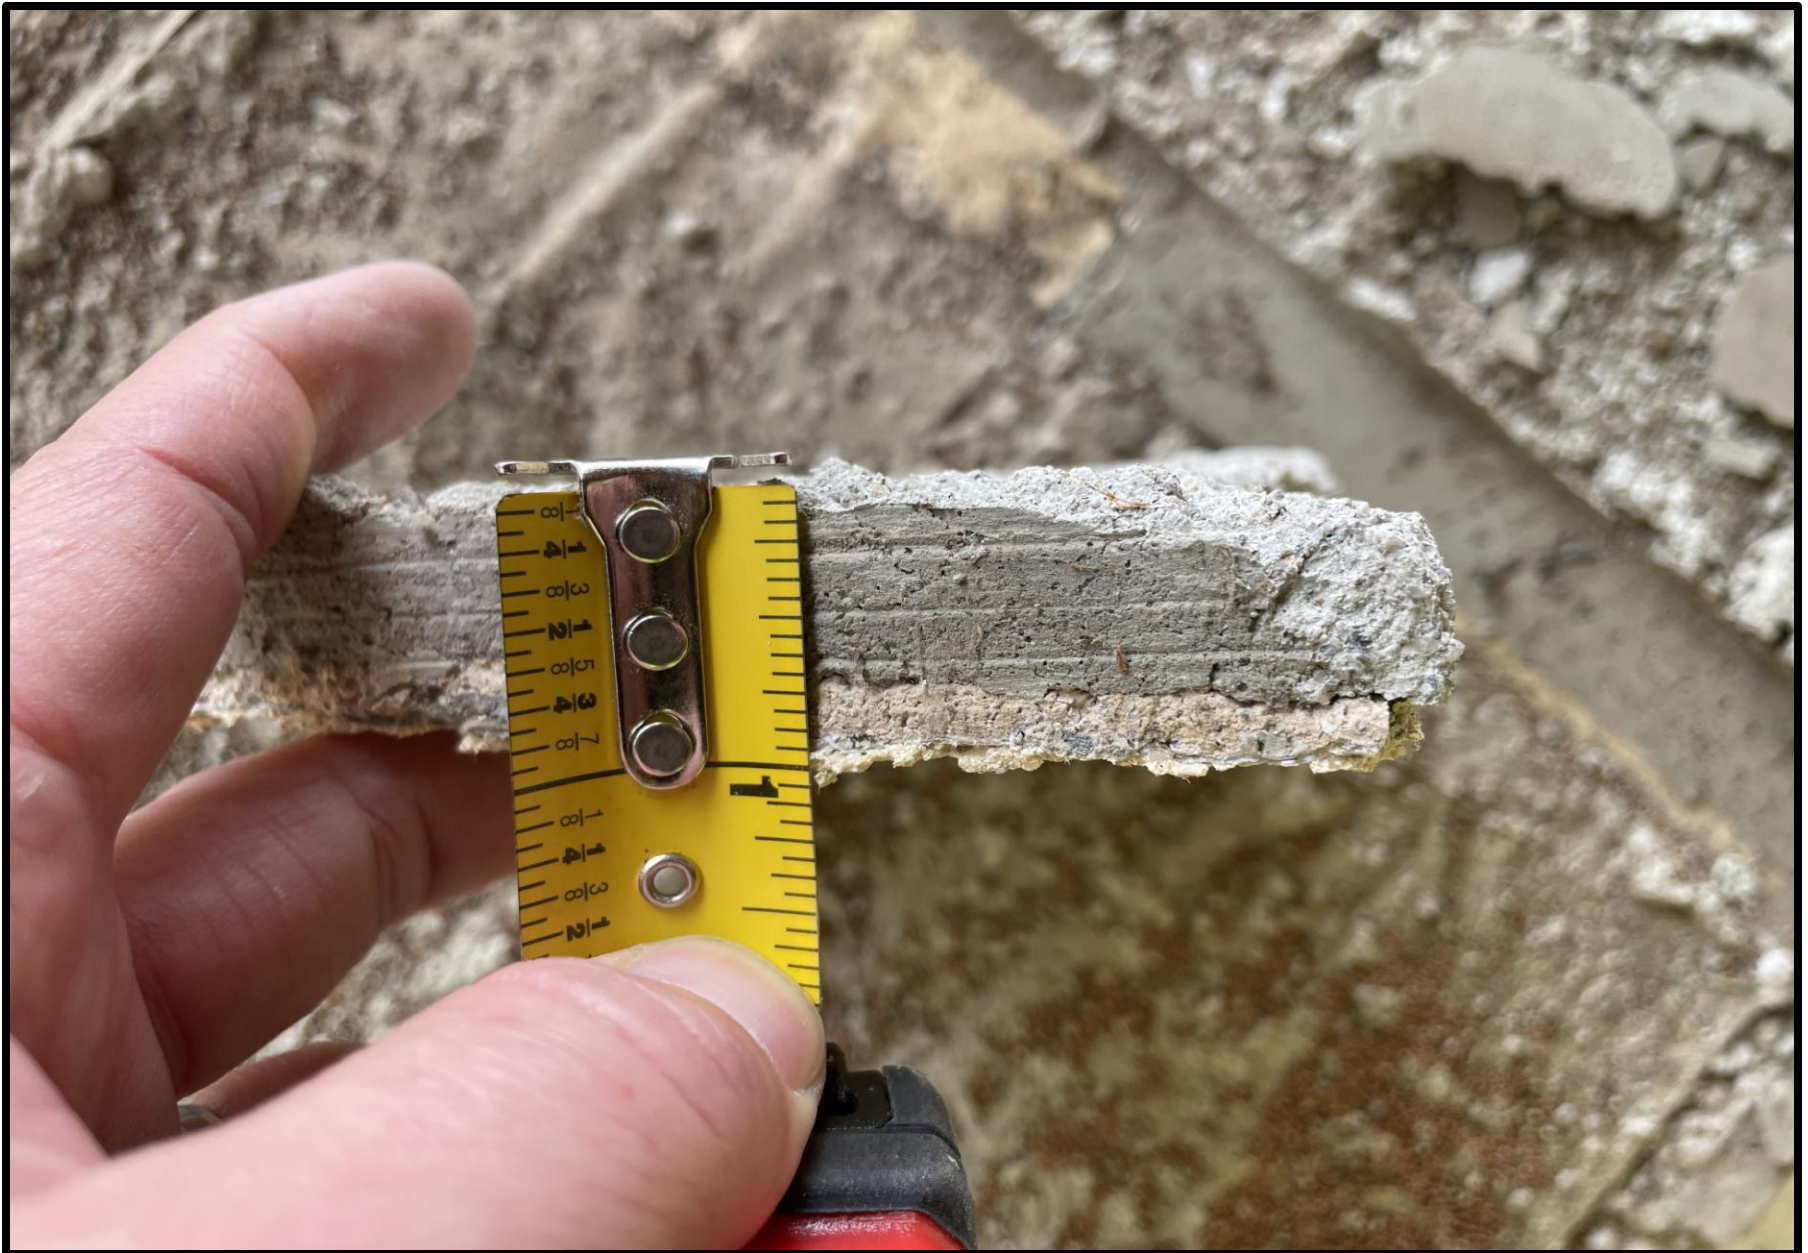
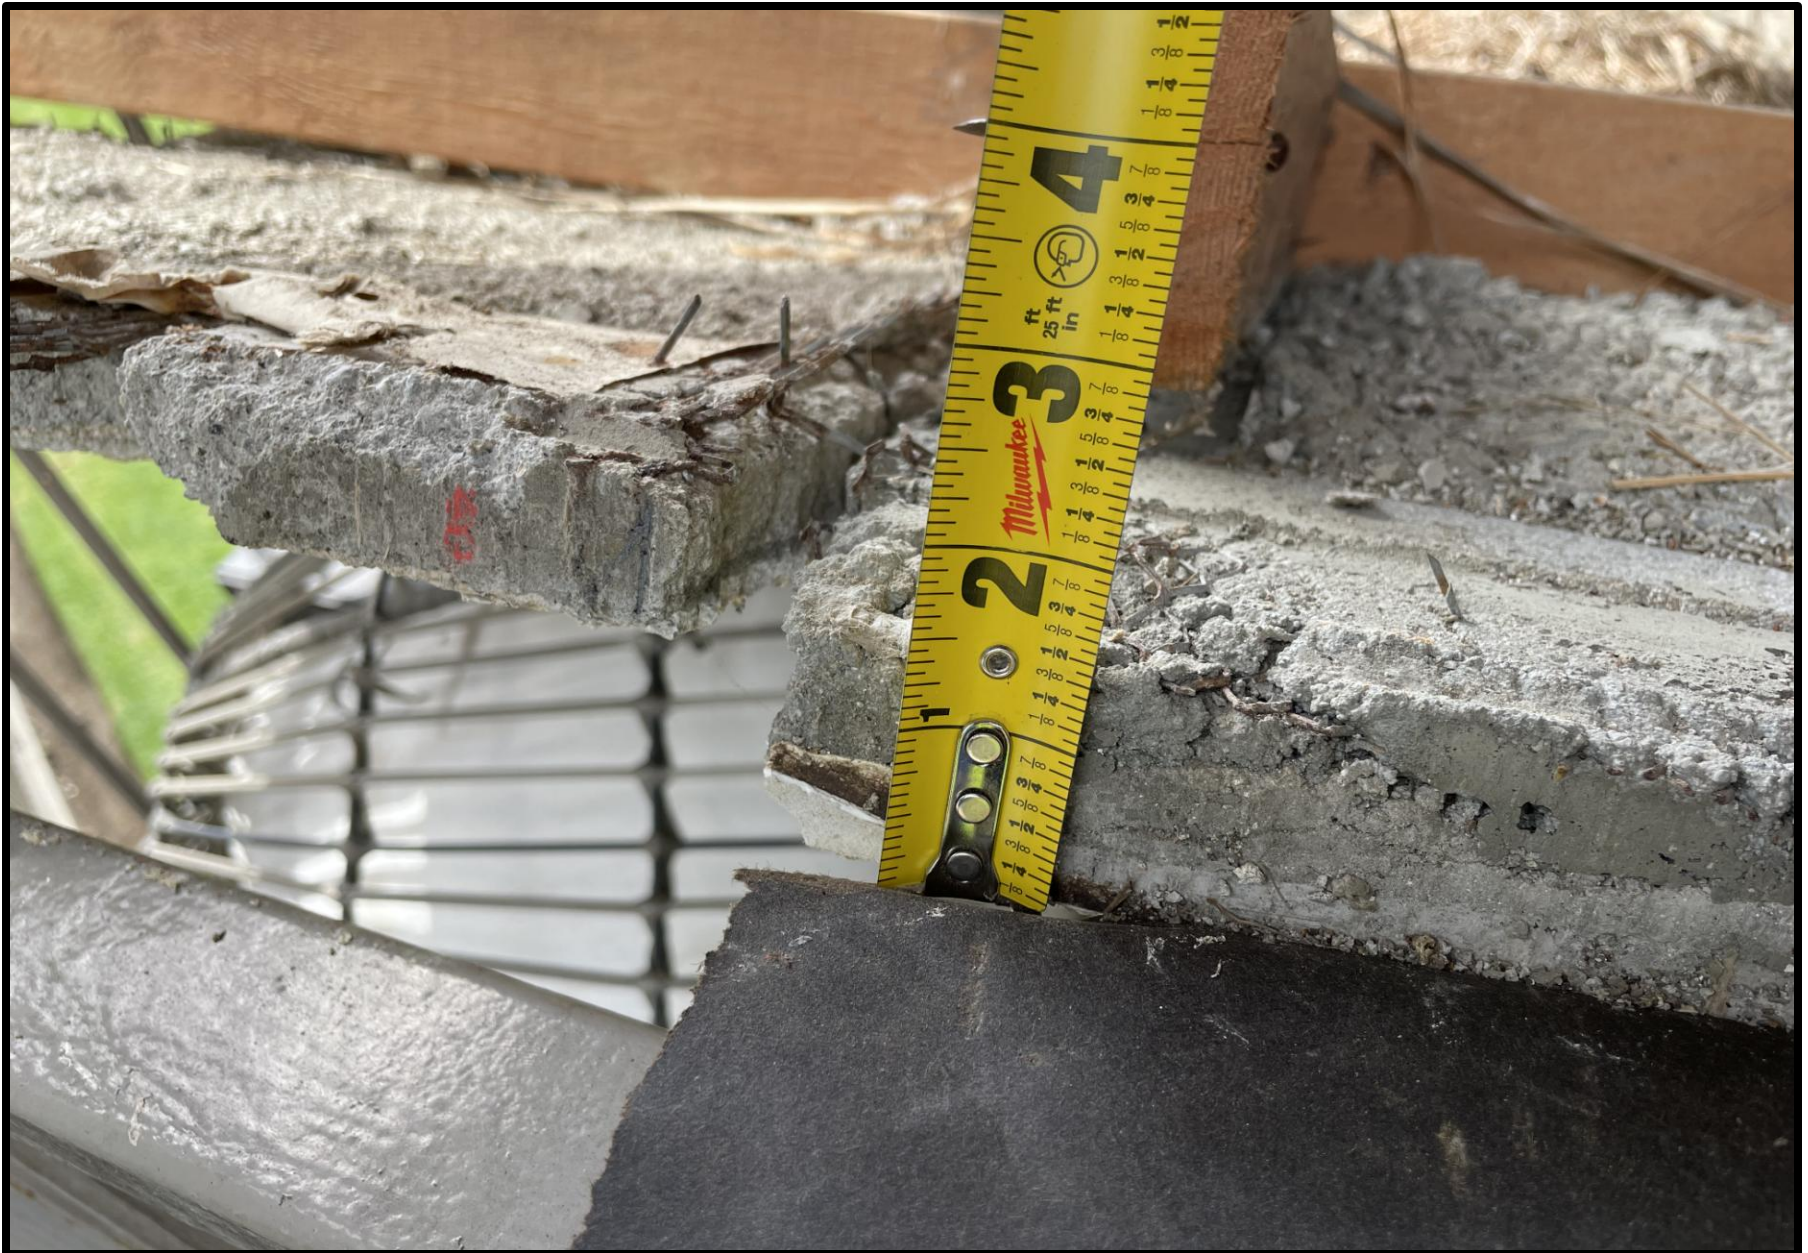
It appears from photographs you provided, that water infiltration, wood decay, rusting of metal lath and fasteners were all likely sources that led to the initial "domino effect" and collapse of the entire stucco soffit (see **Photographs #016- 022**). You indicated that this particular section (corner) of the soffit appears to have been repaired in the past, and where ultimately the soffit began its initial collapse. In my opinion, the consequence of a series of events, including the water infiltration, wood decay, and rusted lath, ultimately set off this chain reaction (domino-effect), due to the above listed lath and plaster deficiencies.
