SURFSIDE III
PROJECT SUMMARY REPORT

JANUARY 26, 2024

This report prepared for:
Surfside III
600 Sunfish Way
Port Hueneme, CA 93041

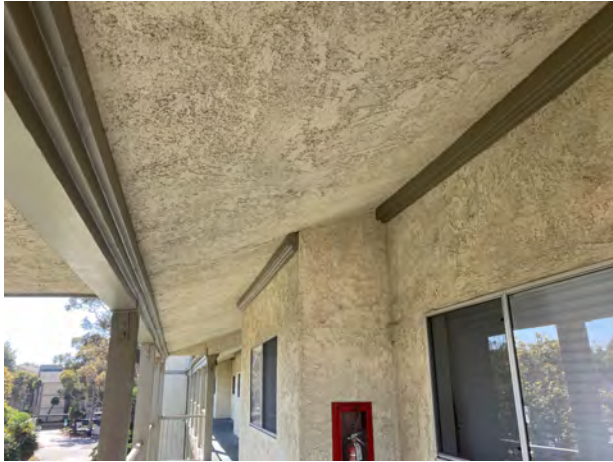
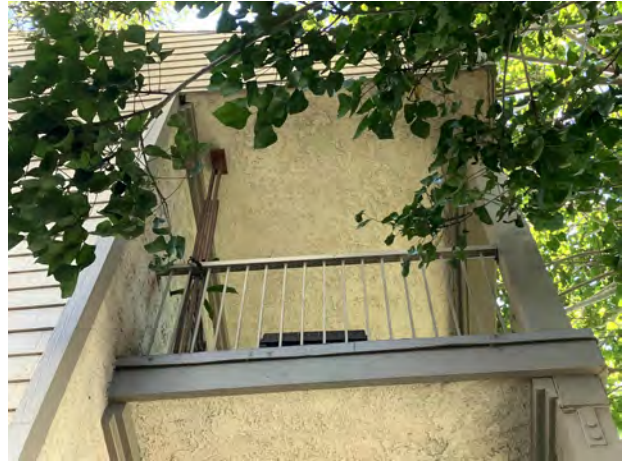
NEW LEDGER @ 3RD FLOOR SOFFIT - 10/23/23

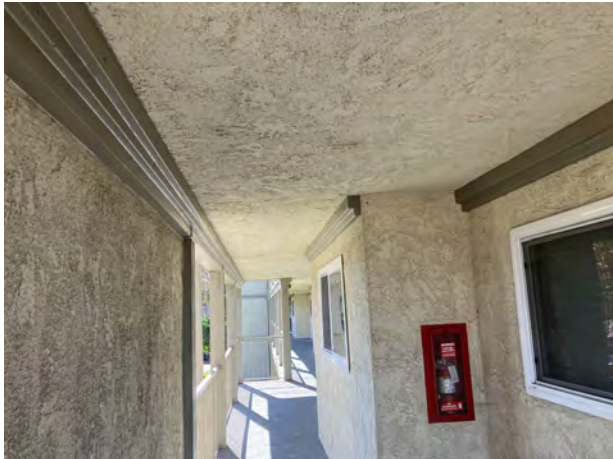
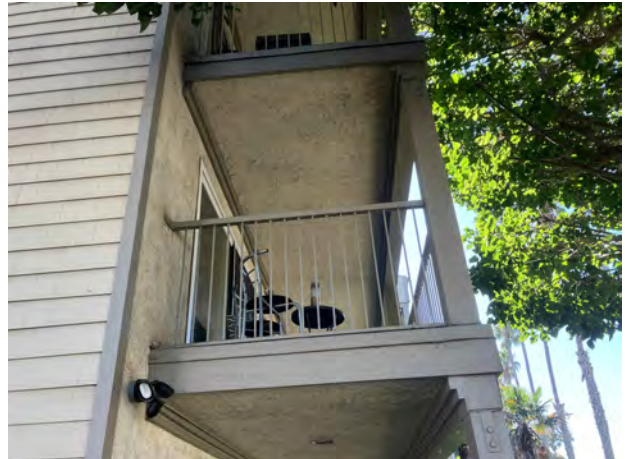
NEW LEDGER @ 2ND FLOOR SOFFIT - 10/23/23

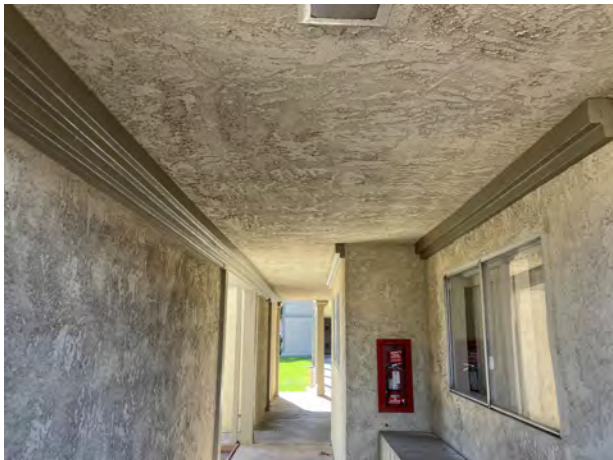
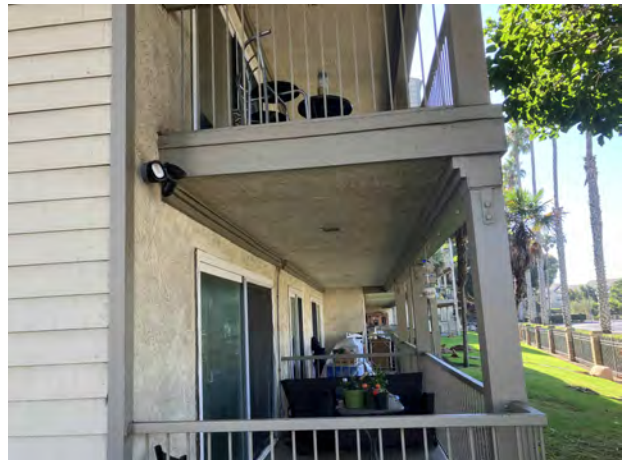
NEW LEDGER @ 1ST FLOOR SOFFIT - 10/23/23

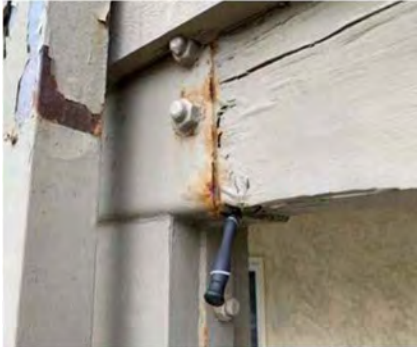
A. ORIGINAL - 8/10/21
(UNIT 512 - DRY ROT AT BEAM)

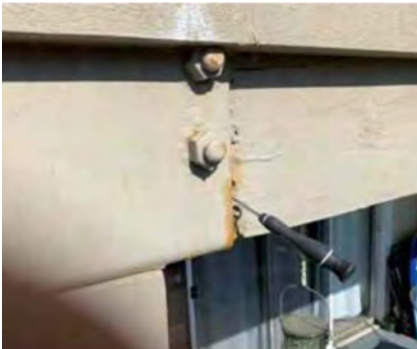
B. ORIGINAL - 8/10/21
(UNIT 570 - DRY ROT AT BEAM)

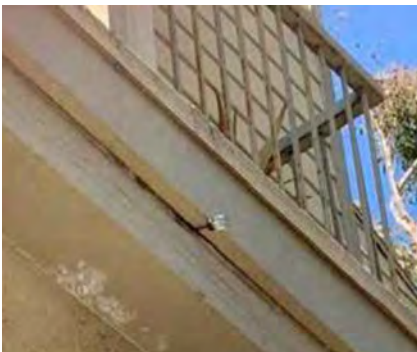
C. ORIGINAL - 8/10/21
(UNIT 576 - DRY ROT AT BEAM)

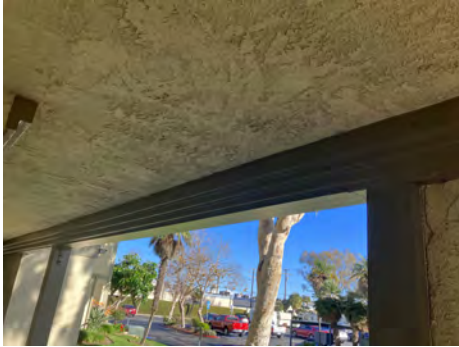
D. UNIT 566 - 1ST FLOOR STAIRWELL
16' BEAM REPLACEMENT - 01-03-24

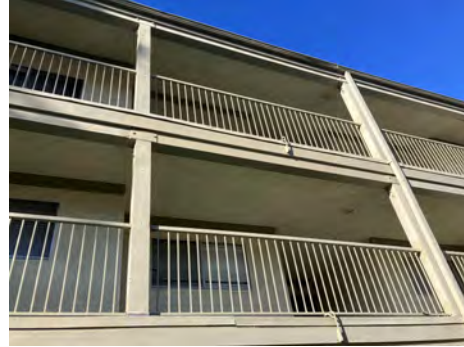
H. UNIT 524 - 2ND FLOOR 14' BEAM
REPLACEMENT - 01-03-24

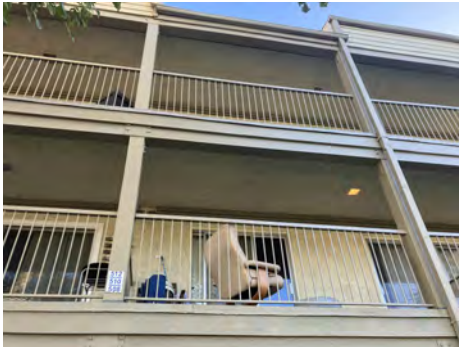
E. UNIT 510 - 2ND FLOOR 12' BEAM
REPLACEMENT - 01-03-24

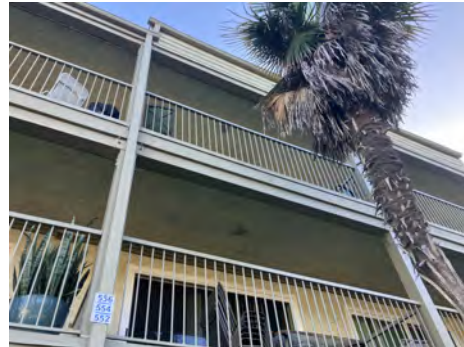
J. UNIT 554 - 2ND FLOOR 14' BEAM
REPLACEMENT - 01-03-24

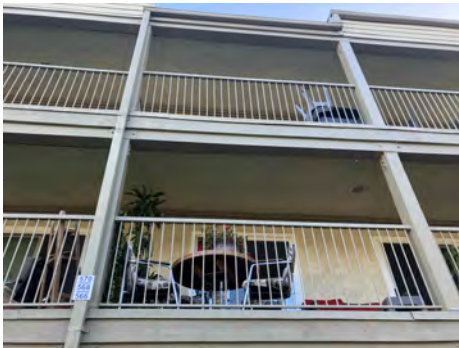
F. UNIT 568 - 2ND FLOOR 12' BEAM
REPLACEMENT - 01-03-24

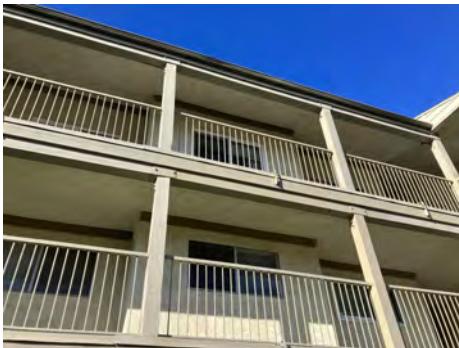
G. UNIT 526 - 2ND FLOOR 12' BEAM
REPLACEMENT - 01-03-24

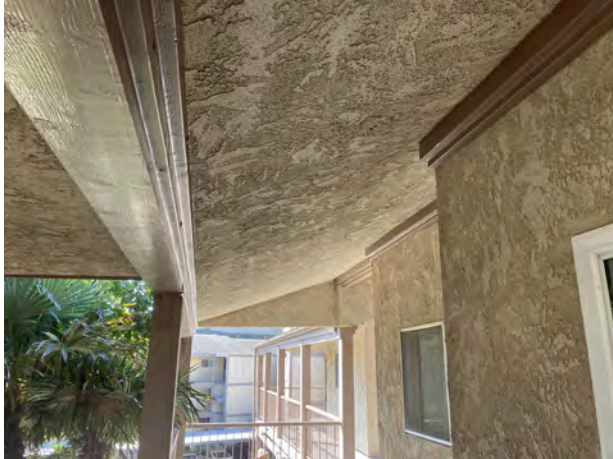
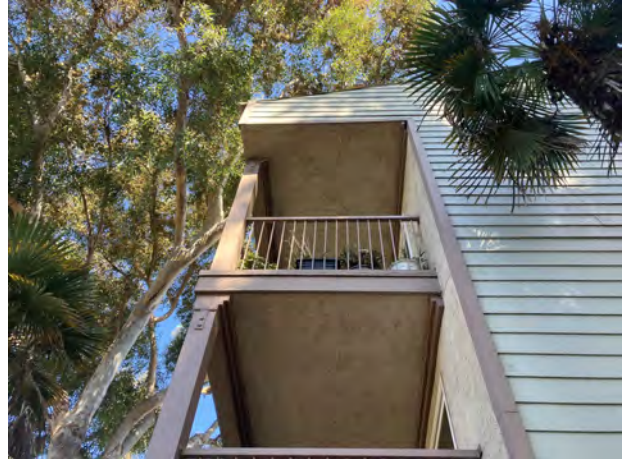
NEW LEDGER @ 3RD FLOOR SOFFIT - 10/23/23

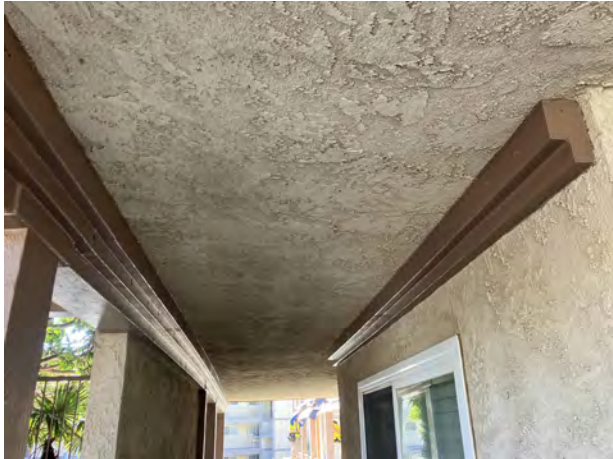
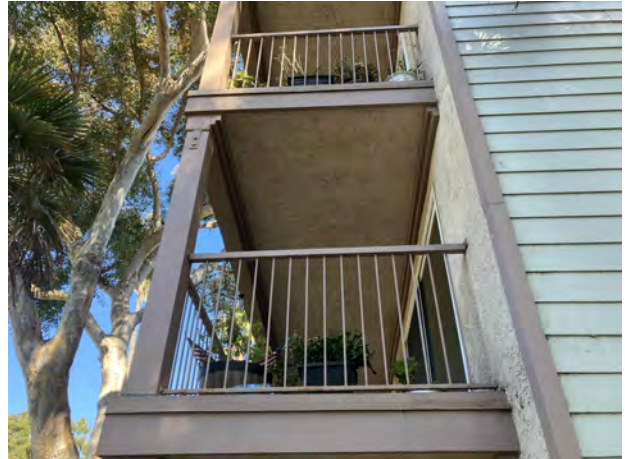
NEW LEDGER @ 2ND FLOOR SOFFIT - 10/23/23

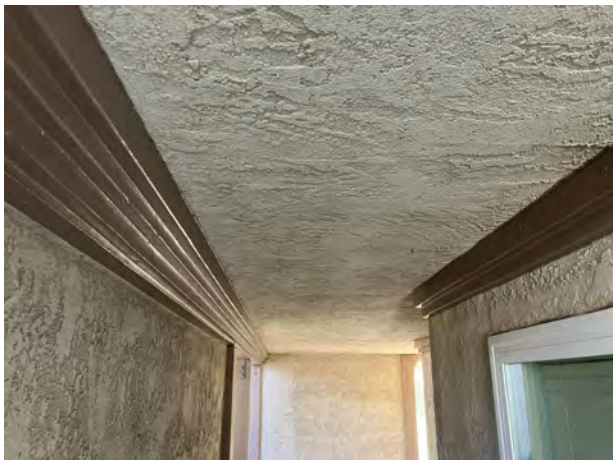
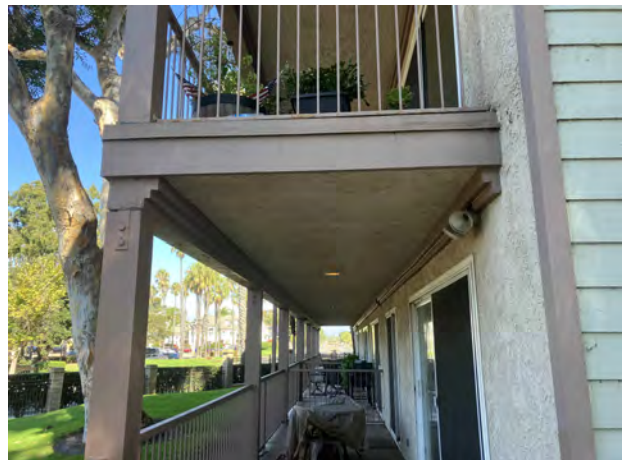
NEW LEDGER @ 1ST FLOOR SOFFIT - 10/23/23

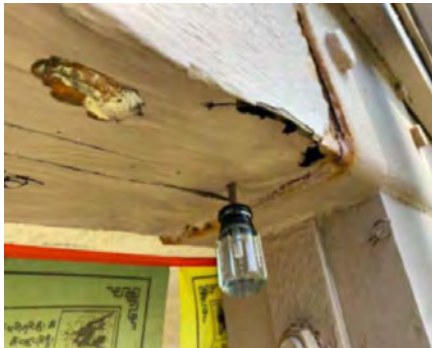
A. ORIGINAL - 8/10/21
(UNIT 616 - DRY ROT AT BEAM)

NEW - 11/14/23

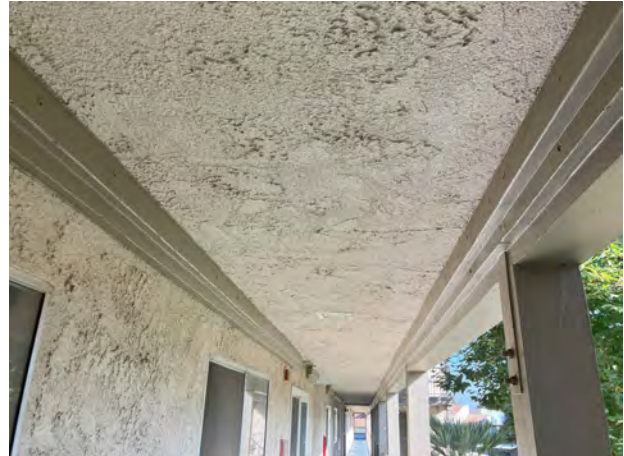
NEW LEDGER @ 2ND FLOOR SOFFIT - 09/25/23

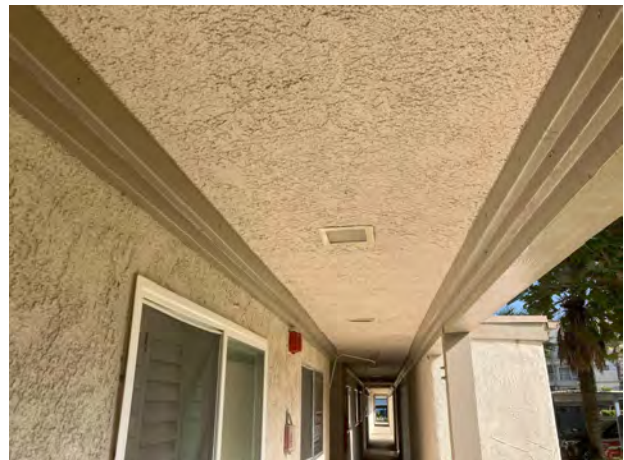
NEW LEDGER @ 1ST FLOOR SOFFIT - 09/25/23

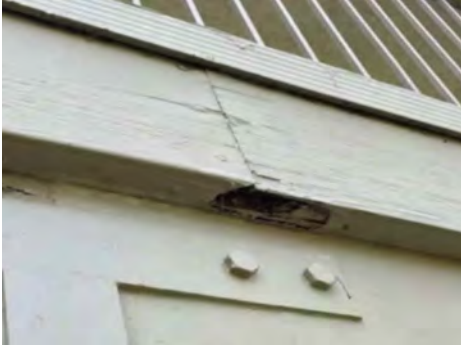
A. ORIGINAL - 8/10/21 (ELEVATED WALK WAY -
DRY ROT AT POST/BEAM)

NEW - 09/25/23

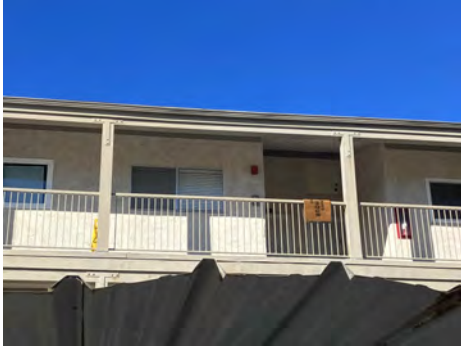
B. UNIT 661 - 3RD FLOOR 14' BEAM
REPLACEMENT - 01-03-24

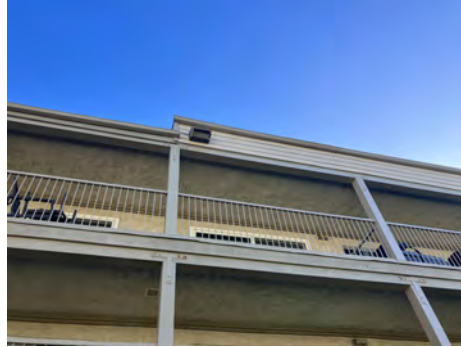
C. UNIT 667 - 3RD FLOOR 12' BEAM &
5. UNIT 667 3RD FLOOR 8' POST
REPLACEMENT - 01-03-24

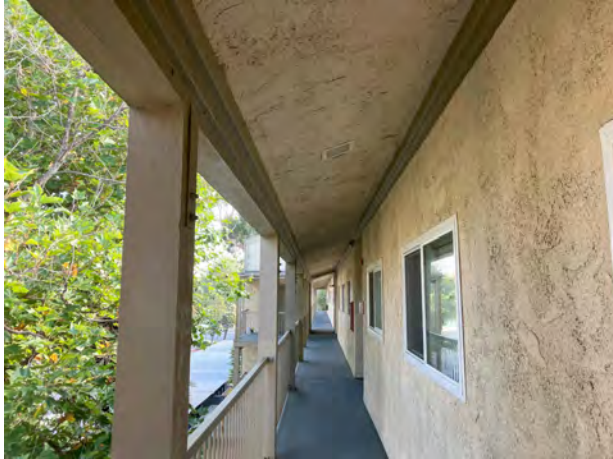
NEW LEDGER @ 3RD FLOOR SOFFIT - 09/25/23

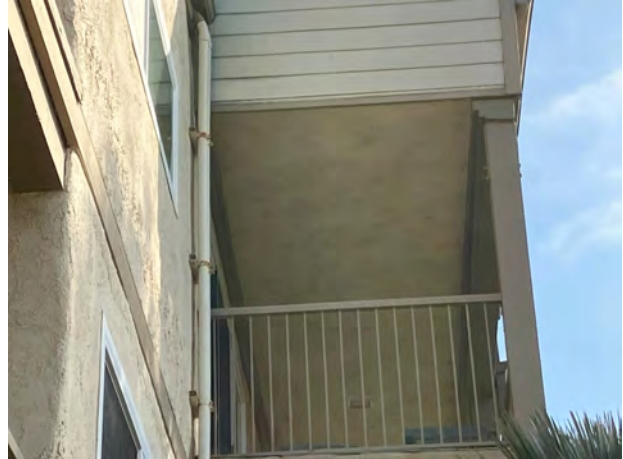
NEW LEDGER @ 3RD FLOOR SOFFIT - 09/25/23

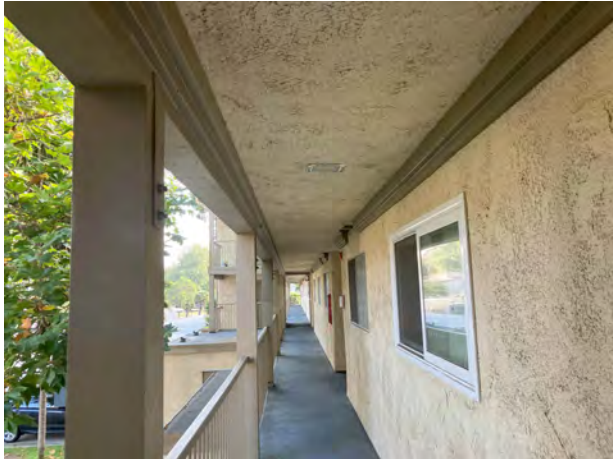
NEW LEDGER @ 2ND FLOOR SOFFIT - 09/25/23

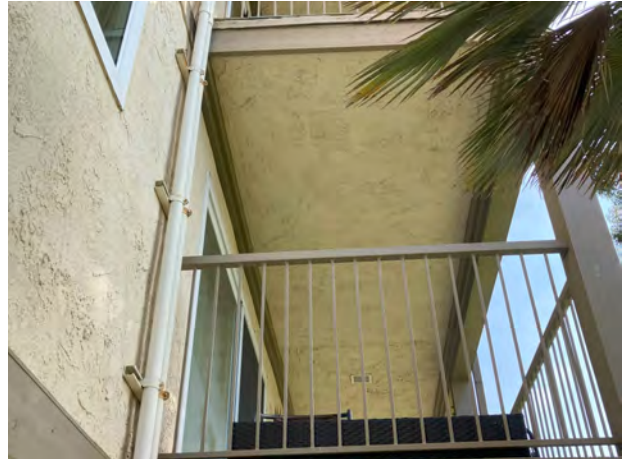
NEW LEDGER @ 2ND FLOOR SOFFIT - 09/25/23

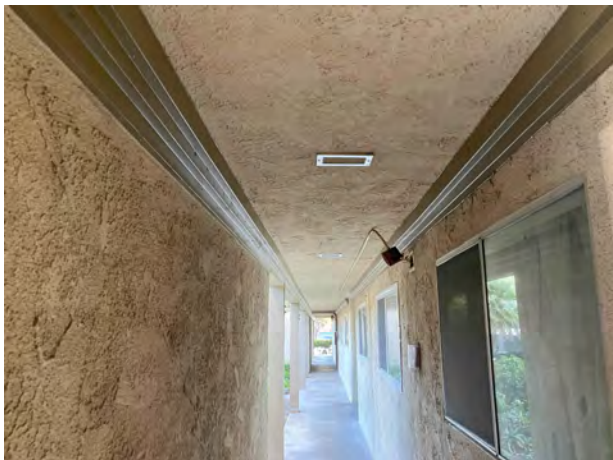
NEW LEDGER @ 1ST FLOOR SOFFIT - 09/25/23

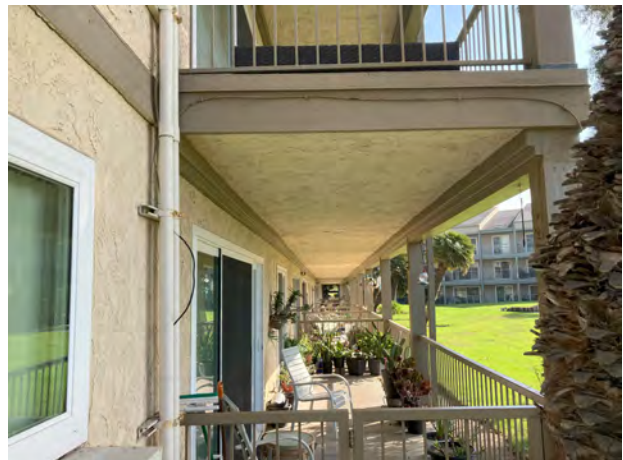
NEW LEDGER @ 1ST FLOOR SOFFIT - 09/25/23

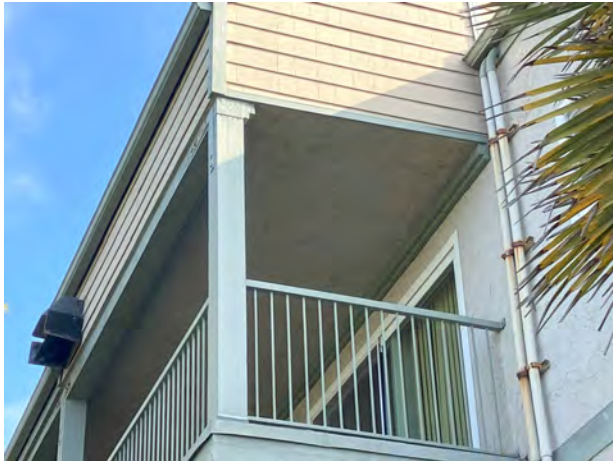
NEW LEDGER @ 3RD FLOOR SOFFIT - 09/25/23

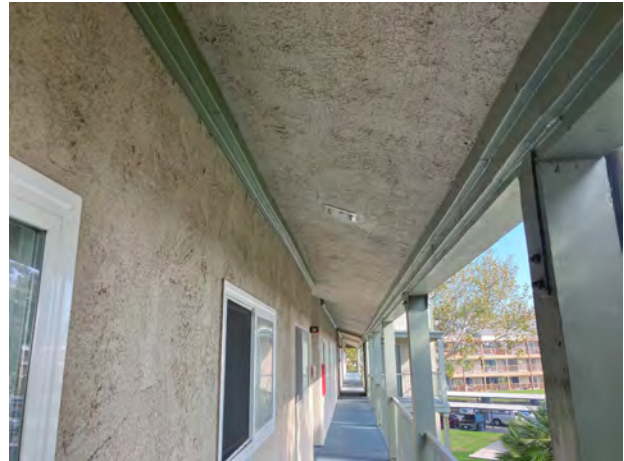
NEW LEDGER @ 3RD FLOOR SOFFIT - 09/25/23

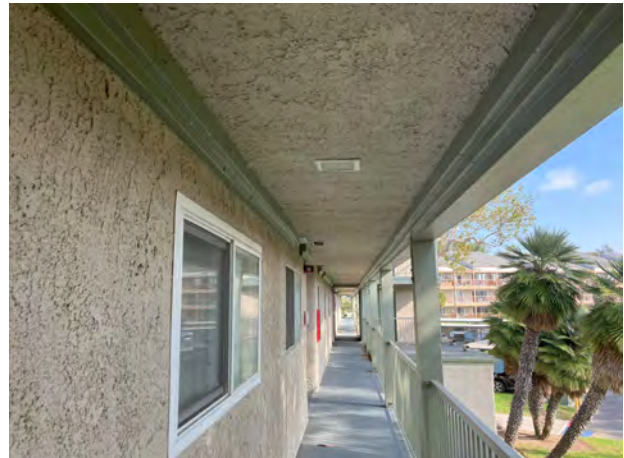
NEW LEDGER @ 2ND FLOOR SOFFIT - 09/25/23

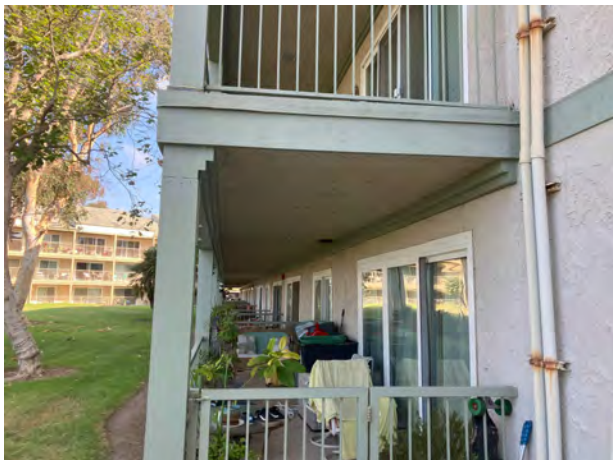
NEW LEDGER @ 1ST FLOOR SOFFIT - 09/25/23

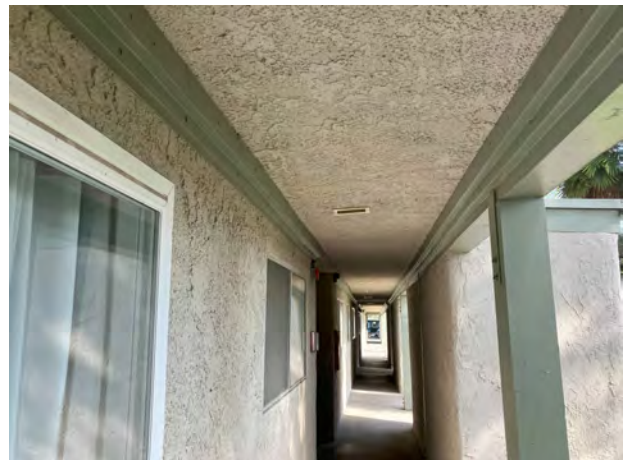
NEW LEDGER @ 1ST FLOOR SOFFIT - 09/25/23

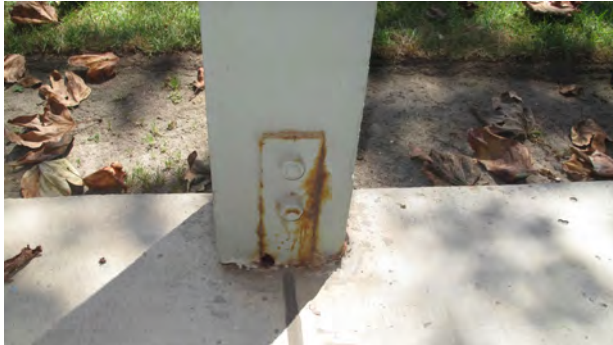
1. ORIGINAL - 8/10/21
(ELEVATED WALK- RUST AT HARDWARE)

NEW - 07/26/23

- REMOVE AND REPLACE ANY DAMAGED AND/OR IMPROPERLY INSTALLED MATERIALS AS REQUIRED
- NEW COMPONENTS SHALL BE PROPERLY INTEGRATED INTO BUILDING ASSEMBLIES PER CODE AND INDUSTRY STANDARDS.
- PREP, PRIME AND PAINT ALL 6 SIDES OF NEW EXPOSED WOOD COMPONENTS
- PROVIDE SEALANT AT ALL JOINTS AND PAINT TO MATCH AS REQUIRED
- WHERE MISSING, INSTALL NEW GALVANIZED HARDWARE AND/OR STRUCTURAL BUILDING COMPONENT AS REQUIRED.

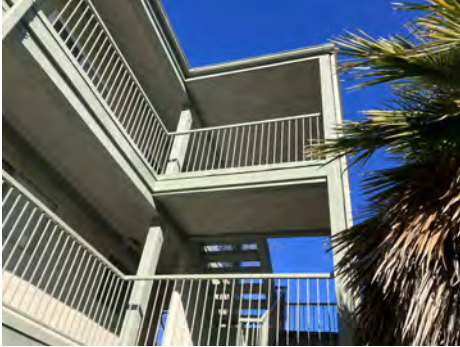
A. UNIT 864 - 2ND FLOOR 10' BEAM
REPLACEMENT & STUCCO - 01-03-24

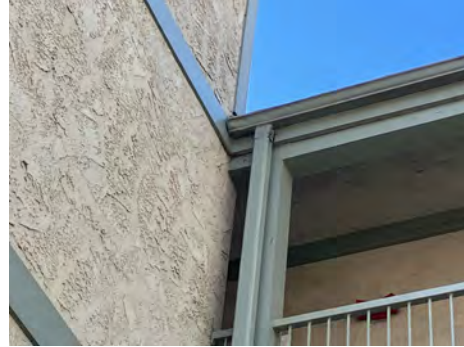
C. UNIT 836 - 3RD FLOOR 1' BEAM
REPLACEMENT - 01-03-24

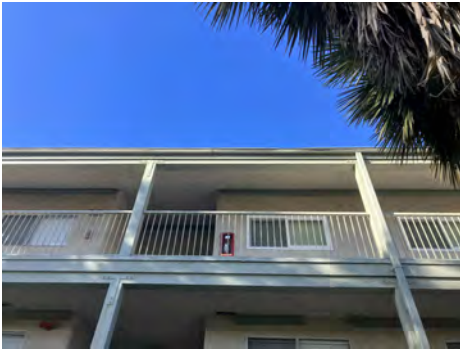
B. UNIT 824 - 3RD FLOOR 16' BEAM
REPLACEMENT - 01-03-24

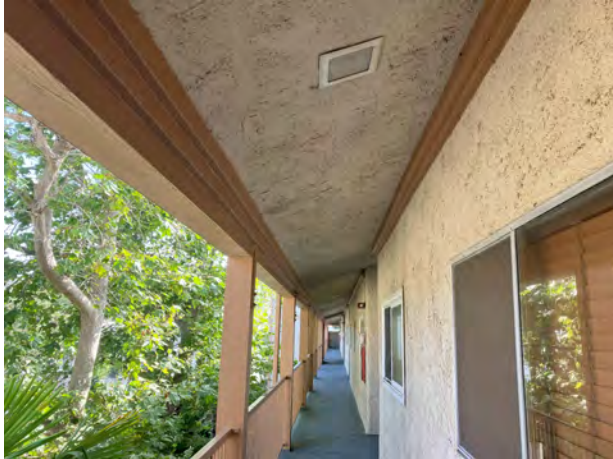
NEW LEDGER @ 3RD FLOOR SOFFIT - 09/25/23

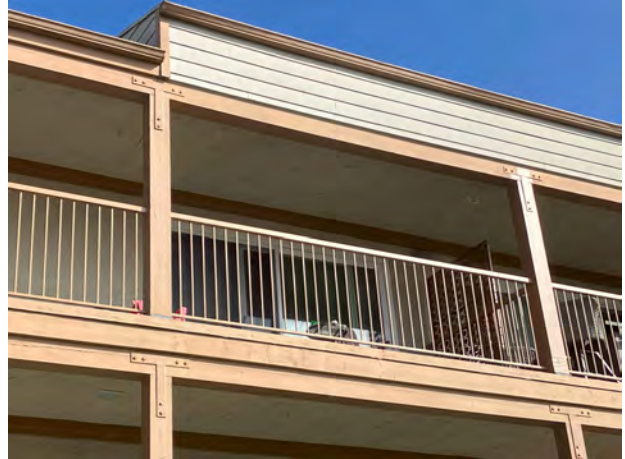
NEW LEDGER @ 3RD FLOOR SOFFIT - 09/25/23

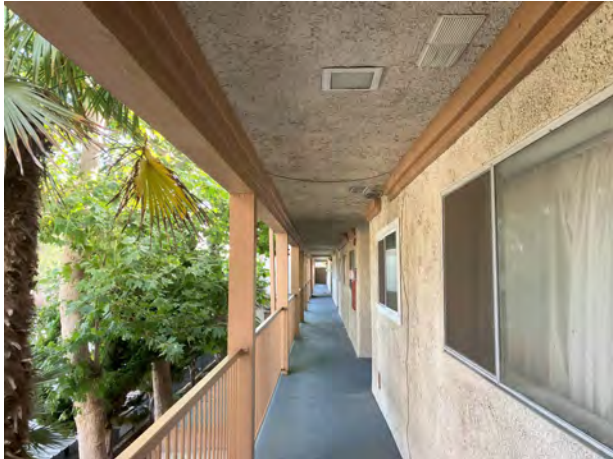
NEW LEDGER @ 2ND FLOOR SOFFIT - 09/25/23

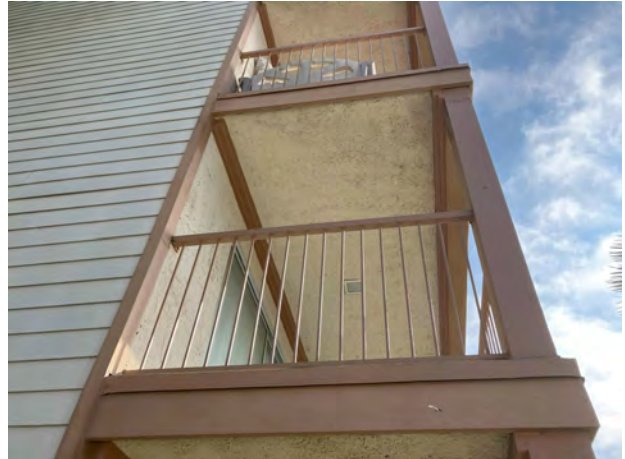
NEW LEDGER @ 2ND FLOOR SOFFIT - 09/25/23

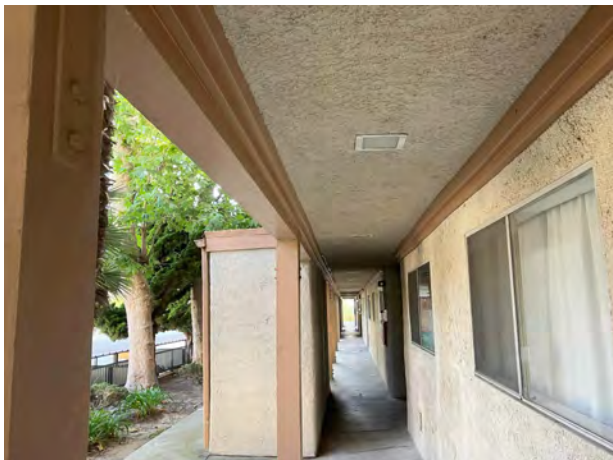
NEW LEDGER @ 1ST FLOOR SOFFIT - 09/25/23

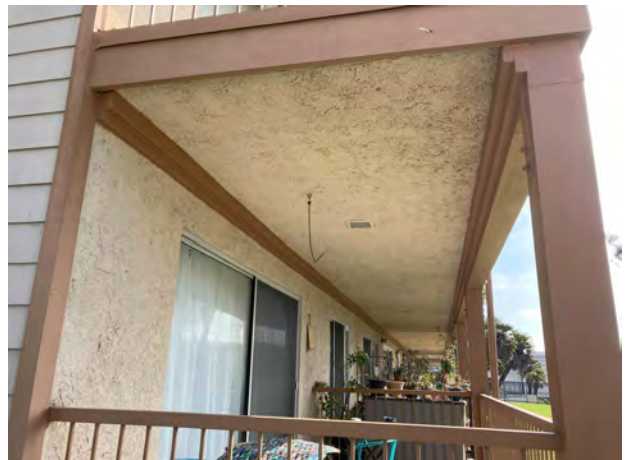
NEW LEDGER @ 1ST FLOOR SOFFIT - 09/25/23

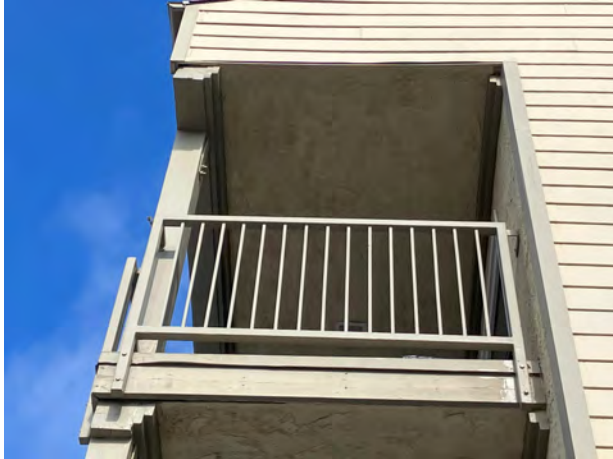
NEW LEDGER @ 3RD FLOOR SOFFIT - 09/25/23

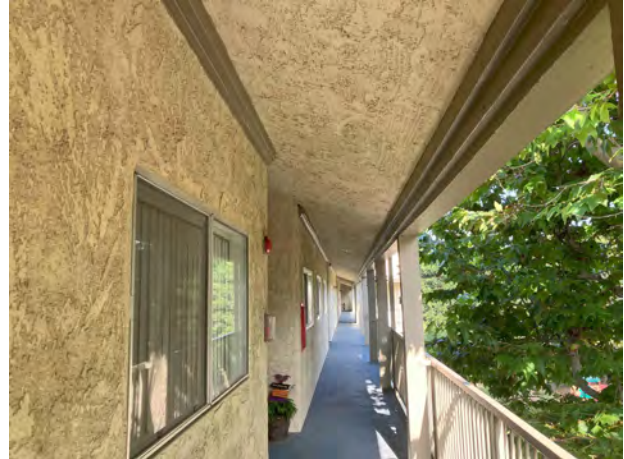
NEW LEDGER @ 3RD FLOOR SOFFIT - 09/25/23

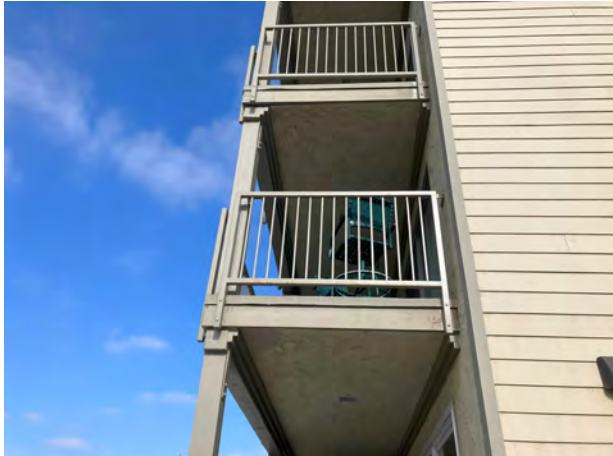
NEW LEDGER @ 2ND FLOOR SOFFIT - 09/25/23

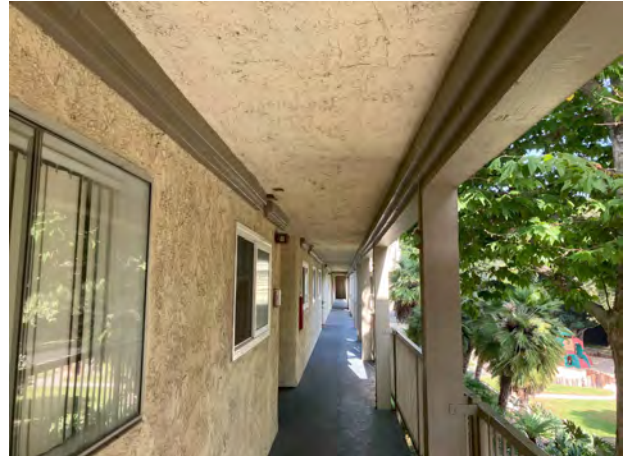
NEW LEDGER @ 2ND FLOOR SOFFIT - 09/25/23

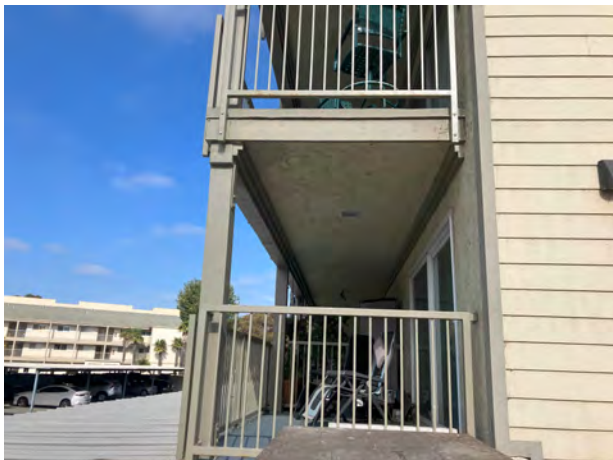
NEW LEDGER @ 1ST FLOOR SOFFIT - 09/25/23

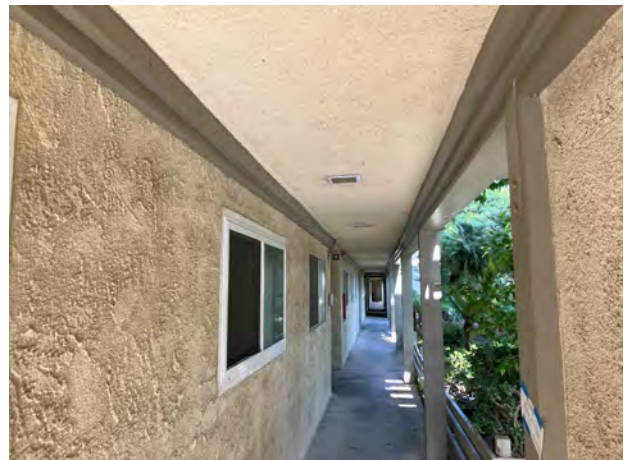
NEW LEDGER @ 1ST FLOOR SOFFIT - 09/25/23

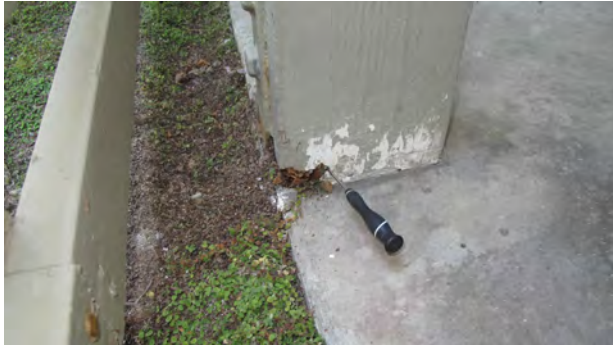
5. ORIGINAL - 8/10/21
(ELEVATED WALK- DRY ROT AT POST)

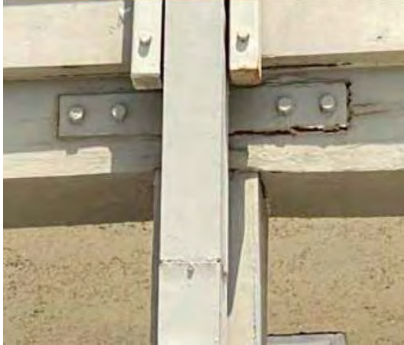
A. ORIGINAL - 8/10/21
(UNIT 643 - DRY ROT AT BEAM)

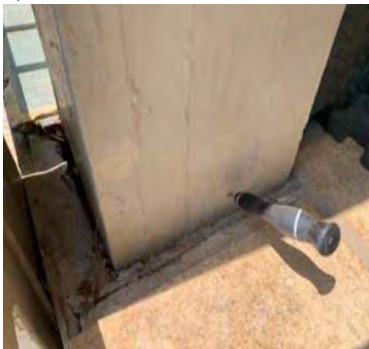
B. ORIGINAL - 8/10/21
(UNIT 685 - DRY ROT AT BEAM)

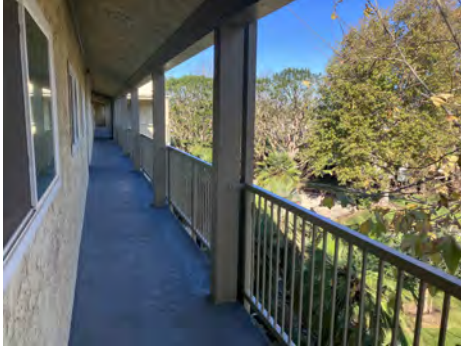
9. UNIT 687 - 3RD FLOOR 8' POST REPLACEMENT - 01-03-24

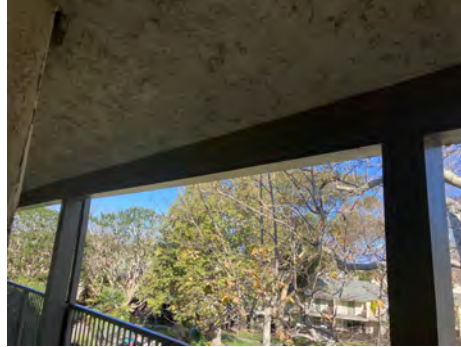
D. UNIT 687 - 3RD FLOOR 14' BEAM REPLACEMENT - 01-03-24

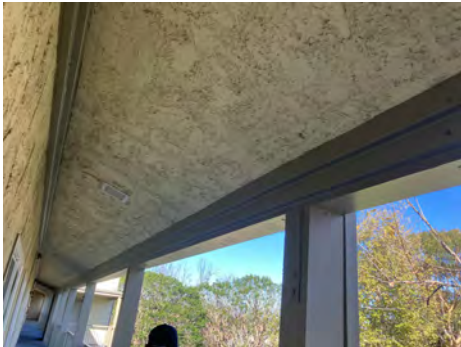
C. UNIT 687 - 3RD FLOOR 12' BEAM REPLACEMENT - 01-03-24

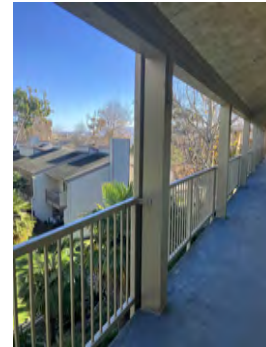
12. UNIT 669 - 3RD FLOOR 8' POST REPLACEMENT - 01-03-24

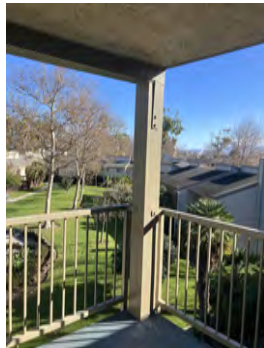
10. UNIT 669 - 3RD FLOOR ELEVATOR 8' POST REPLACEMENT - 01-03-24

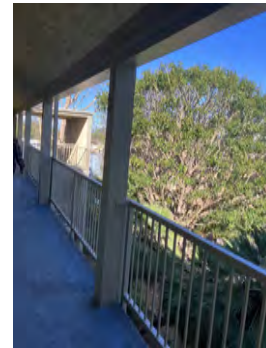
13. UNIT 663 - 3RD FLOOR 8' POST REPLACEMENT - 01-03-24

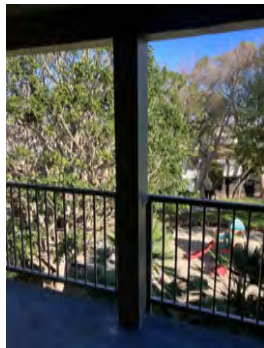
11. UNIT 651 - 3RD FLOOR 8' POST REPLACEMENT - 01-03-24
