SURFSIDE III
PROJECT SUMMARY REPORT

JANUARY 26, 2024

This report prepared for:
Surfside III
600 Sunfish Way
Port Hueneme, CA 93041

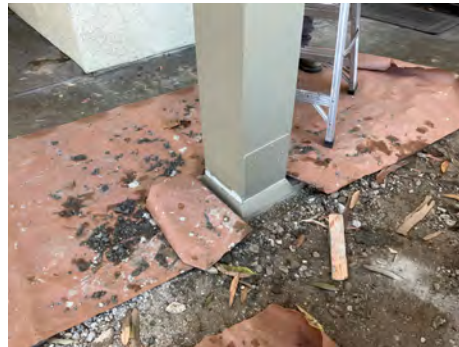
NEW - 10/23/23

1. ORIGINAL - 8/10/21
(ELEVATED WALK- RUST AT HARDWARE)

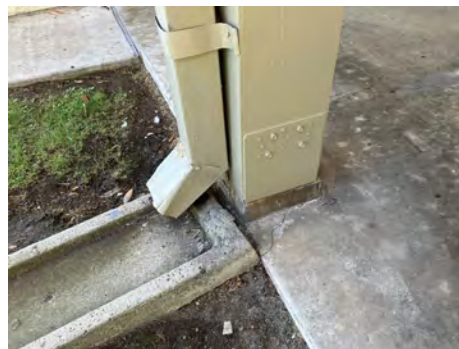
NEW - 10/23/23

2. ORIGINAL - 8/10/20212.
(ELEVATED WALK- DRY ROT AT POST)

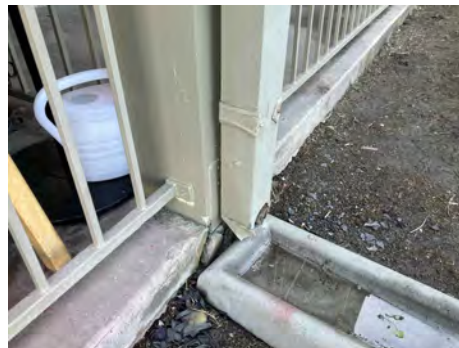
NEW - 10/23/23

4. ORIGINAL - 8/10/21
(ELEVATED WALK- RUST AT HARDWARE)

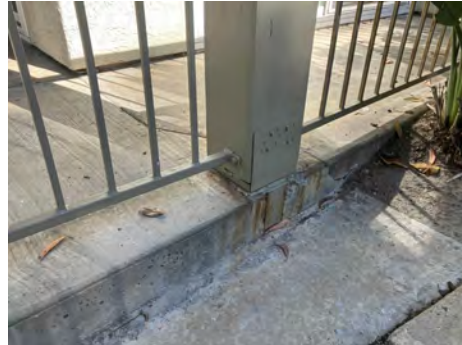
NEW - 10/23/23

5. ORIGINAL - 8/10/21
(ELEVATED WALK- DRY ROT AT POST)

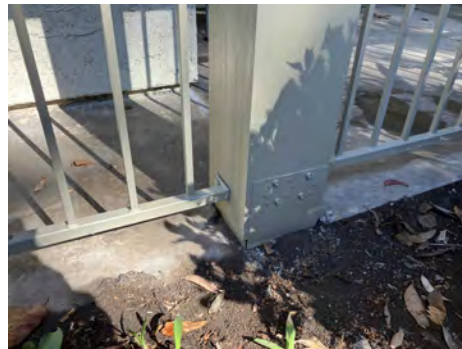
NEW - 10/23/23

6. ORIGINAL - 8/10/21
(ELEVATED WALK- RUST AT HARDWARE)

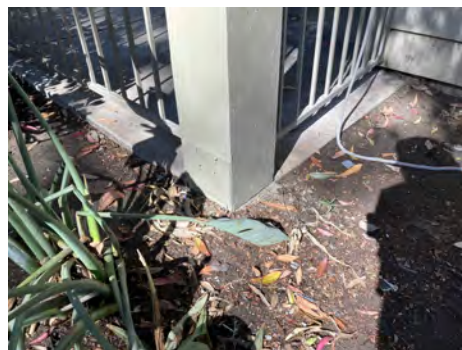
NEW - 10/23/23

7. ORIGINAL - 8/10/21
(ELEVATED WALK- RUST AT HARDWARE)

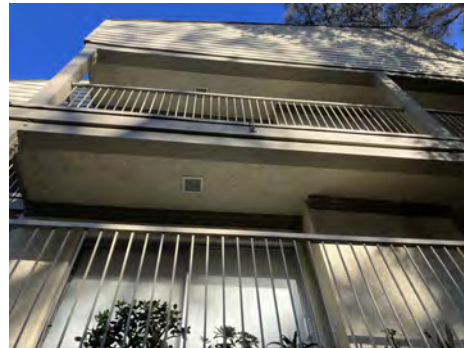
K. UNIT 574 - 2ND FLOOR 16' BEAM
REPLACEMENT - 01-03-24

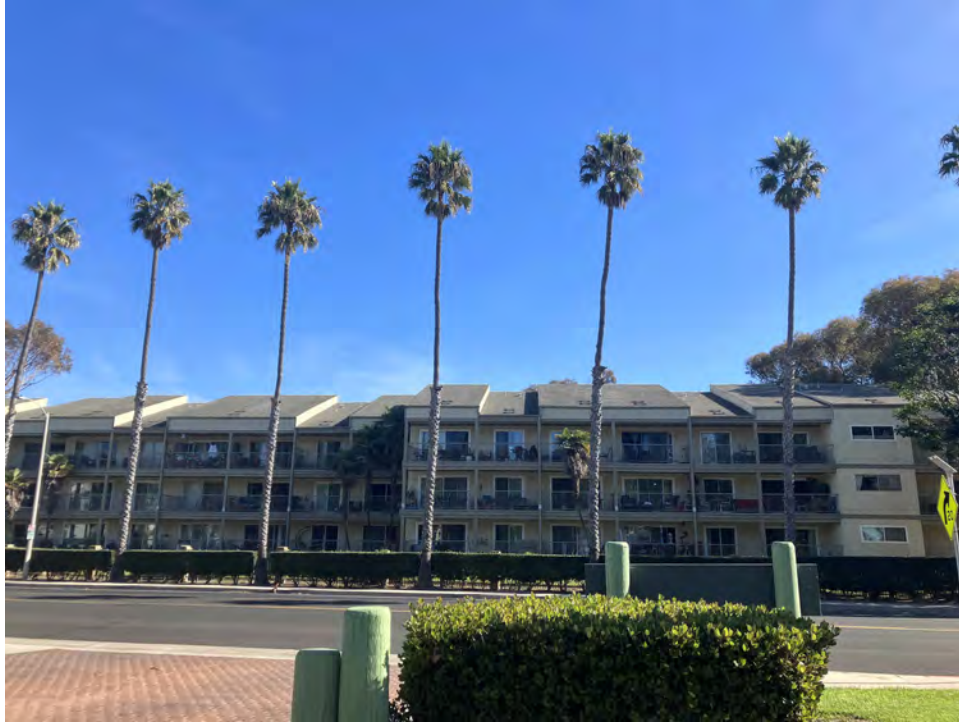
BUILDING 1 ROOF VENTS

TOTAL VENTS
 INSTALLED: 26

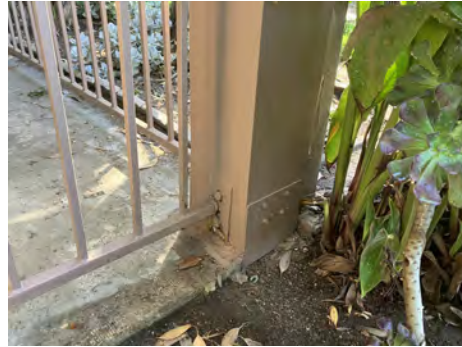
NEW - 10/23/23

1. ORIGINAL - 8/10/21
(ELEVATED WALK- RUST AT HARDWARE)

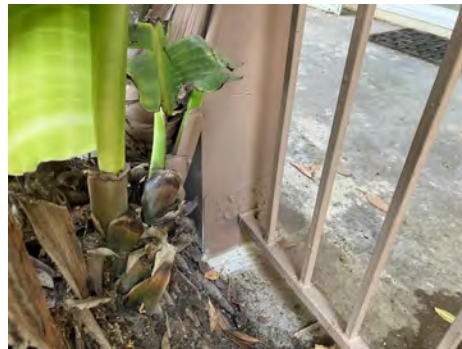
NEW - 10/23/23

2. ORIGINAL - 8/10/21
(ELEVATED WALK- RUST AT HARDWARE)

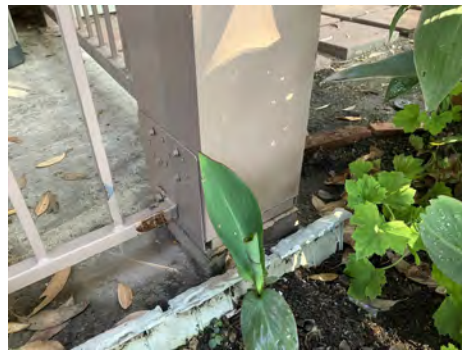
3. ORIGINAL - 8/10/21 (ELEVATED WALK- RUST
AT HARDWARE AND DRY ROT AT POST)

NEW - 10/23/23

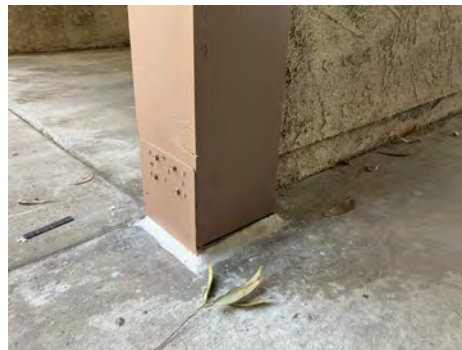
4. ORIGINAL - 8/10/21
(ELEVATED WALK- RUST AT HARDWARE)

NEW - 10/23/23

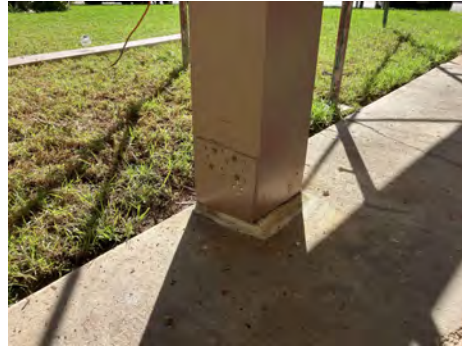
5. ORIGINAL - 8/10/21
(ELEVATED WALK- RUST AT HARDWARE)

NEW - 10/23/23

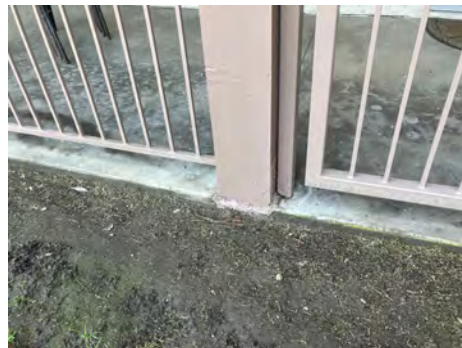
8. ORIGINAL - 8/10/21
(ELEVATED WALK- RUST AT HARDWARE)

NEW - 10/23/23

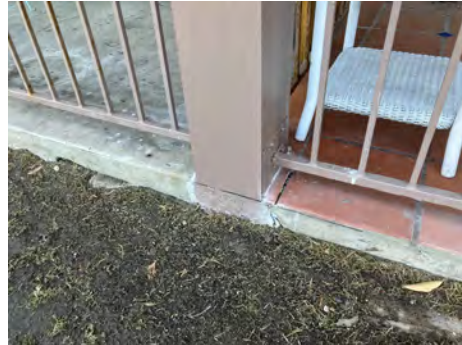
9. ORIGINAL - 8/10/21
(ELEVATED WALK - RUST AT HARDWARE)

NEW - 10/23/23

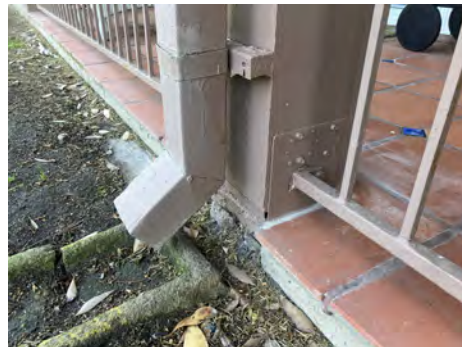
10. ORIGINAL - 8/10/21
(ELEVATED WALK- RUST AT HARDWARE)

NEW - 10/23/23

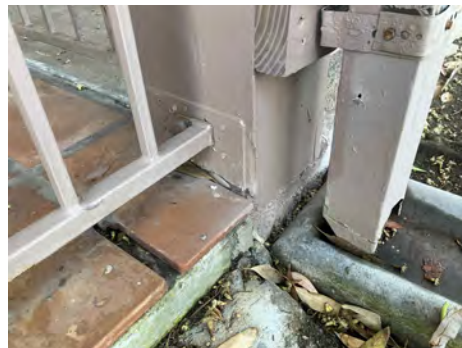
11. ORIGINAL - 8/10/21
(ELEVATED WALK- RUST AT HARDWARE)

NEW - 10/23/23

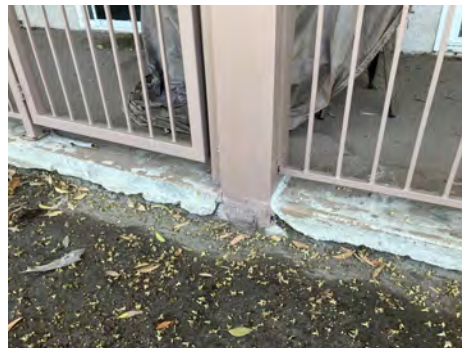
12. ORIGINAL - 8/10/21
(ELEVATED WALK- RUST AT HARDWARE)

NEW - 10/23/23

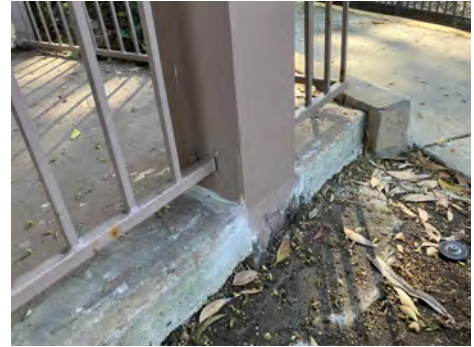
13. ORIGINAL - 8/10/21
(ELEVATED WALK- RUST AT HARDWARE)

NEW - 10/23/23

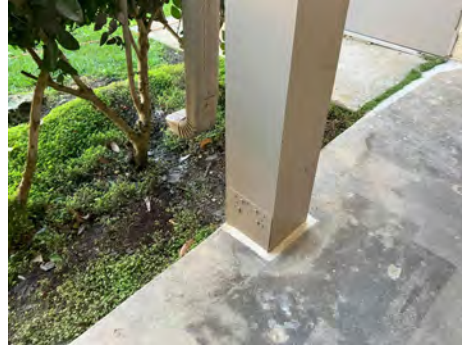
1. ORIGINAL - 8/10/21
(ELEVATED WALK- RUST AT HARDWARE)

NEW - 09/25/23

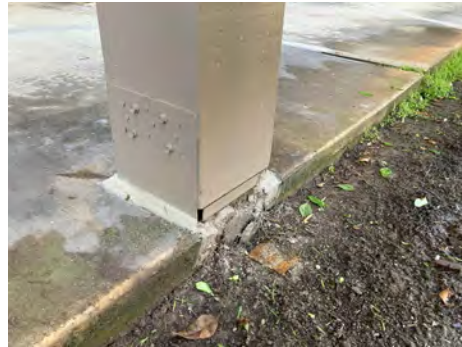
2. ORIGINAL - 8/10/21 (ELEVATED WALK- RUST AT HARDWARE AND DRY ROT AT POST)

NEW - 09/25/23

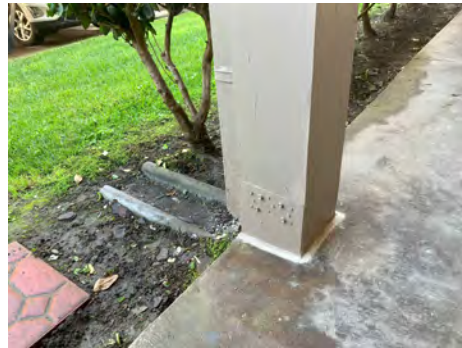
3. ORIGINAL - 8/10/21
(ELEVATED WALK- RUST AT HARDWARE)

NEW - 09/25/23

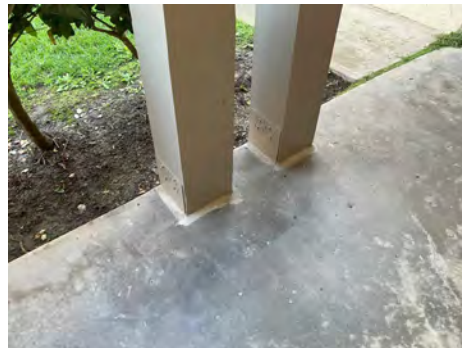
4. ORIGINAL - 8/10/21
(ELEVATED WALK- RUST AT HARDWARE)

NEW - 09/25/23

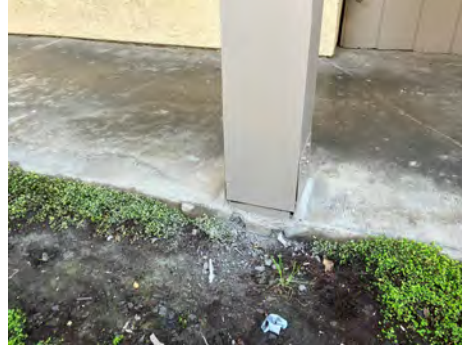
5. ORIGINAL - 8/10/21
(ELEVATED WALK- RUST AT HARDWARE)

NEW - 09/25/23

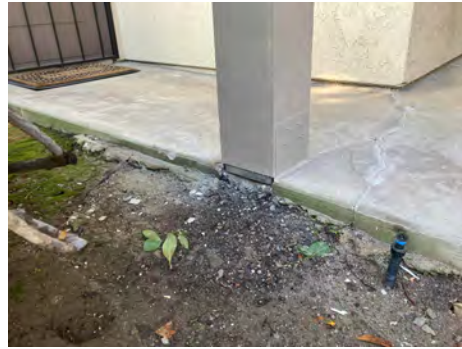
6. ORIGINAL - 8/10/21
(ELEVATED WALK- RUST AT HARDWARE)

NEW - 09/25/23

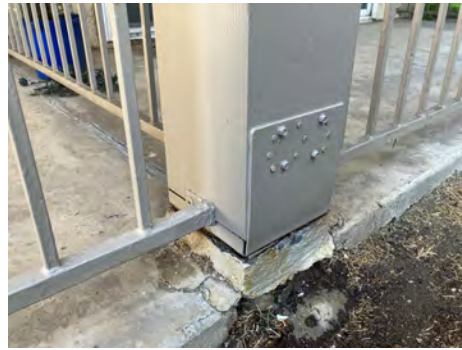
7. ORIGINAL - 8/10/21 (ELEVATED WALK- DRY
ROT AT POST AND RUST AT HARDWARE)

NEW - 10/23/23

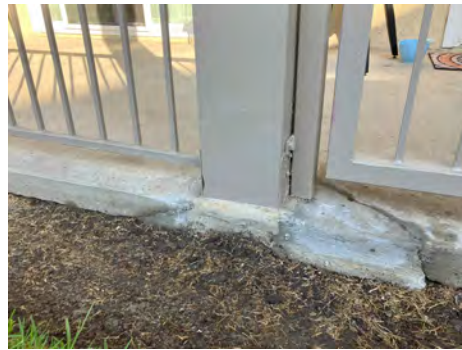
8. ORIGINAL - 8/10/21
(ELEVATED WALK- RUST AT HARDWARE)

NEW - 09/25/23

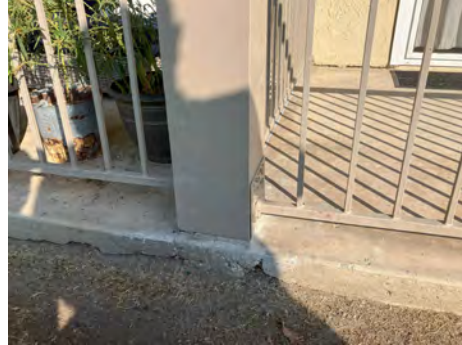
9. ORIGINAL - 8/10/21 (ELEVATED WALK- DRY ROT AT POST AND RUST AT HARDWARE)

NEW - 09/25/23

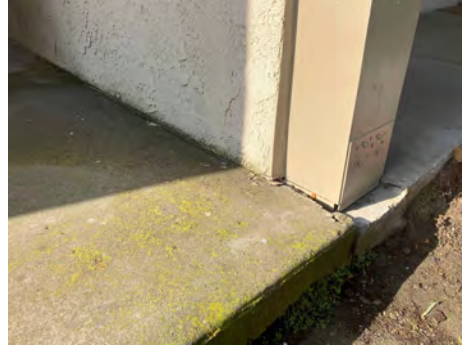
1. ORIGINAL - 8/10/21
(ELEVATED WALK- RUST AT HARDWARE)

NEW - 09/25/23

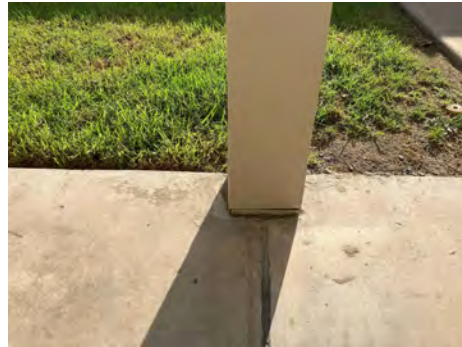
2. ORIGINAL - 8/10/21
(ELEVATED WALK- RUST AT HARDWARE)

NEW - 09/25/23

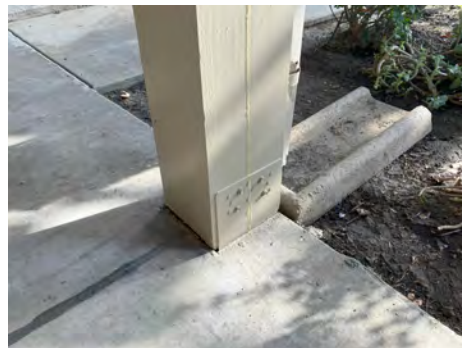
3. ORIGINAL - 8/10/21 (ELEVATED WALK- DRY
ROT AT POST AND RUST AT HARDWARE)

NEW - 09/25/23

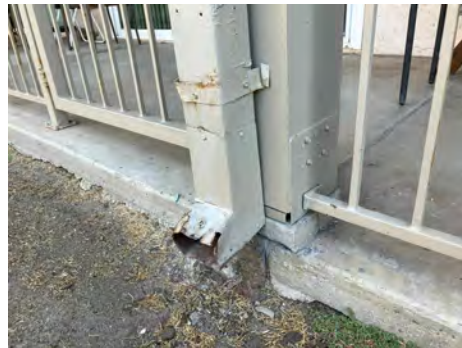
4. ORIGINAL - 8/10/21
(ELEVATED WALK- RUST AT HARDWARE)

NEW - 09/25/23

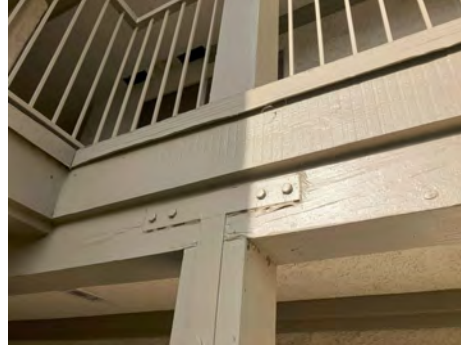
A. ORIGINAL - 8/10/21 (ELEVATED WALK WAY -
DRY ROT AT POST/BEAM)

NEW - 09/25/23

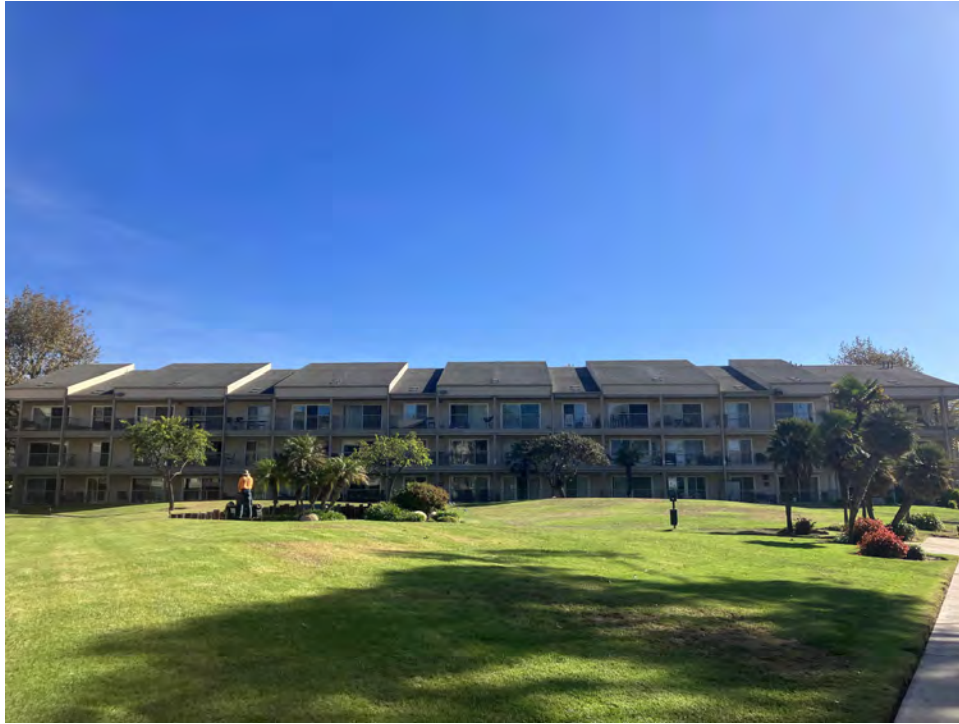
BUILDING 4 ROOF VENTS

OBSERVATION
 DATE: 11/14/23

TOTAL VENTS
 INSTALLED: 26

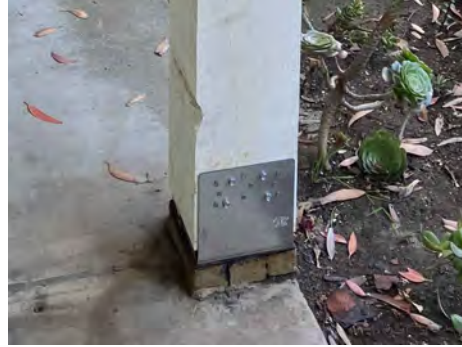
1. ORIGINAL - 8/10/21
(ELEVATED WALK- RUST AT HARDWARE)

NEW - 07/26/23

- REMOVE AND REPLACE ANY DAMAGED AND/OR IMPROPERLY INSTALLED MATERIALS AS REQUIRED
- NEW COMPONENTS SHALL BE PROPERLY INTEGRATED INTO BUILDING ASSEMBLIES PER CODE AND INDUSTRY STANDARDS.
- PREP, PRIME AND PAINT ALL 6 SIDES OF NEW EXPOSED WOOD COMPONENTS
- PROVIDE SEALANT AT ALL JOINTS AND PAINT TO MATCH AS REQUIRED
- WHERE MISSING, INSTALL NEW GALVANIZED HARDWARE AND/OR STRUCTURAL BUILDING COMPONENT AS REQUIRED.

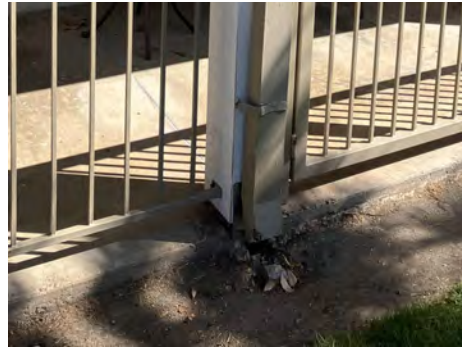
2. ORIGINAL - 8/10/21
(ELEVATED WALK- RUST AT HARDWARE)

NEW - 07/26/23

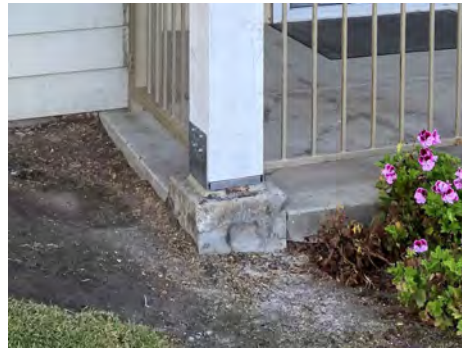
3. ORIGINAL - 8/10/21
(ELEVATED WALK- RUST AT HARDWARE)

NEW - 07/26/23

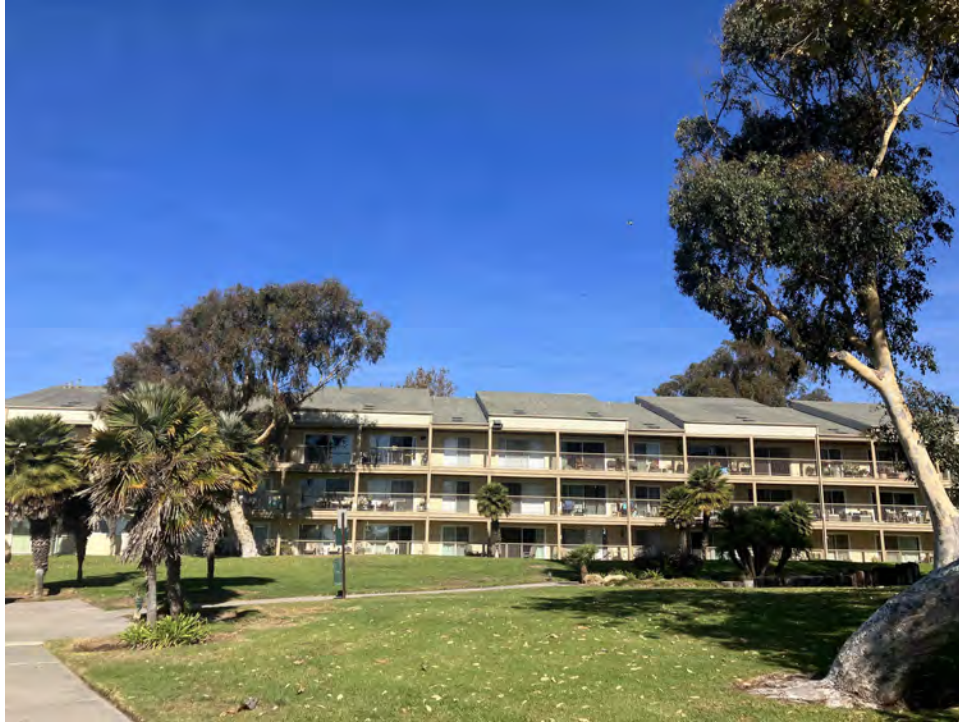
BUILDING 5 ROOF VENTS

OBSERVATION
 DATE: 11/14/23

TOTAL VENTS
 INSTALLED: 26

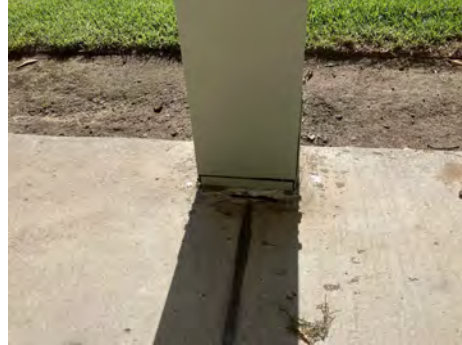
1. ORIGINAL - 8/10/21
(ELEVATED WALK- RUST AT HARDWARE)

NEW - 07/26/23

- REMOVE AND REPLACE ANY DAMAGED AND/OR IMPROPERLY INSTALLED MATERIALS AS REQUIRED
- NEW COMPONENTS SHALL BE PROPERLY INTEGRATED INTO BUILDING ASSEMBLIES PER CODE AND INDUSTRY STANDARDS.
- PREP, PRIME AND PAINT ALL 6 SIDES OF NEW EXPOSED WOOD COMPONENTS
- PROVIDE SEALANT AT ALL JOINTS AND PAINT TO MATCH AS REQUIRED
- WHERE MISSING, INSTALL NEW GALVANIZED HARDWARE AND/OR STRUCTURAL BUILDING COMPONENT AS REQUIRED.

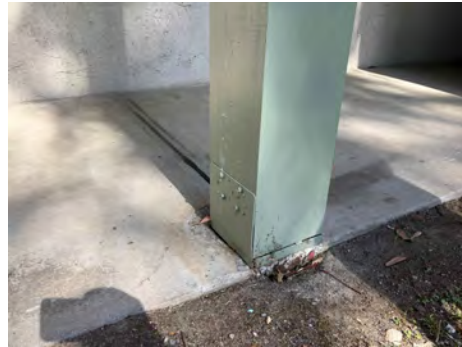
2. ORIGINAL - 8/10/21
(ELEVATED WALK- RUST AT HARDWARE)

NEW - 07/26/23

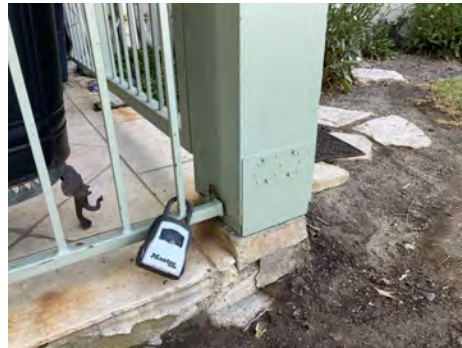
3. ORIGINAL - 8/10/21 (ELEVATED WALK- DRY
ROT AT POST AND RUST AT HARDWARE)

NEW - 07/26/23

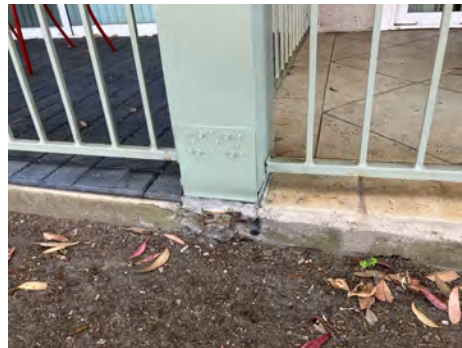
4. ORIGINAL - 8/10/21
(ELEVATED WALK- RUST AT HARDWARE)

NEW - 07/26/23

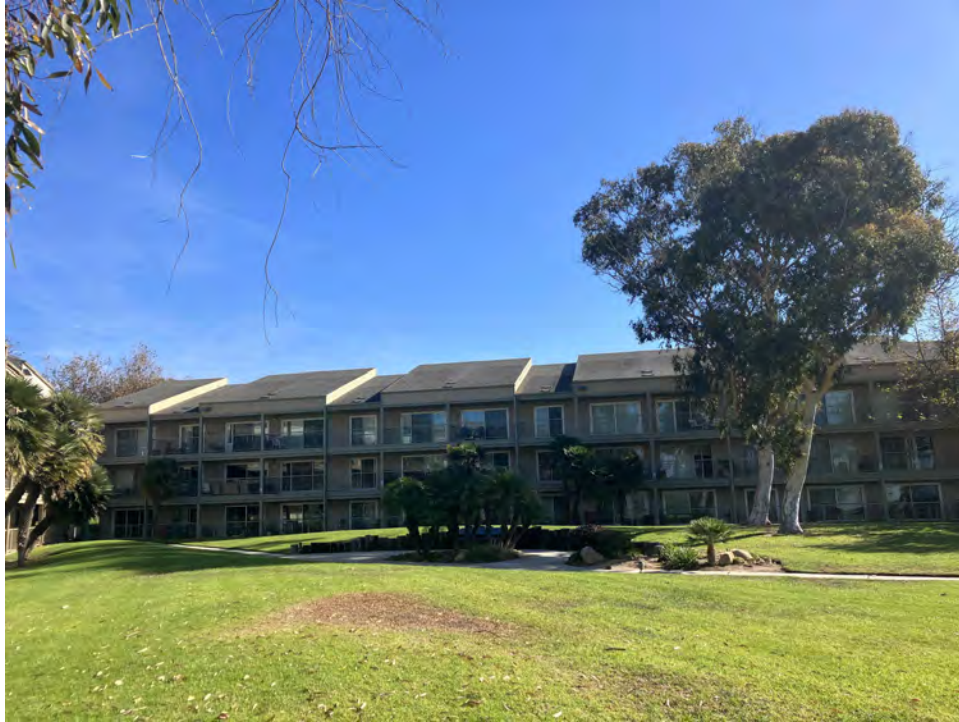
BUILDING 6 ROOF VENTS

TOTAL VENTS
 INSTALLED: 26

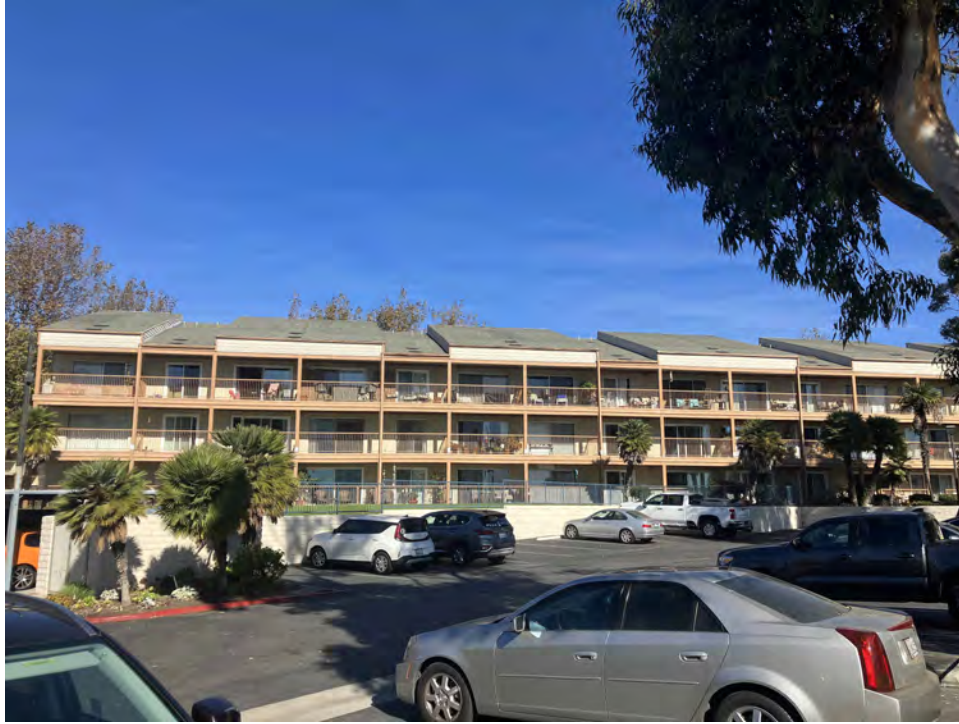
BUILDING 7 ROOF VENTS

TOTAL VENTS
 INSTALLED: 22

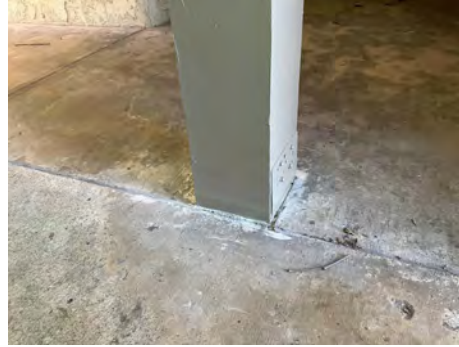
NEW - 07/26/23

1. ORIGINAL - 8/10/21 (ELEVATED WALK- DRY ROT AT POST AND RUST AT HARDWARE)

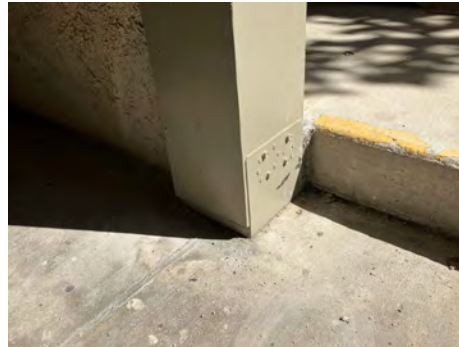
NEW - 07/26/23

2. ORIGINAL - 8/10/21
(ELEVATED WALK- RUST AT HARDWARE)

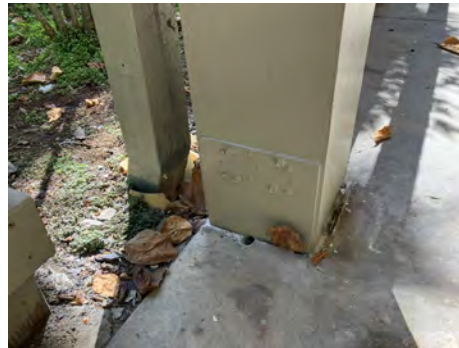
NEW - 07/26/23

3. ORIGINAL - 8/10/21 (ELEVATED WALK- DRY ROT AT POST AND RUST AT HARDWARE)

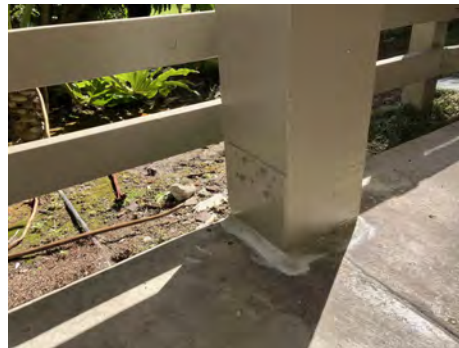
NEW - 07/26/23

4. ORIGINAL - 8/10/21
(ELEVATED WALK- RUST AT HARDWARE)

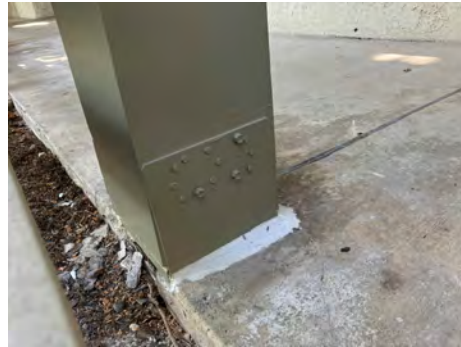
NEW - 07/26/23

6. ORIGINAL - 8/10/21
(ELEVATED WALK- RUST AT HARDWARE)

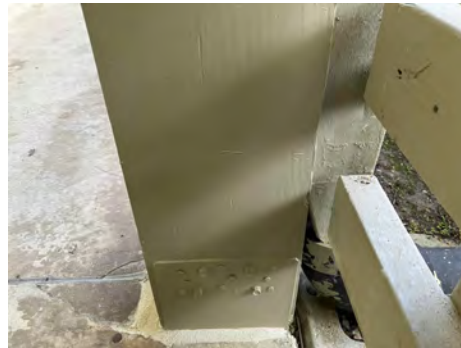
NEW - 07/26/23

7. ORIGINAL - 8/10/21
(ELEVATED WALK- RUST AT HARDWARE)

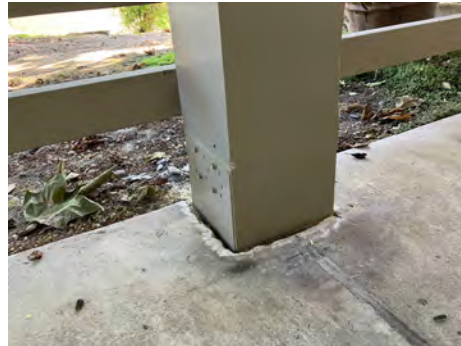
NEW - 07/26/23

8. ORIGINAL - 8/10/21
(ELEVATED WALK- RUST AT HARDWARE)
